The Interim CCT – Down the Drain in Silver Spring

February 14, 2006

The Trail is hazardous and uninviting
east of Rock Creek Park

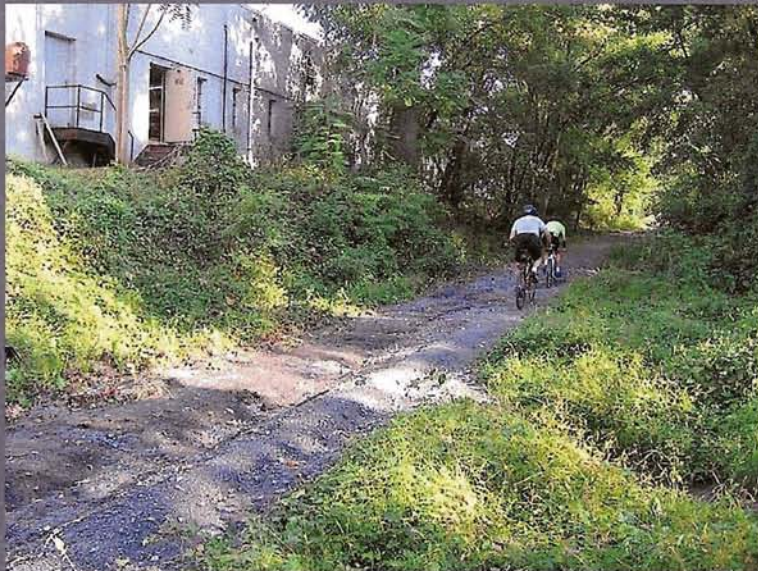
Storm water erosion leaves deep ruts and loose gravel
on the Interim CCT (a.k.a. Georgetown Branch Trail).

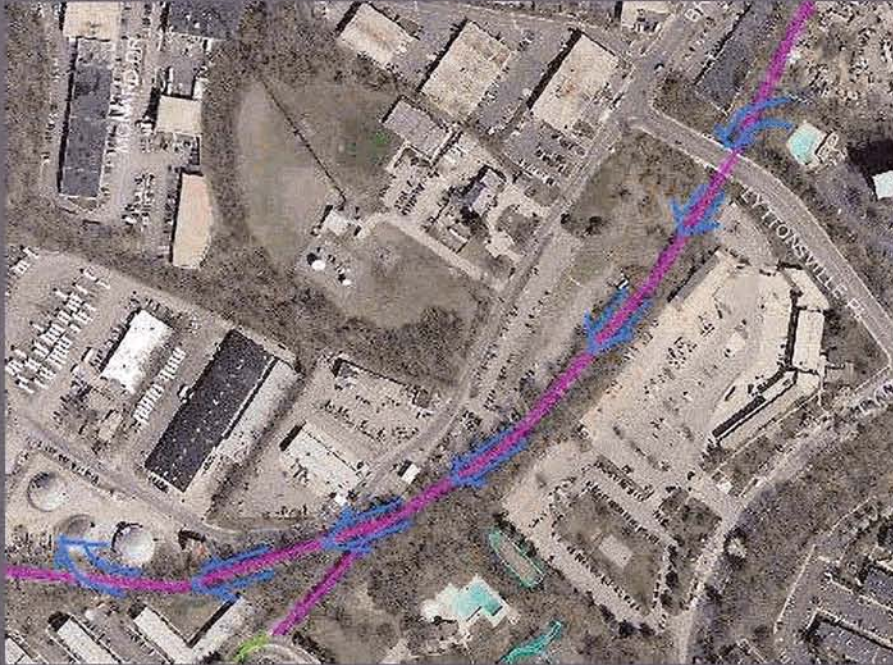
The Trail is in a drainage channel for approx. 1/2 mile near the east end

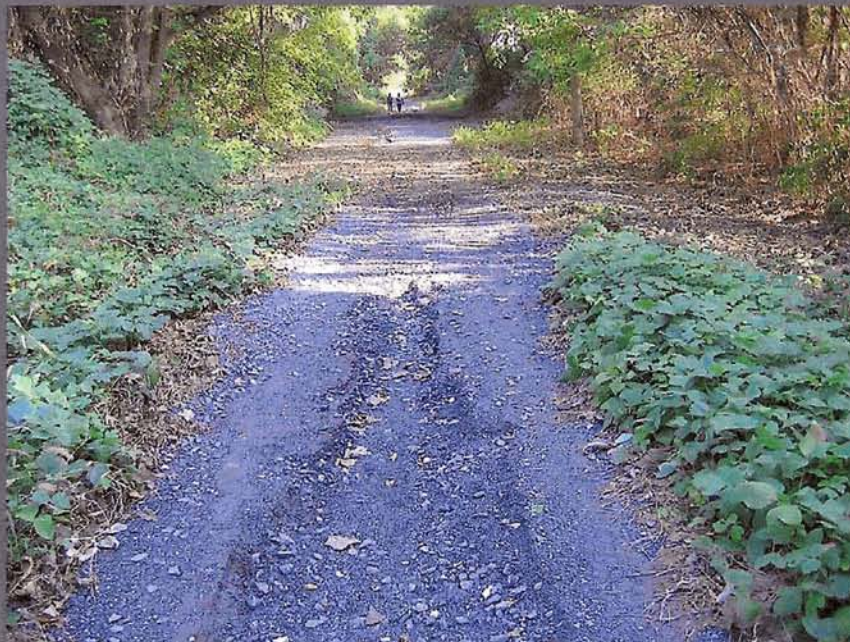
Storm water removes the crushed stone surface, leaving deep ruts in the trail

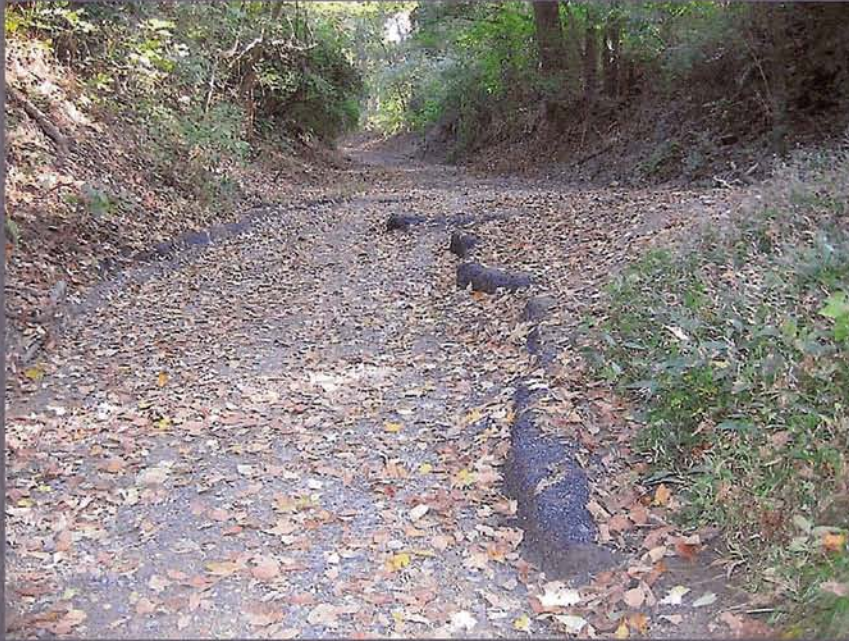
Hazardous "curbs" are created
that can upset a cyclist

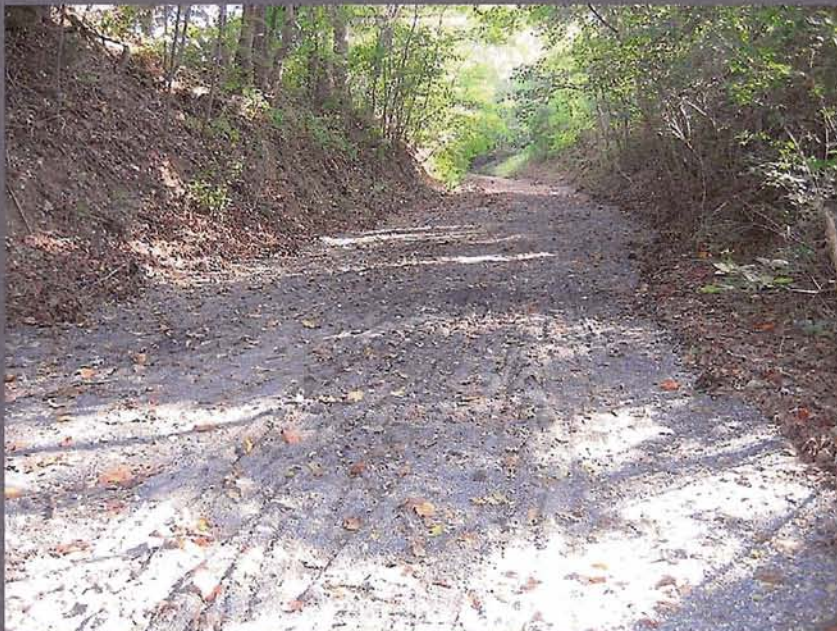
The crushed stone is deposited elsewhere on
the trail to form bicyclist "sand traps"

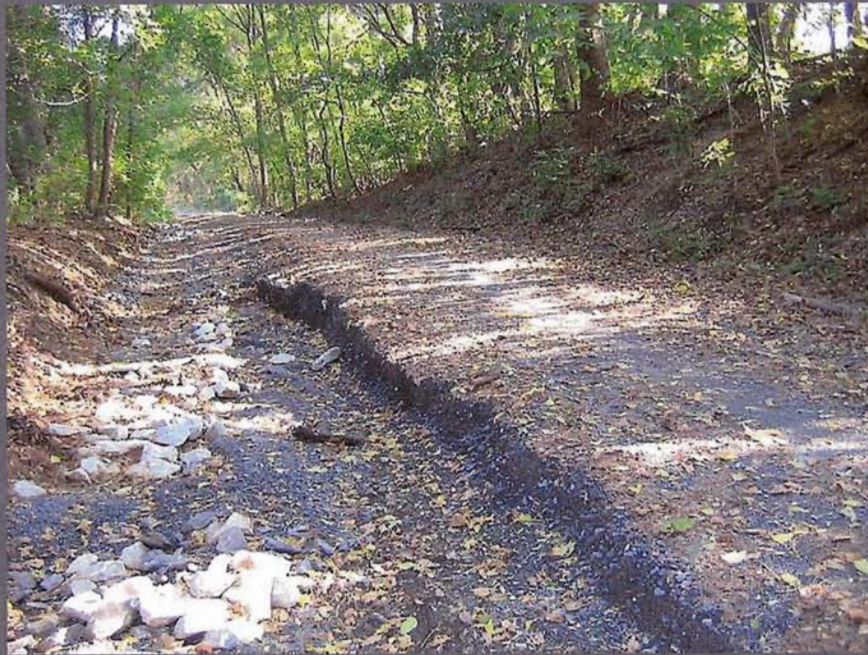
Drainage ditches alongside the trail fill
with crushed stone from the trail

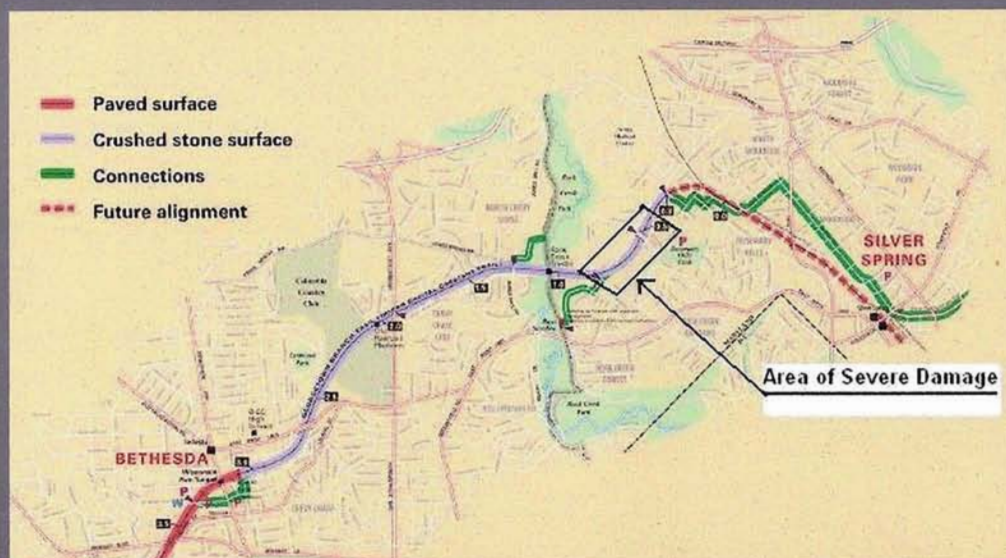
The area of severe storm water erosion is
limited to a small part of the Trail

The Georgetown Branch Trail is 4+ miles long.
The area of severe erosion is ½ mile long.

Cost of a hard surface to protect the Trail from storm water: approx. \$160K

- ▶ Cost for 2640 linear feet of asphalt paving @ \$30/linear foot = \$80K
- ▶ Cost for regrading the side channel and lining with asphalt = \$80K
(say equal to cost of paving trail)
- ▶ Regrading the crushed stone trail to repair erosion damage costs \$30-40K and is needed several times a year, after every bad storm.
