The Interim CCT – Down the Drain in Silver Spring

February 14, 2006

The Trail is hazardous and uninviting
east of Rock Creek Park

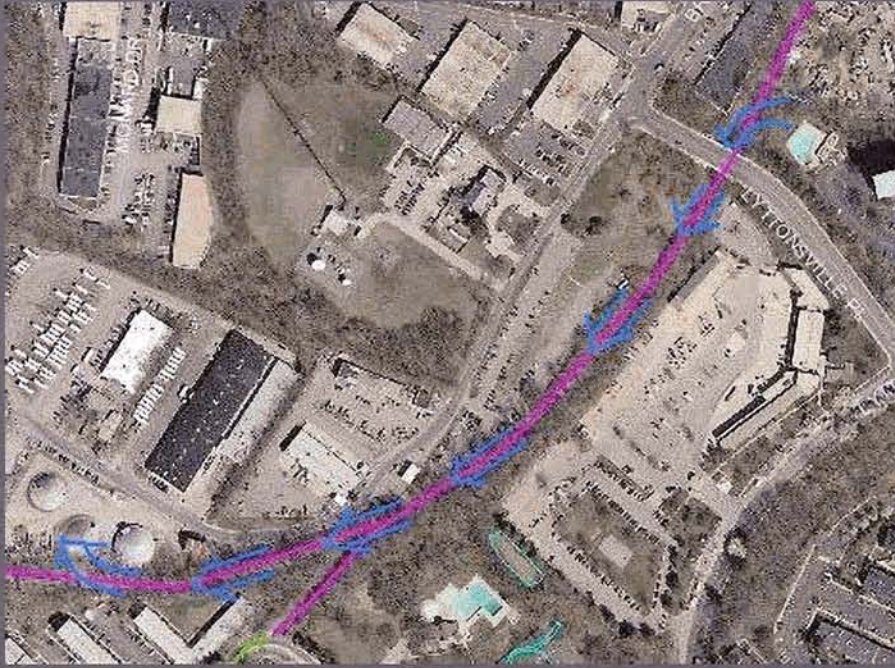
The Trail is in a drainage channel for approx. 1/2 mile near the east end

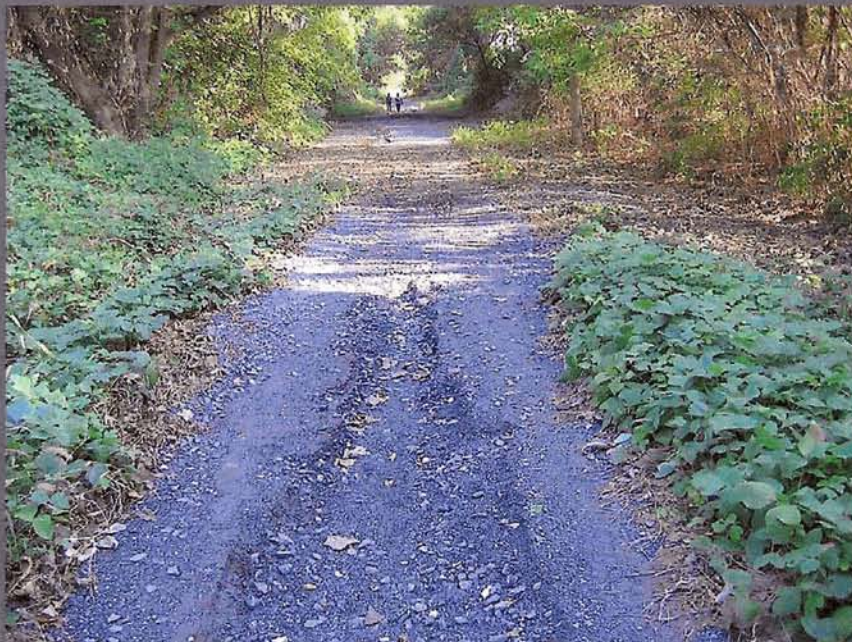
Storm water removes the crushed stone surface, leaving deep ruts in the trail

Cost of a hard surface to protect the Trail from storm water: approx. \$160K

- ▶ Cost for 2640 linear feet of asphalt paving @\$30/linear foot = \$80K
- ▶ Cost for regrading the side channel and lining with asphalt = \$80K
(say equal to cost of paving trail)
- ▶ Regrading the crushed stone trail to repair erosion damage costs \$30-40K and is needed several times a year, after every bad storm.

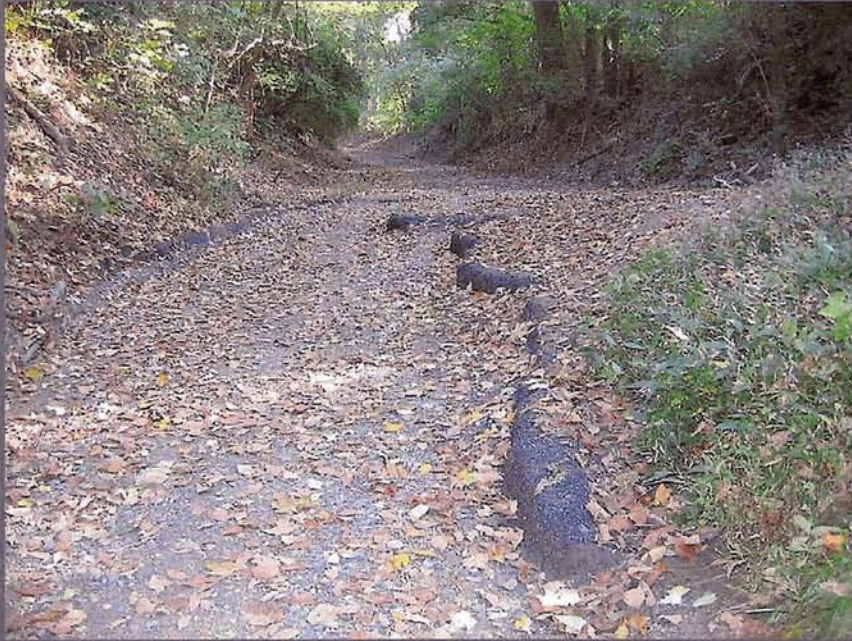
Hazardous "curbs" are created
that can upset a cyclist

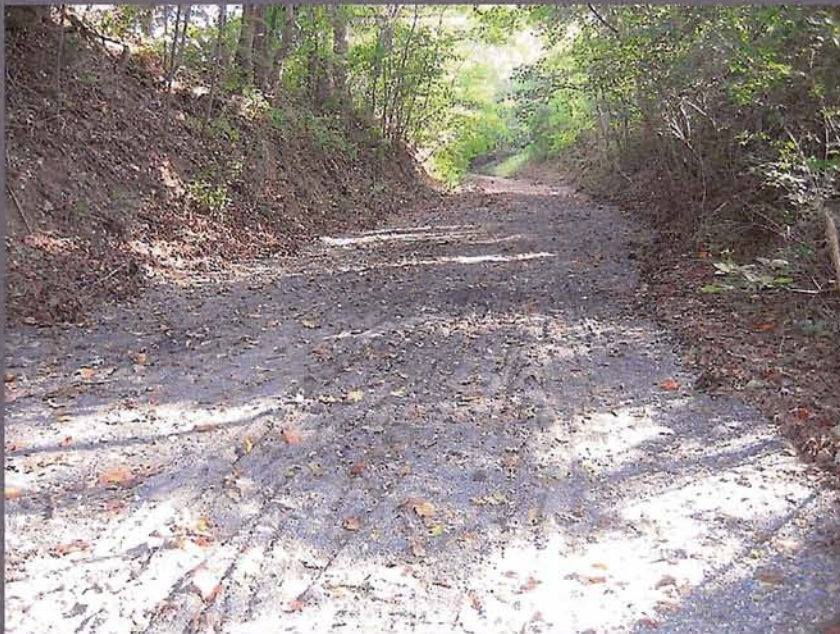
The crushed stone is deposited elsewhere on
the trail to form bicyclist "sand traps"

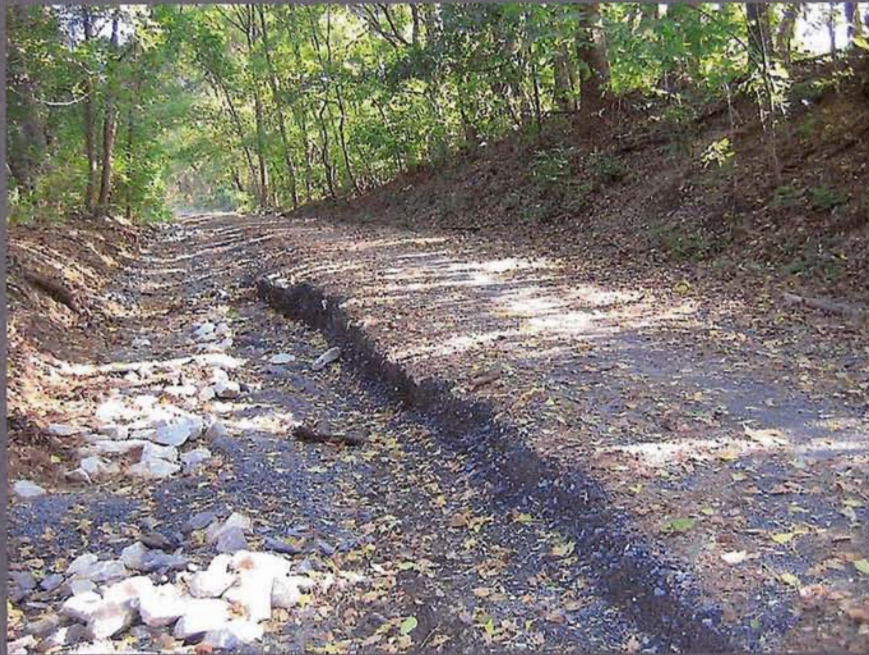
Drainage ditches alongside the trail fill with crushed stone from the trail

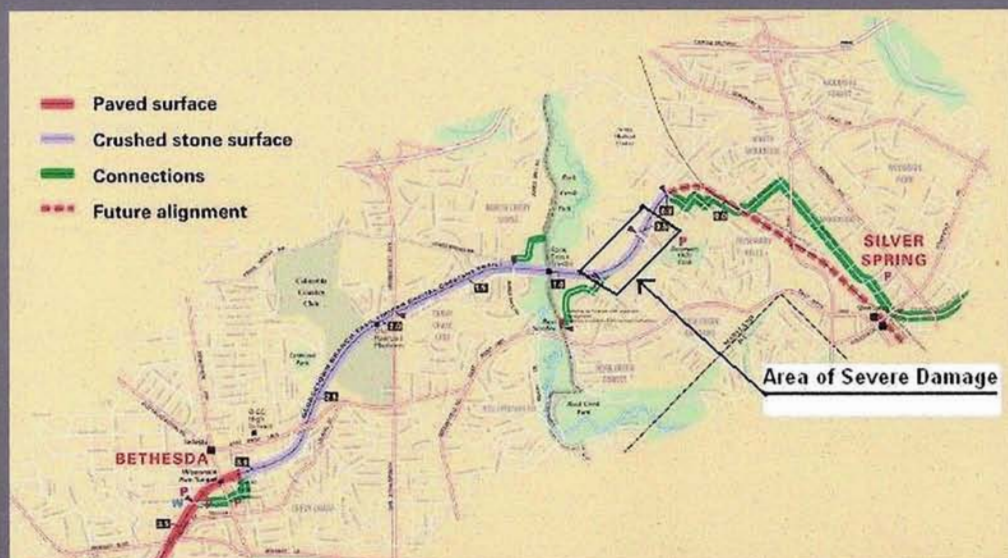
The area of severe storm water erosion is limited to a small part of the Trail

The Georgetown Branch Trail is 4+ miles long.
The area of severe erosion is 1/2 mile long.
