Rainforest logging breach report – VicForests "Granton Road" VicForests coupe 868-506-0009, Lind forest block

Date of survey: 24th March 2019 **Date of report:** 27th March 2019

Report author: Ed Hill Mapping: Owen Hanson

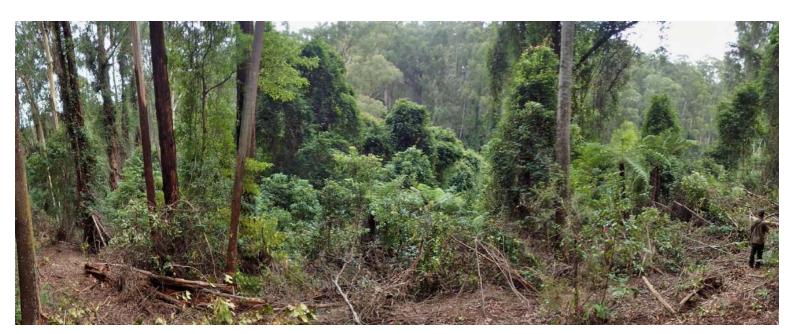
Photo (below): Logging disturbance at rainforest edge at breach site one, rainforest canopy species have been pushed over along dozer track, note placement of VicForests pink boundary tape in area dominated by rainforest.

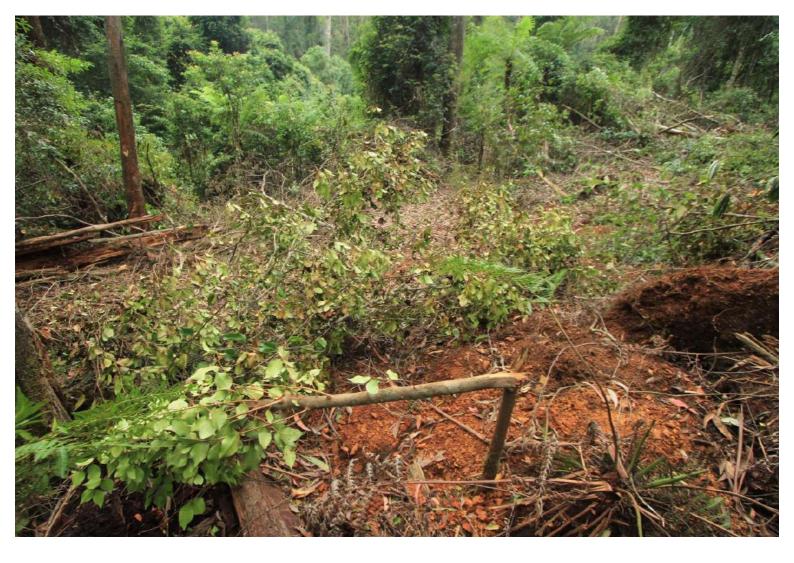
Photo: Pushed over rainforest canopy on dozer track in breach site one. VicForests boundary tape adjacent to rainforest in centre right of frame. Location 55 H 0678543 / 5842211 (above) Logged rainforest at breach site 1 (below).

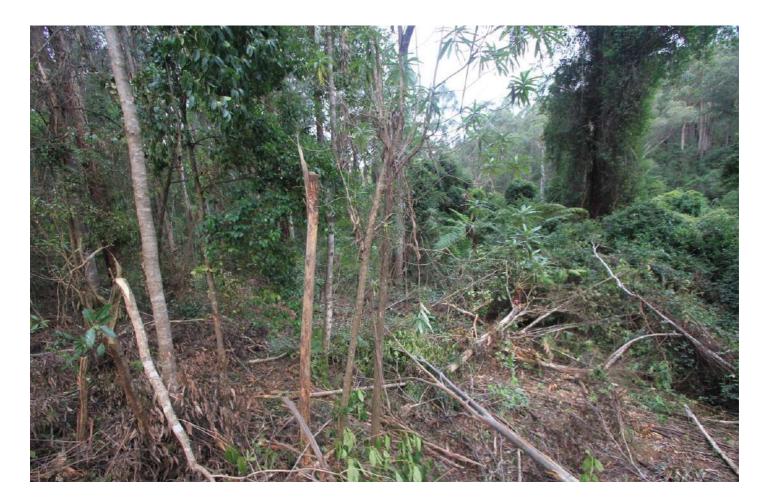
Logging disturbance has occurred meters away from a stand of closed canopy rainforest comprising of species listed as canopy species in 4.4.7.1 of the Code, Lily Pily (*Acmena Smitii*), Blackwood (*Acacia melanoxlyn*) Sweet Pittosporum (*Pittosporum undulatum*), Blue Olive Berry (*elaeocarpus holopetalus*), Jungle Grape (*Cissus hypoglauca*).

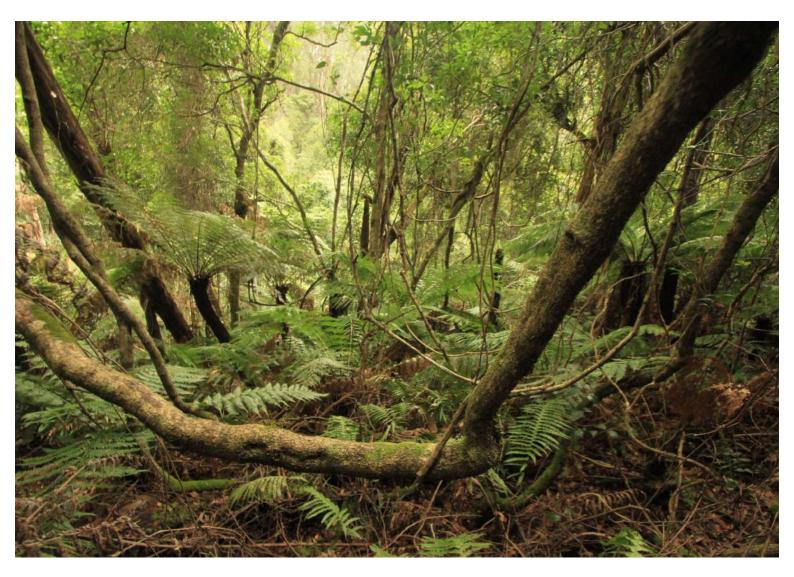
Photo (above): Rainforest approximately 10 meters from VicForests coupe boundary demarcation tape that is located at 0678546 / 5842205 GDA 94 (photo below)

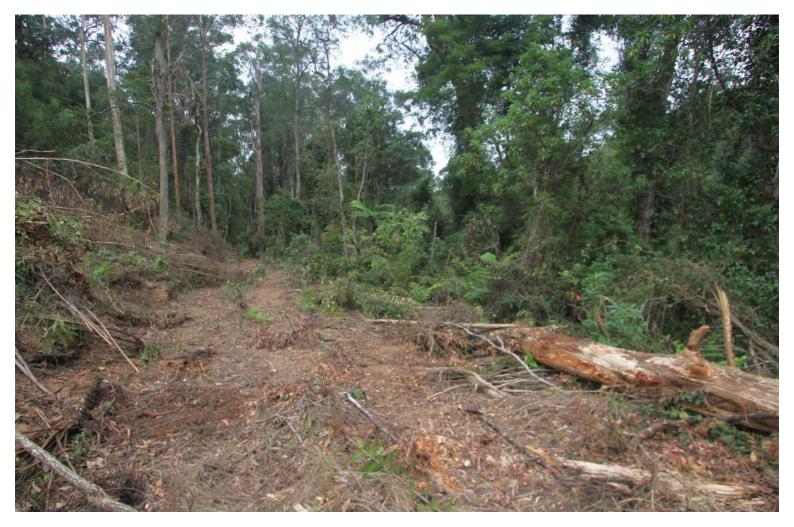
Photo (above): Logging disturbance at breach site two within required rainforest buffer on southern boundary of coupe. Note logging has occurred adjacent to rainforest canopy.

In some locations VicForests coupe boundary tapes are placed in areas dominated by rainforest species and directly adjacent to or tied to established rainforest canopy species. Placement of these tapes indicates that VicForests staff have failed to identify rainforest vegetation and DELWP staff have failed to conduct an appropriate 'rainforest spot check'

VicForests coupe boundary demarcation tapes have been incorrectly placed along this section of the southern boundary resulting in significant damage to forest directly adjacent to the rainforest stand that should have been retained within a rainforest buffer.

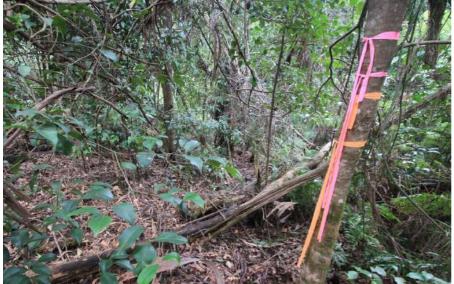
Photo (left): VicForests coupe boundary tapes tied to rainforest canopy (Lily Pily tree) in rainforest.

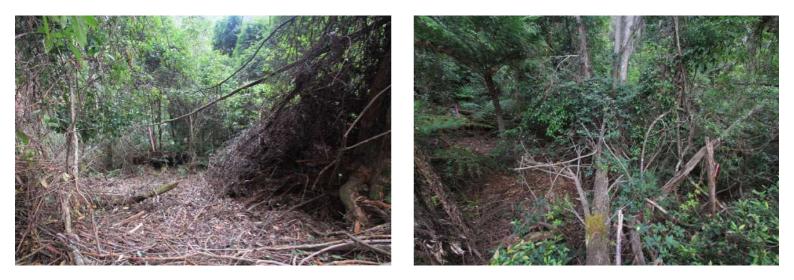
Photos: VicForests coupe boundary tapes in areas of rainforest along the southern boundary of the coupe in site one and two.

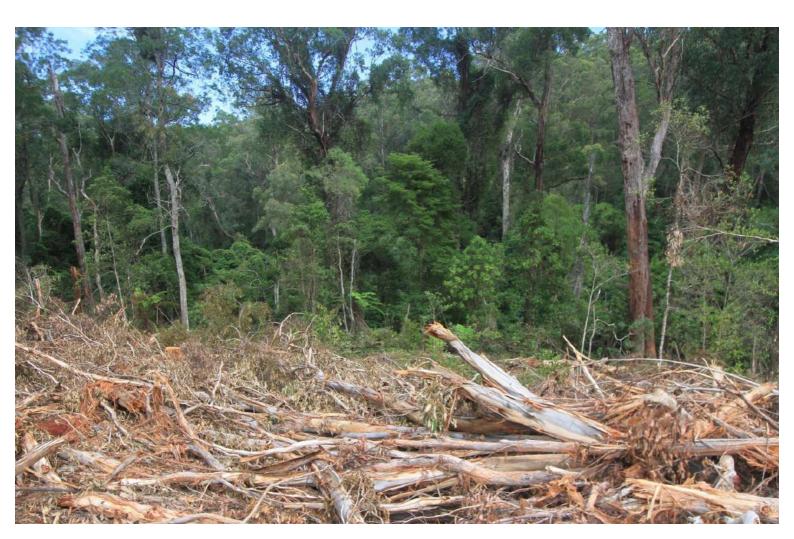
Rainforest areas greater than 0.4 hectares are required to be buffered by 40m from the rainforest edge. Forest within 40m of the rainforest edge has been logged. The required buffer of 40m (depicted as the blue line on the Map in figure 2) has not been implemented in this area of the southern boundary.

Rainforest canopy species were observed pushed over in logged areas indicating that logging has removed rainforest canopy. Logging has possibly made incursions into the stand of closed canopy rainforest along the southern boundary reducing its overall extent and size.

Photo (below): Logged rainforest buffer adjacent to southern boundary of coupe.

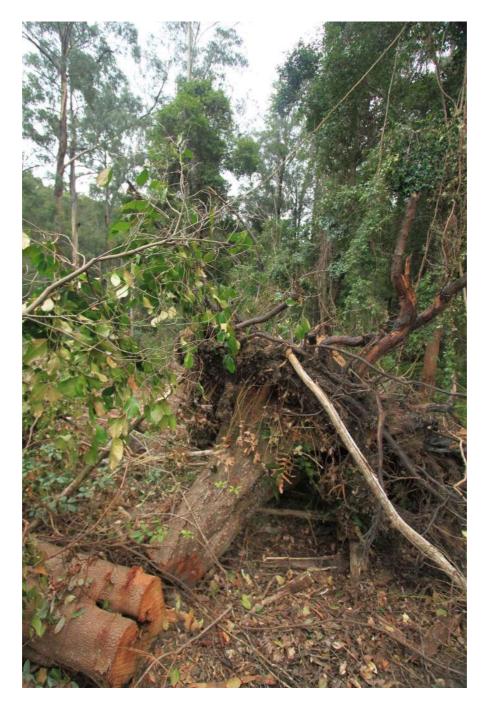
The rainforest at site 3 extends past the edge of the logging disturbance, a section of canopy has been removed along the dozer track.

Prior to logging the rainforest stand was likely to have been significantly larger. Logging in site 3 is likely to be in breach of the requirement to protect all stands of rainforest. If the rainforest stand at site 3 is found to be greater than 0.2 hectares or part of an aggregated stand equal too or larger than 0.2ha VicForests has logged the required buffer zones.

Photo (below): Rainforest at plot 3 location 55 H 0678428 / 5842301 GDA94 a mature Lily Pily tree has been cut and large jungle grape vines that were forming closed canopy are hanging down after being torn from the canopy by the impact of logging.

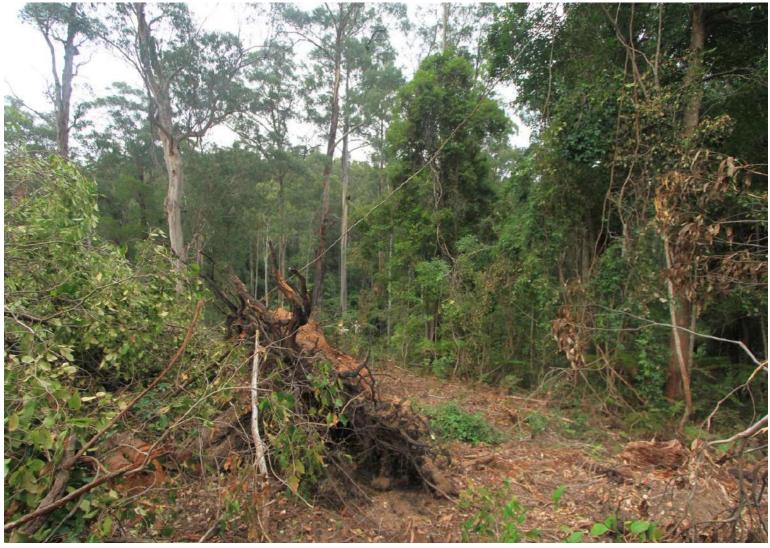
Photo (above): Logged Lily Pily with root ball showing and jungle grape canopy at breach site 3

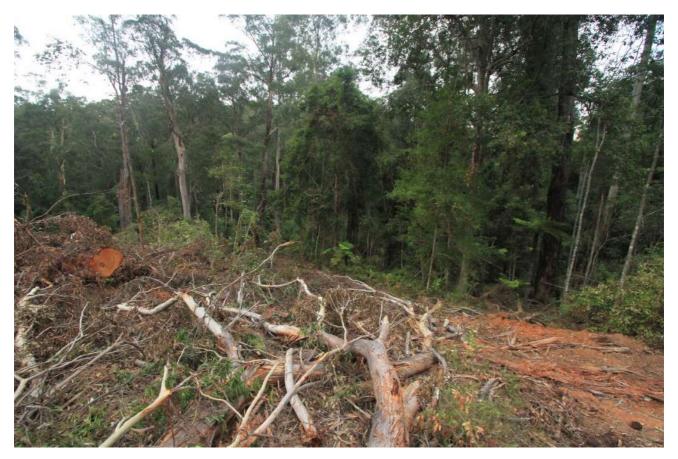
Photo (above): Logging adjacent to rainforest at site 3 on the southern boundary of the coupe

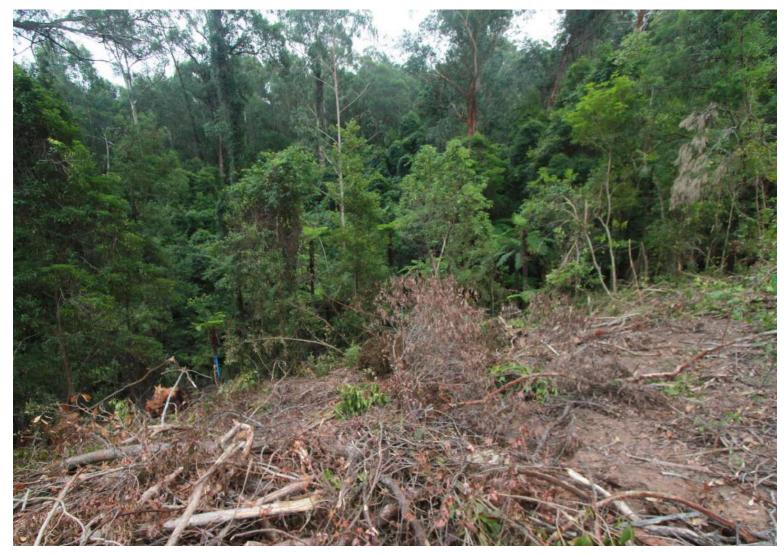
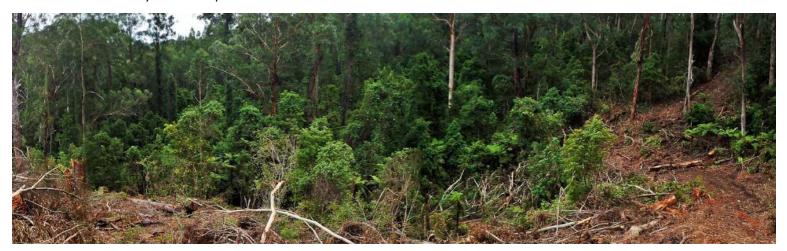
Photo above and below: Logging within and adjacent to warm temperate rainforest on the western boundary of the coupe at site 4

The rainforest stand was likely to be larger than 0.4 hectares prior to logging as areas of rainforest appear to have been cleared. Rainforest canopy species were observed pushed over from logging.

A large Eucalypt tree has been felled into a depression that was occupied by rainforest canopy species that are now knocked over and disturbed by logging.

VicForests has failed to implement a 40m buffer to the stand of rainforest at site 4 and logged a significant area of forest within the required buffer.

The felling of a large old Eucalypt tree into a rainforest gully for no apparent reason is extremely poor forestry practice.
