POTENTIAL HAZARDOUS BUILDING MATERIALS INVENTORY

**Miller's Department Store
230 Penobscot Avenue
Millinocket, Maine 04462**

June 2016

TRC Project No: 233392

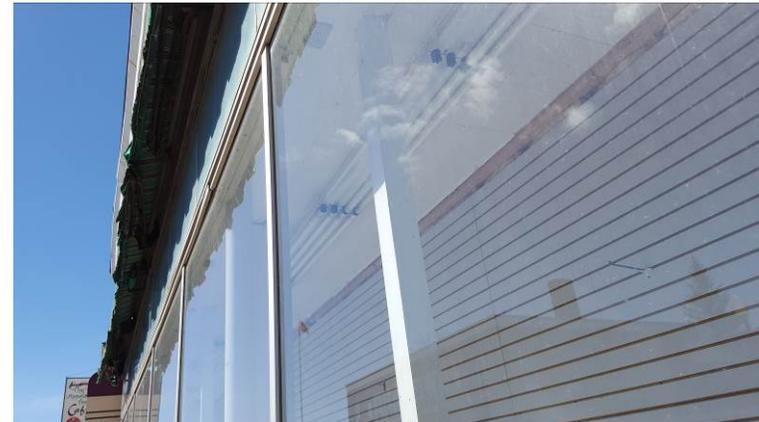
Expansion joint and window caulk/glaze compound can contain PCBs. Expansion joint and window caulk/glaze compounds are present in most of the building's windows.

^G Refer to Photograph 4 in the Photograph Log found in **Appendix C**.

4. Image showing 1' X 1' ceiling tile, fluorescent lamps - 4 foot tube, ballasts, window caulk, and window glaze in the front display area.
