## PICUS 3 TOMOGRAPH REPORT

**Fig Tree, Davies Park, Brisbane**

**October 2020**

Document reference: PIT/2010/20

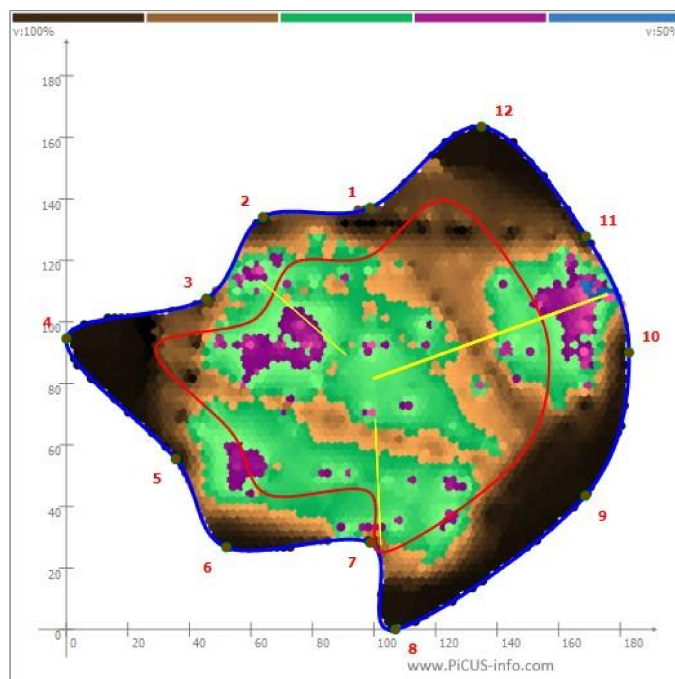
### T1 Sonic Tomography Result of Stem at 140cm above ground level (20.10.2020)

Measurement at 140cm above ground level (AGL), shows the green and violet colours are evident within the stem wall at several levels, where the fungus is beginning to penetrate the stem wall, which illustrates the possible progress of the fungi as it continues to attack the sound wood of the trunk.

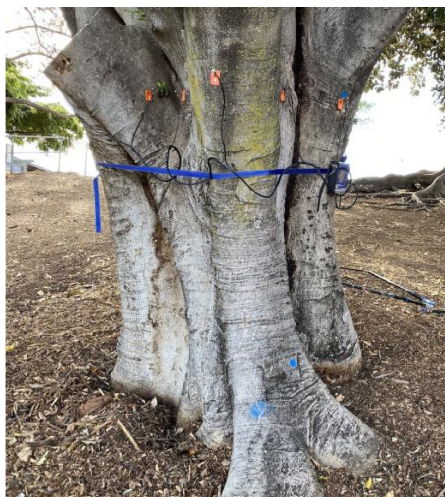
Photo 1 – Showing level of Picus test at 140cm above ground level

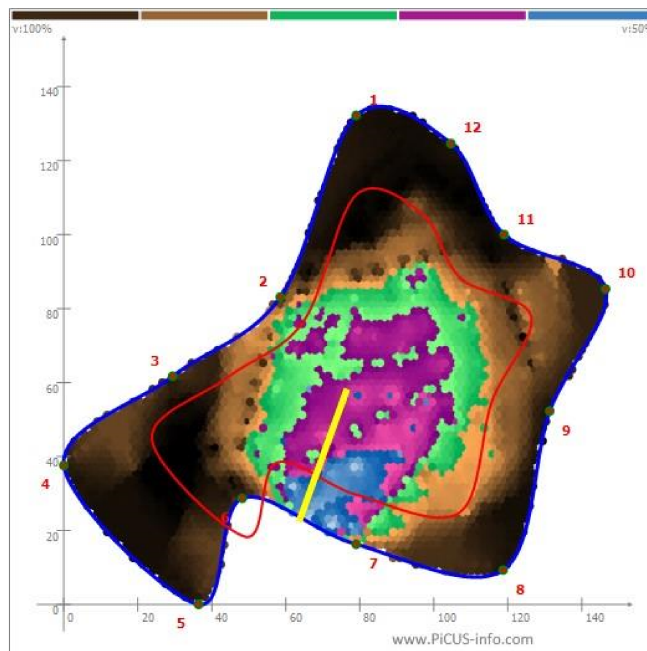
## T2 Sonic Tomography Result of Stem at 10cm above ground level (20.10.2020)

Measurement at 10cm above ground level (AGL), The blue, green and violet colours only penetrate the required residual wall thickness in two areas. One at MP2 and the most noticeable area between MP 6 and MP7 where the fungal fruiting bodies are clearly visible.

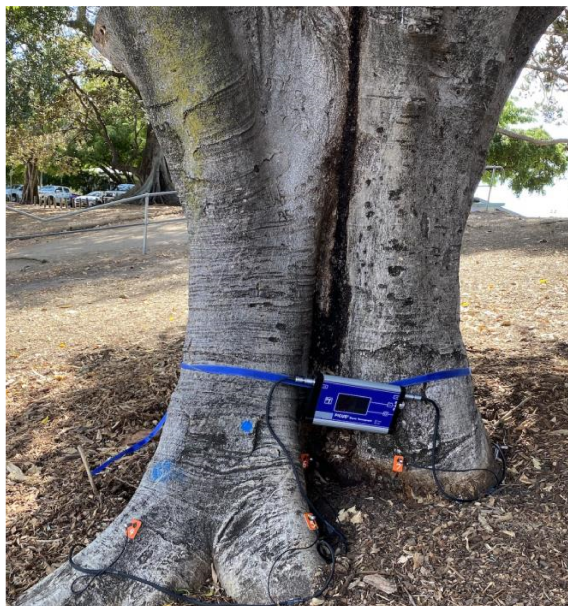
Photo 2 – Showing level of Picus test at 10cm above ground level
