**Mackay Conversation Group complaint – significant apparent erosion and sediment control breaches on the Adani rail corridor**

### Photographs showing lack of sediment and erosion control measures at Adani's North Galilee Basin Rail Project.

These photographs were taken between Serpentine Creek and Chainage 266, on the 6th of July 2021.

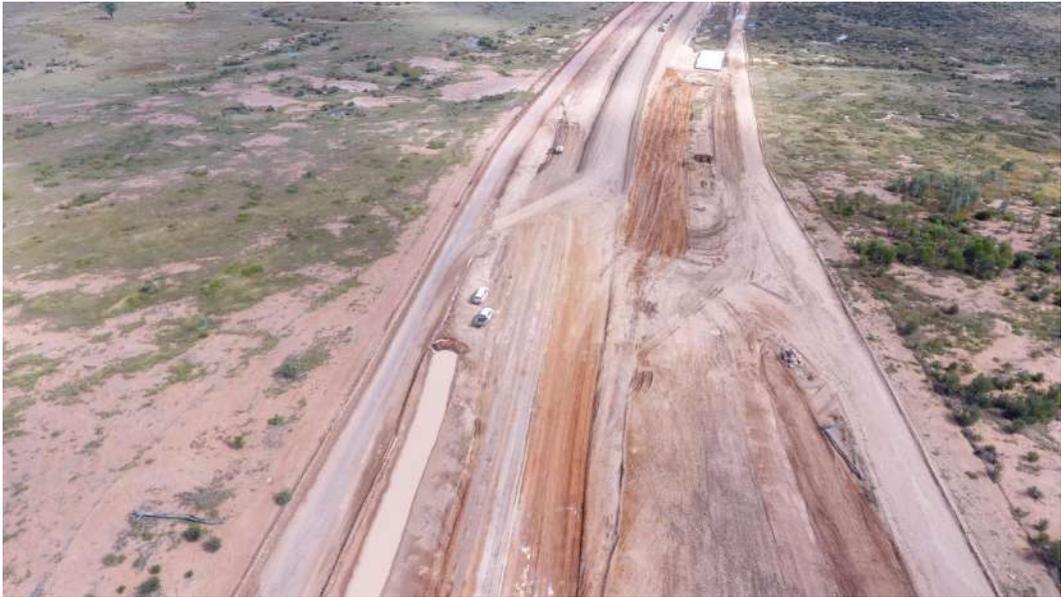
Pic No	Xcoord (GDA94)	Ycoord (GDA94)	
21	542288.955	7614002.94

- **Image 21:** There is no sediment control work on the exit of the pond in the centre of the left hand side of the image. There are no erosion control banks, water control banks or vegetative control to stop soil erosion from water travelling along the rail corridor.

<p>Looking west There is no sediment control work on the exit of the pond in the centre of the left hand side of the image. There are no erosion control banks, water control banks or vegetative control to stop soil erosion from water travelling along the rail corridor.</p>

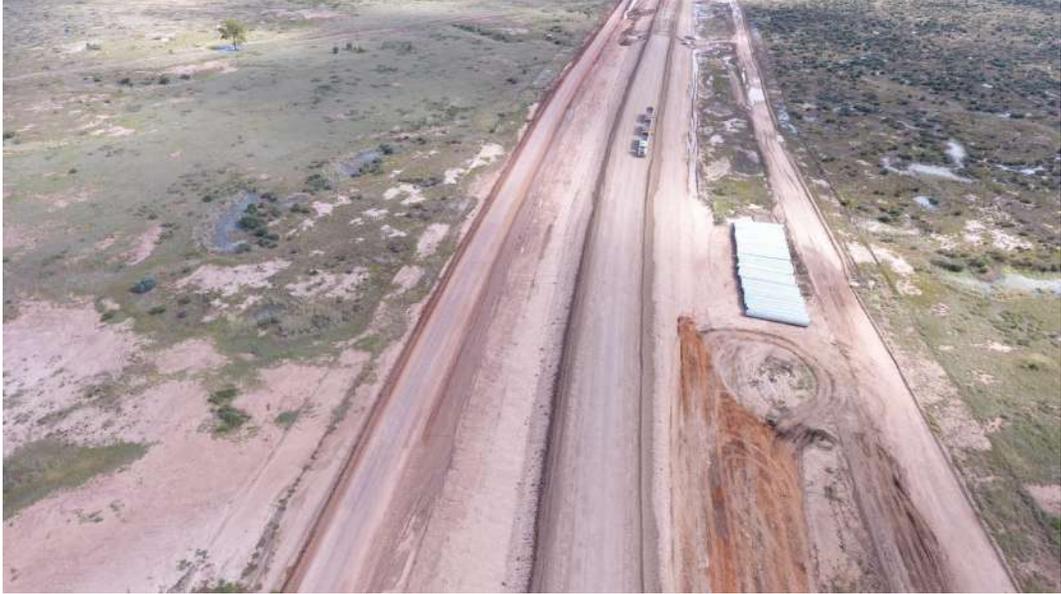
24	542072.991	7613985.171

- **Images 24, 25 and 28:** There is no evidence of any sediment or erosion control works in these images. The left hand side of image 24 also appears to show the deposition of fine sand, silt or clay particles out of the rail corridor, as a result.

<p data-bbox="483 814 1463 926">Same as 25 There is no evidence of any sediment or erosion control works in these images. The left hand side of image 24 also appears to show the deposition of fine sand, silt or clay particles out of the rail corridor, as a result.</p>
25	542072.991	7613985.171

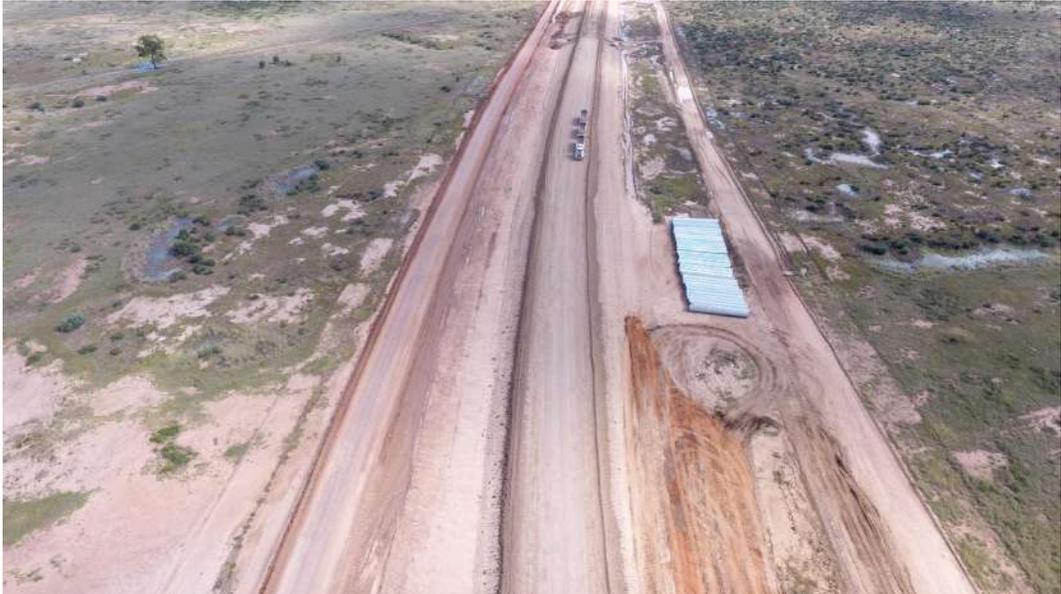
<p data-bbox="483 1591 613 1619">Looking west</p>

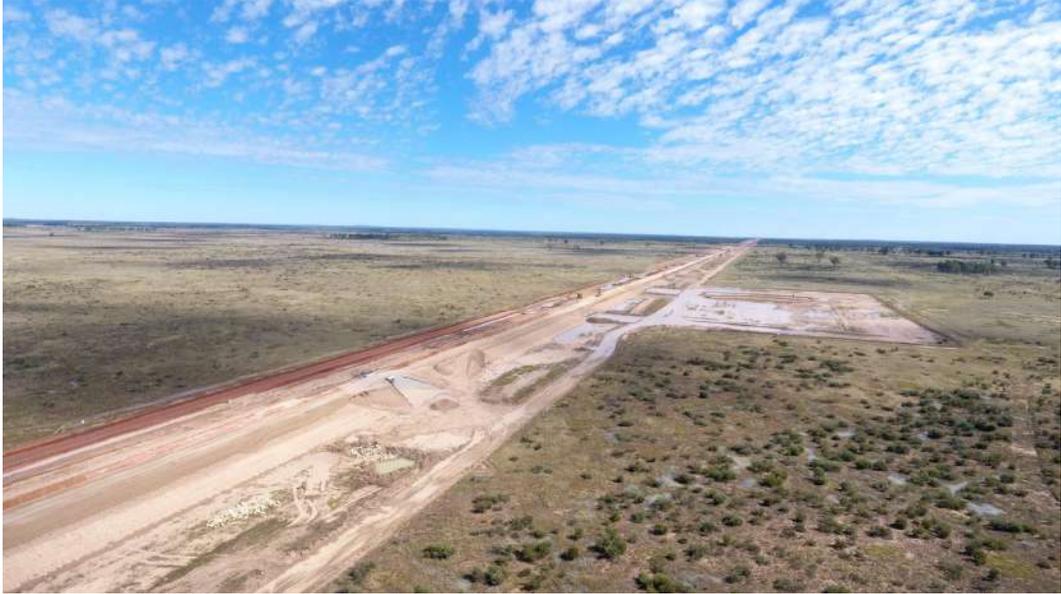
29	541654.907	7614126.824

- **Image 29:** The two dams in the image are holding a large amount of very turbid water. However, there is no apparent detention pond works and no specific measures in place for trapping sediment at the discharge points of these dams. There are no works around inlet and outlet of the pipes. Our client understands that compliant conduct would have, at least, included erosion and sediment control works as a part of an overflow system with some geotextile fabric to control erosive flows.

<p data-bbox="483 814 1463 989"><b>Looking west</b> The two dams in the image are holding a large amount of very turbid water. However, there is no apparent detention pond works and no specific measures in place for trapping sediment at the discharge points of these dams. There are no works around inlet and outlet of the pipes. Our client understands that compliant conduct would have, at least, included erosion and sediment control works as a part of an overflow system with some geotextile fabric to control erosive flows.</p>
31	541520.184	7614114.117

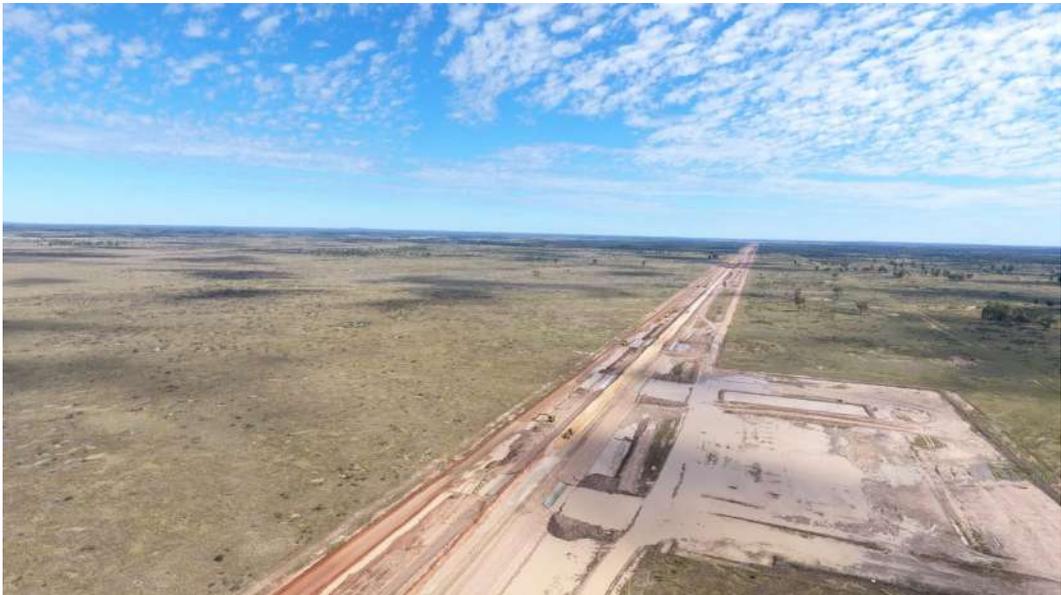
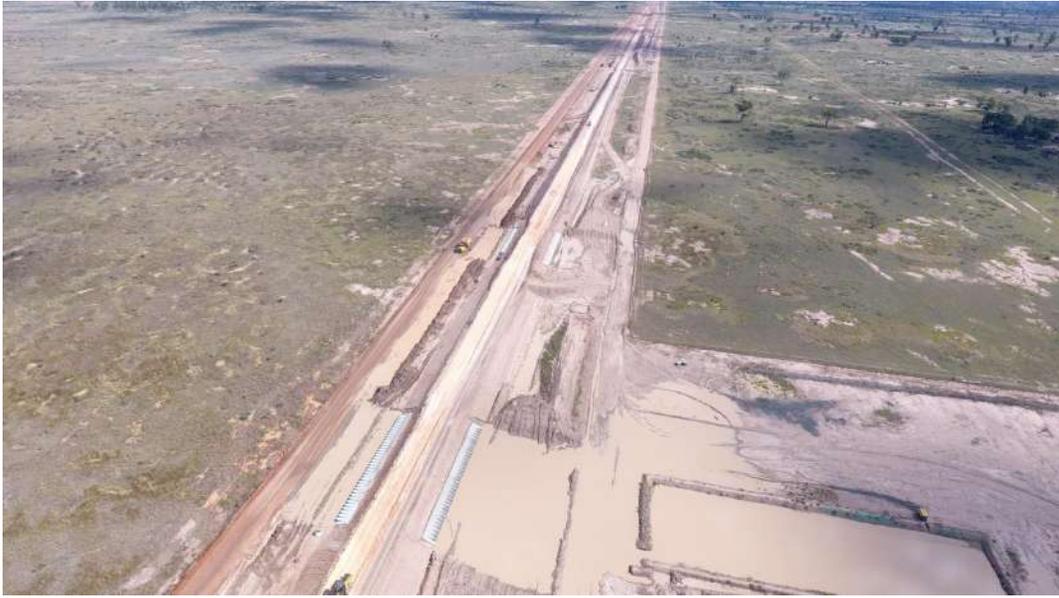
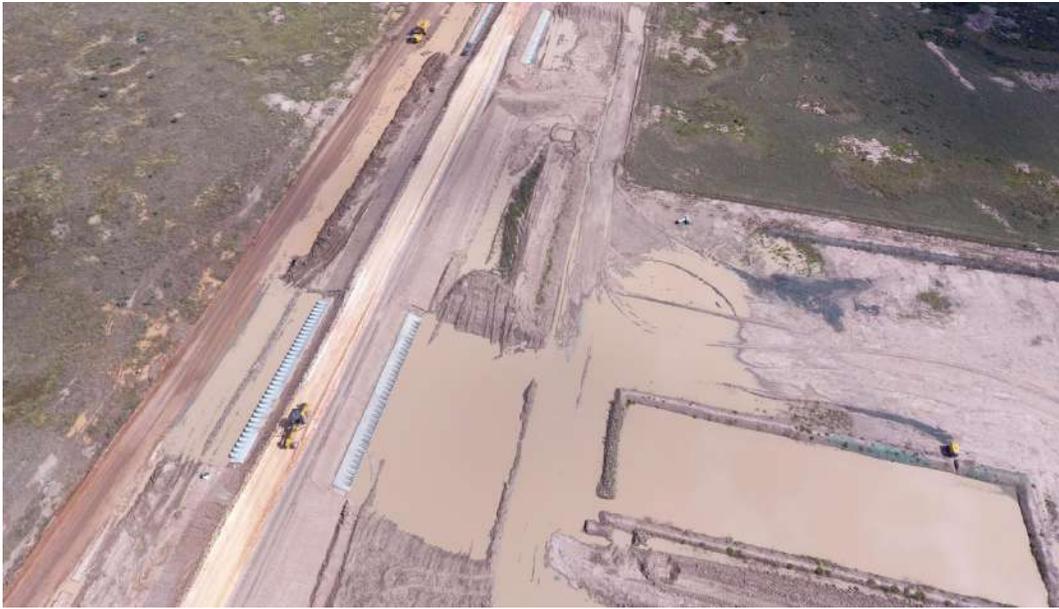
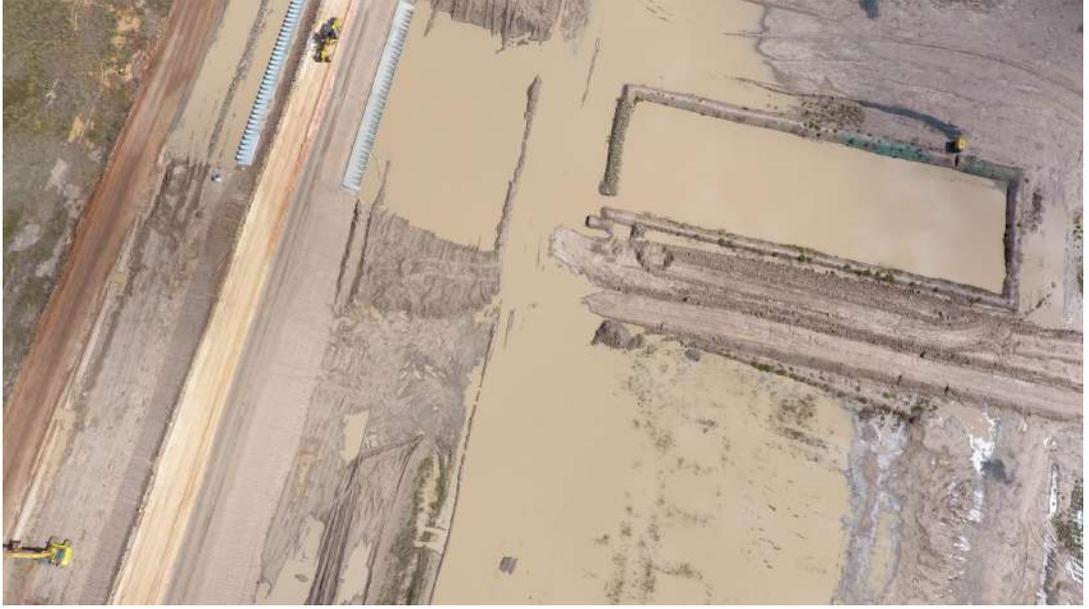
- **Images 31, 33, 34, 35:** Two ponds in these images appear to be collecting discharge from pipes along the rail corridor, but there is no sediment trap on the exit of those two ponds. It appears that water is also able to and may be flowing from Dam 1 to Dam 2. In the context of the anonymous sources' report about contractors pumping water off the rail corridor and directly into waterways, our client is also concerned about a visible pump in these images.

<p data-bbox="483 1648 1463 1822"><b>Looking west</b> Two ponds in these images appear to be collecting discharge from pipes along the rail corridor, but there is no sediment trap on the exit of those two ponds. It appears that water is also able to and may be flowing from Dam 1 to Dam 2. In the context of the anonymous sources' reports about contractors pumping water off the rail corridor and directly into waterways, our client is also concerned about a visible pump in these images.</p>

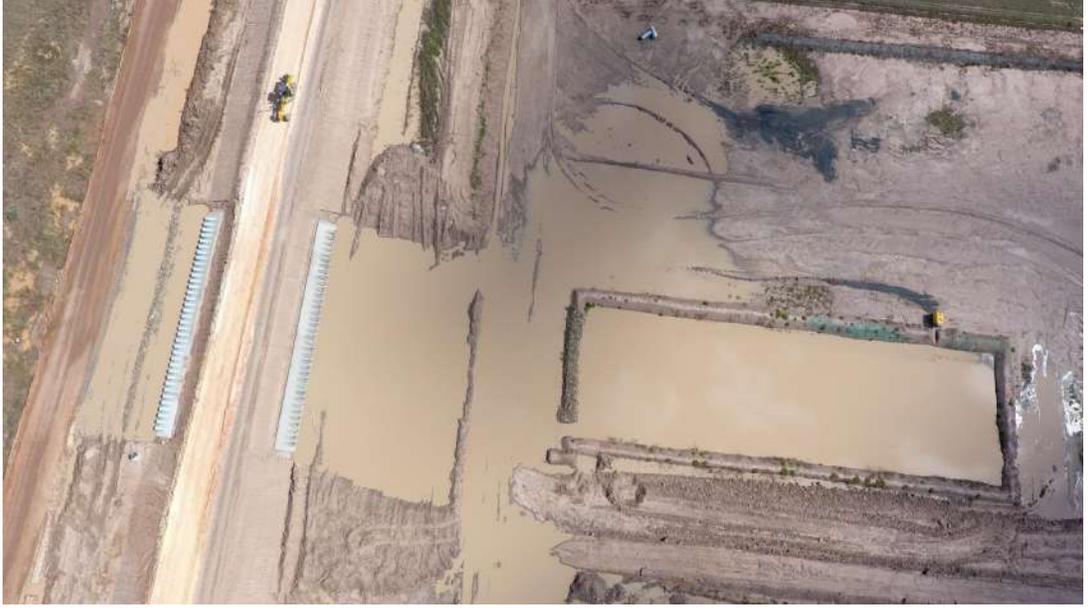
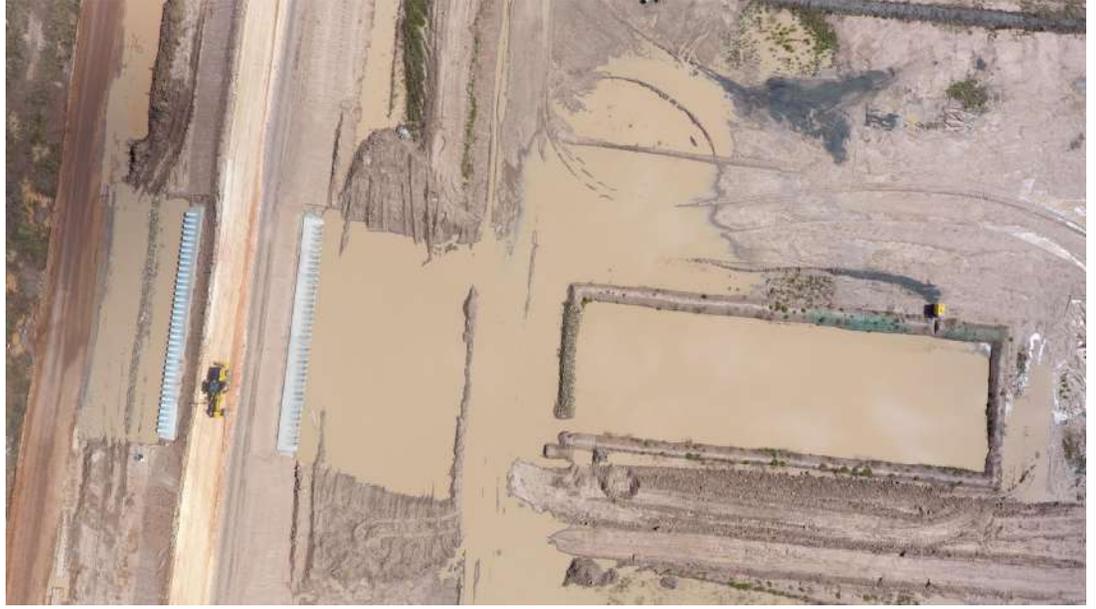
- **Images 37 and 39:** These images show a storage structure collecting water from pipes on the corridor. However there is no sediment control works on the inlet or the outlet of this structure. It also appears that fine soils are present in the ponds outside the rail corridor (see the left hand side of the image). The bunding banks in this image also appear to have been damaged, with evidence of erosion. This suggests that water has broken out of the rail corridor and the contaminated water has travelled into the ponds outside the rail corridor.

<p data-bbox="483 1503 1572 1665">These images show a storage structure collecting water from pipes on the corridor. However there is no sediment control works on the inlet or the outlet of this structure. It also appears that fine soils are present in the ponds outside the rail corridor (see the left hand side of the image). The bunding banks in this image also appear to have been damaged, with evidence of erosion. This suggests that water has broken out of the rail corridor and the contaminated water has travelled into the ponds outside the rail corridor.</p>

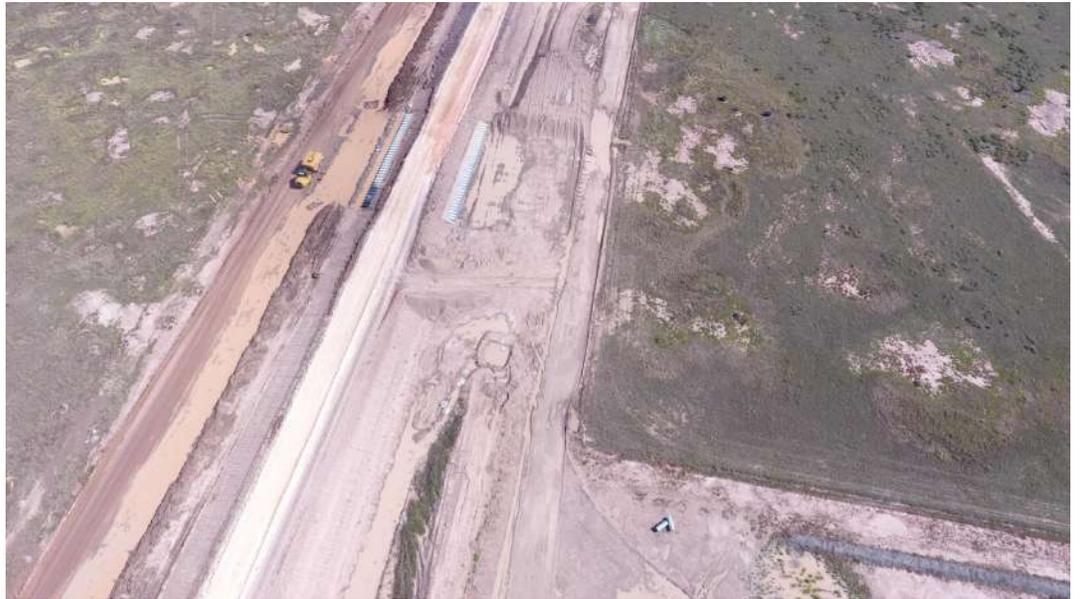
40

- **Image 40:** It appears that the bunding bank in this image is damaged and has been washed away at a point near the top of the image (above the water truck). It also appears that water has escaped from the rail corridor at this point, with evidence of dirty water in the ponds outside the rail corridor. There is no visible evidence of sediment control works at the point of the water breaking out. On the right hand side of the image, another apparent breach of the bunding bank appears, with visible water again outside the rail corridor.

Same position as 39 looking more up and west

It appears that the bunding bank in this image is damaged and has been washed away at a point near the top of the image (above the water truck). It also appears that water has escaped from the rail corridor at this point, with evidence of dirty water in the ponds outside the rail corridor. There is no visible evidence of sediment control works at the point of the water breaking out. On the right hand side of the image, another apparent breach of the bunding bank appears, with visible water again outside the rail corridor.

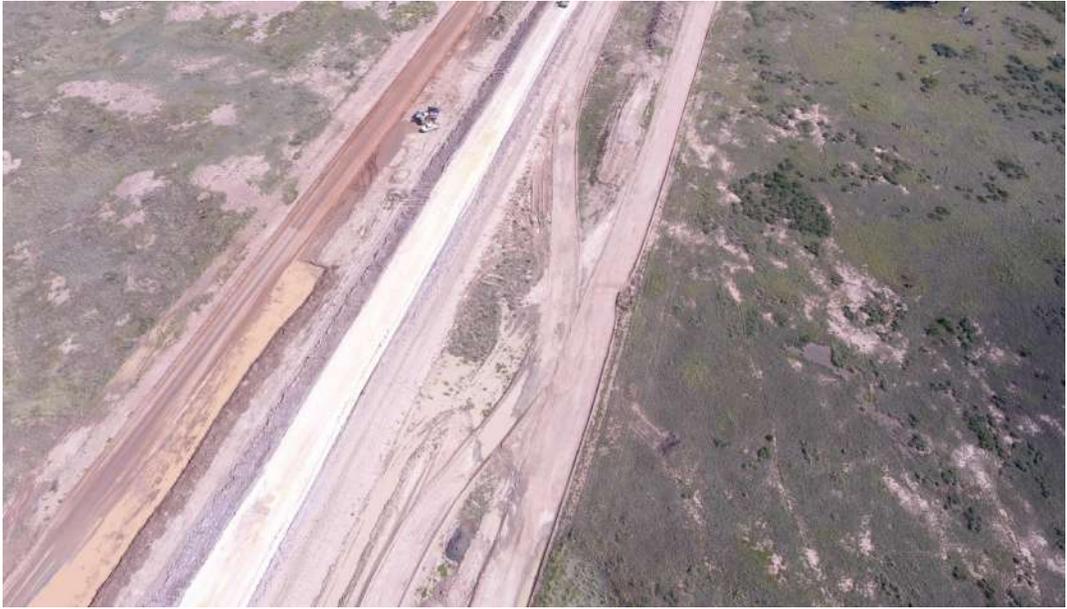
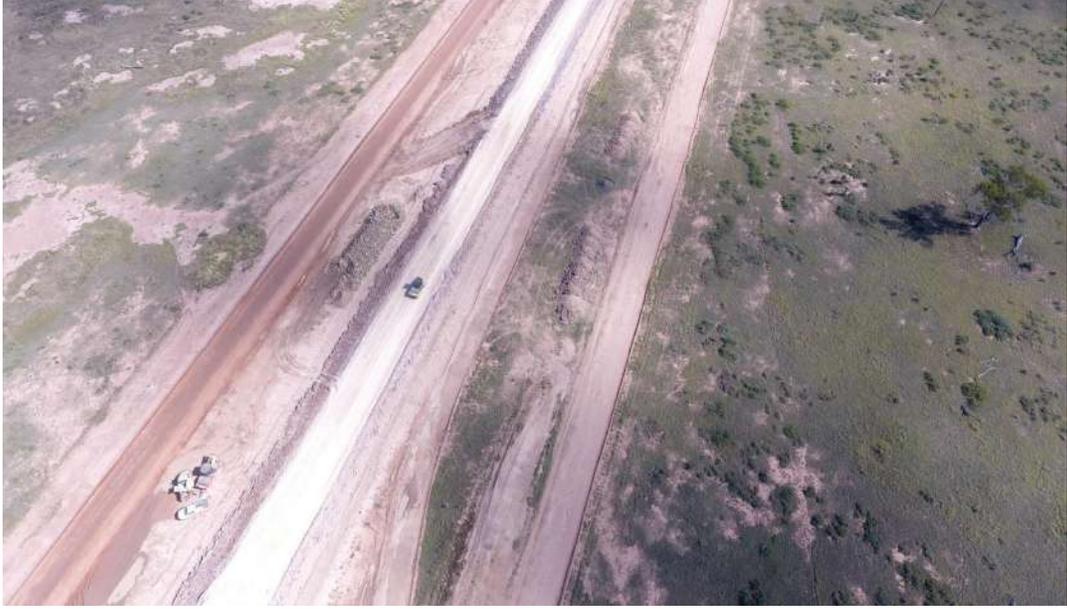
42	541044.403	7614136.115

- **Images 42 and 44:** These images show a lot of exposed soil with no evidence of sediment or erosion control works. Apart from the bunding bank on each side there is no control of water flow, with the effect that water will be expected to run uncontrolled across the rail corridor, with obvious consequential risks of erosion.

<p data-bbox="483 829 1550 966"><b>Looking down, west</b> These images show a lot of exposed soil with no evidence of sediment or erosion control works. Apart from the bunding bank on each side there is no control of water flow, with the effect that water will be expected to run uncontrolled across the rail corridor, with obvious consequential risks of erosion.</p>
44	540790.264	7614161.605

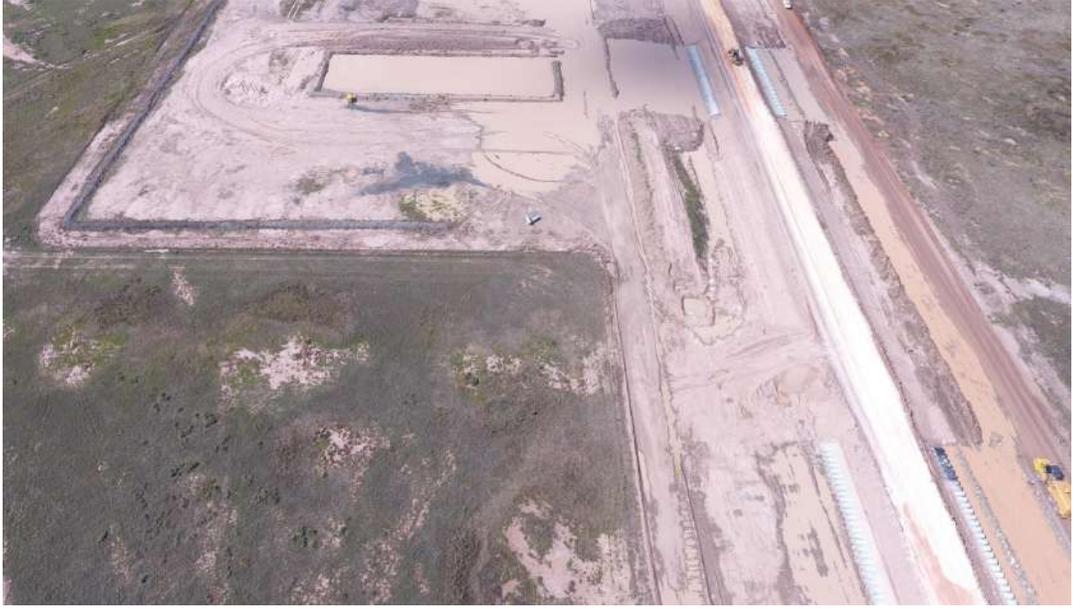
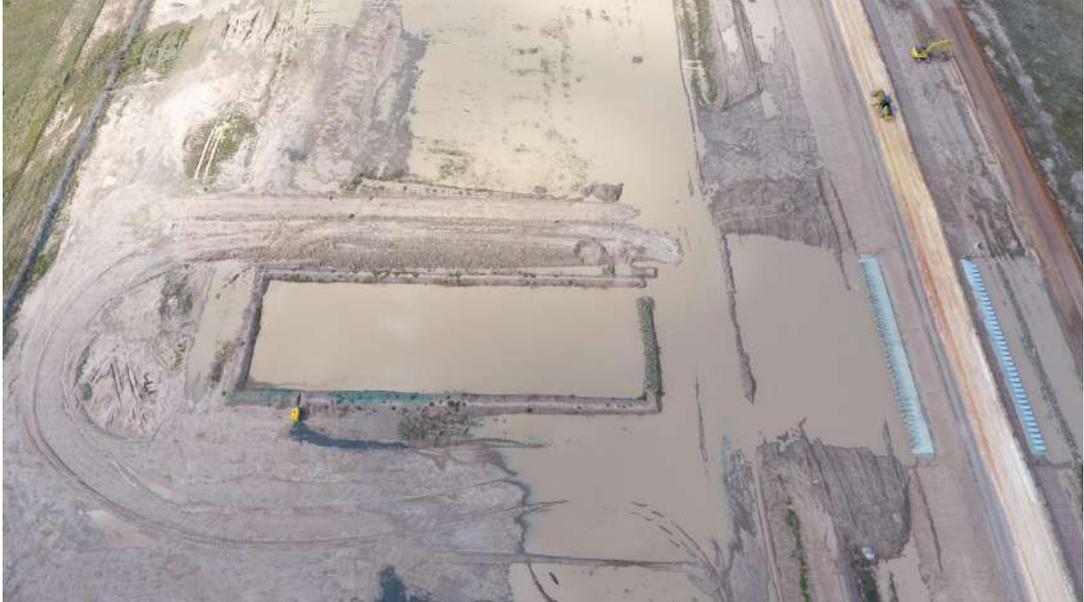
45	540924.903	7614174.5

- **Images 45 and 48 (these images are the reverse of 31, 33, 34 & 35):** Again, these images show extensive ponding. There is visible damage to the bank near the excavator. No erosion or sediment control works are evident on the exits of the dams pictured. A break in the bank is evident in the top left of image 48 especially.

<p data-bbox="483 829 1572 940">Looking east back towards pics 36-39 These images are the reverse of 31, 33, 34 &amp; 35): Again, these images show extensive ponding. There is visible damage to the bank near the excavator. No erosion or sediment control works are evident on the exits of the dams pictured.</p>
46	540924.903	7614174.5

<p data-bbox="483 825 852 909">Looking east back towards pics 36-39 A break in the bank is evident in the top left of image 48 especially.</p>
50	541678.816	7614029.988

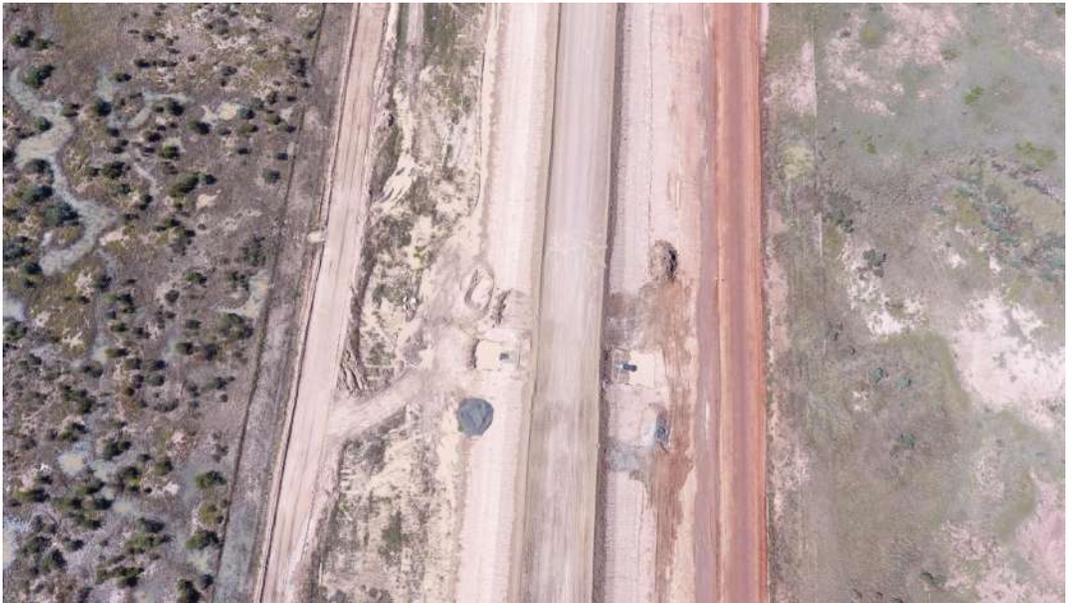
- **Image 50:** There is no evidence of sediment or erosion control works. There is wash evident on the bank, and there appears to be a breach in the bunding bank on the left hand side.

<p data-bbox="483 1554 1356 1638">Looking down, east.. There is no evidence of sediment or erosion control works. There is wash evident on the bank, and there appears to be a breach in the bunding bank on the left hand side.</p>

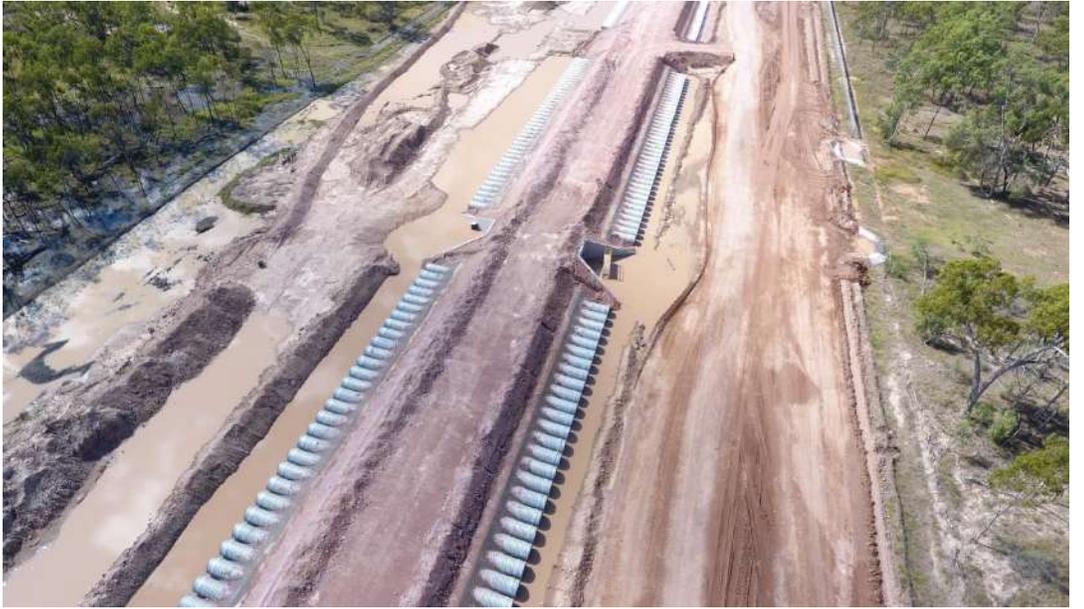
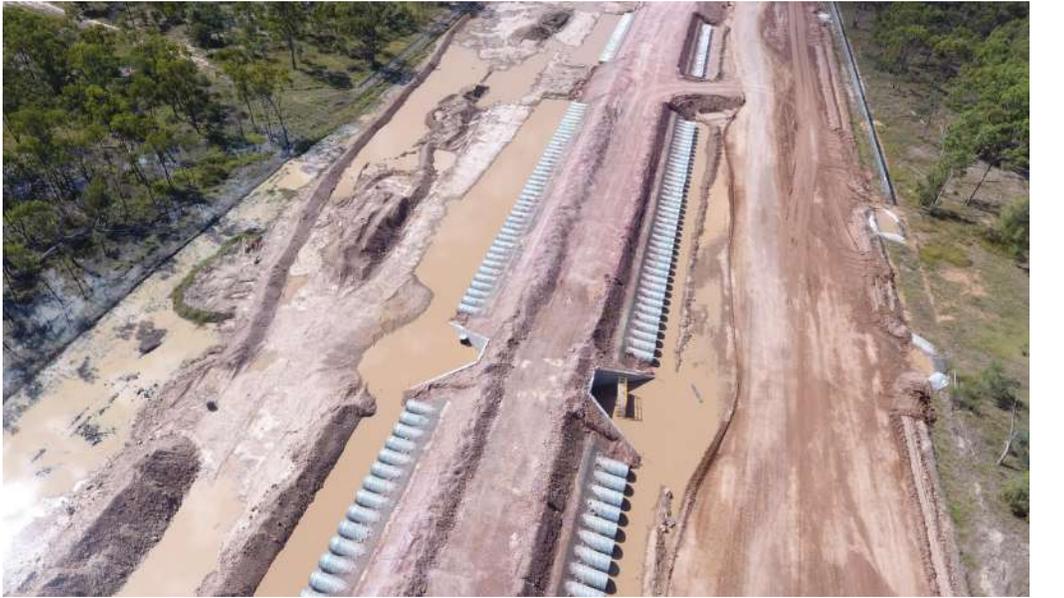
54	543356.01	7614289.304

- **Images 54 and 56:** The large banks of pipes in this image indicate that a similarly large quantity of water will be moving across the rail corridor. However, the two small structures in the image are insufficient to manage the volumes of anticipated water, and to allow sediment to settle or to trap it.

<p>Same as 55 The large banks of pipes in this image indicate that a similarly large quantity of water will be moving across the rail corridor. However, the two small structures in the image are insufficient to manage the volumes of anticipated water, and to allow sediment to settle or to trap it.</p>
----	-----------	-------------	---

<p>Similar to 55, best shot of 3 detention outflows with geotextile fabric (there are 2 other detention outflows in video 53 before these)</p>

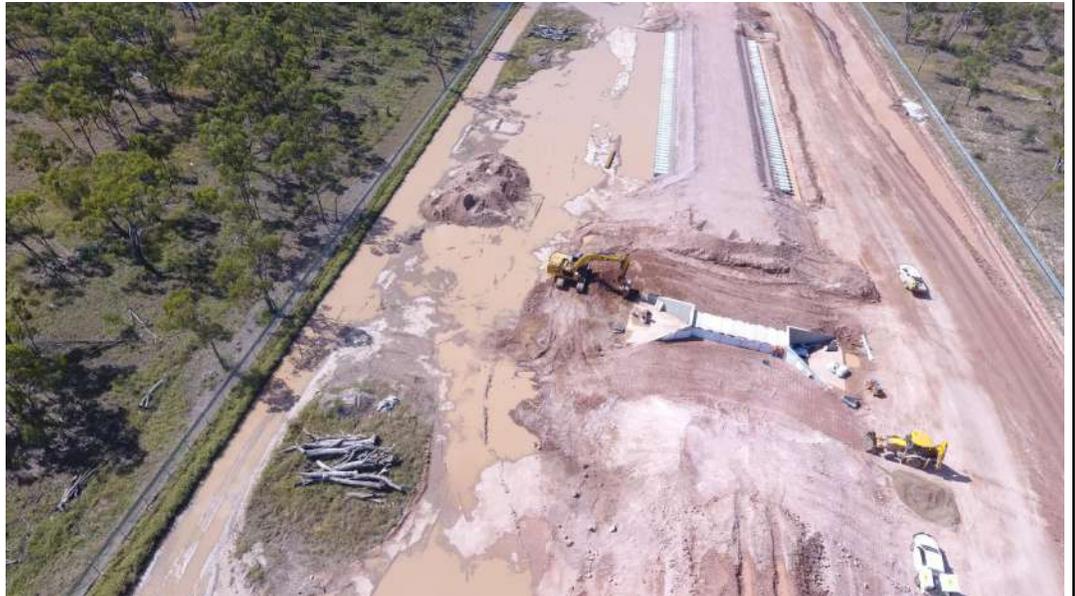
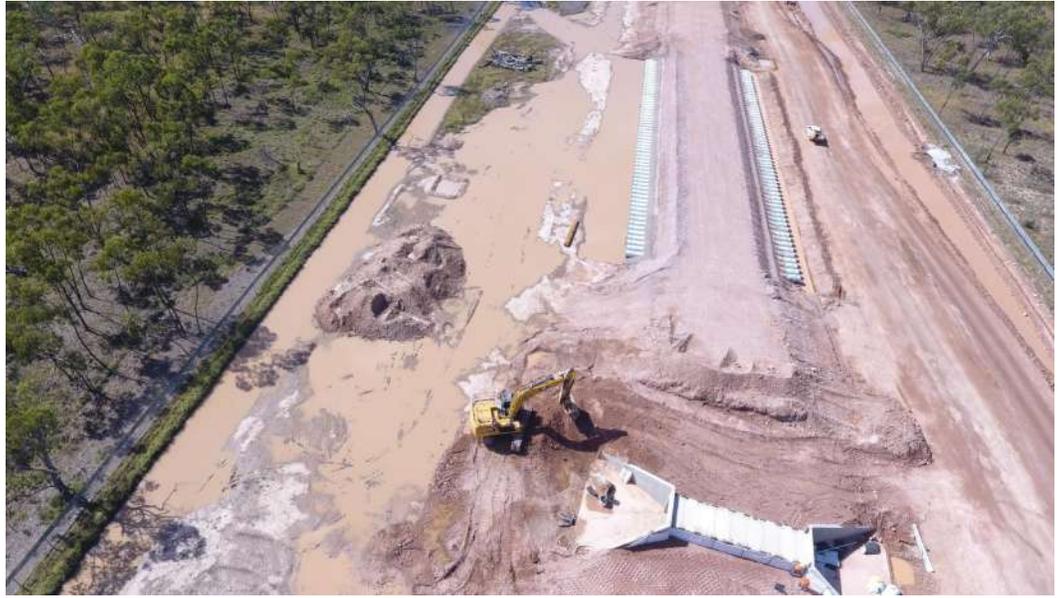
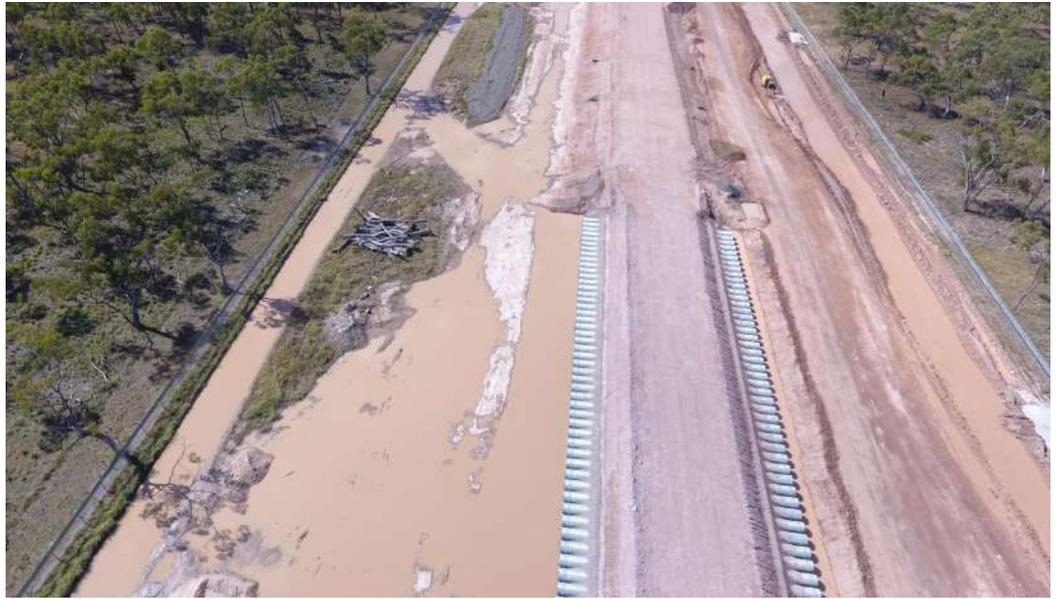
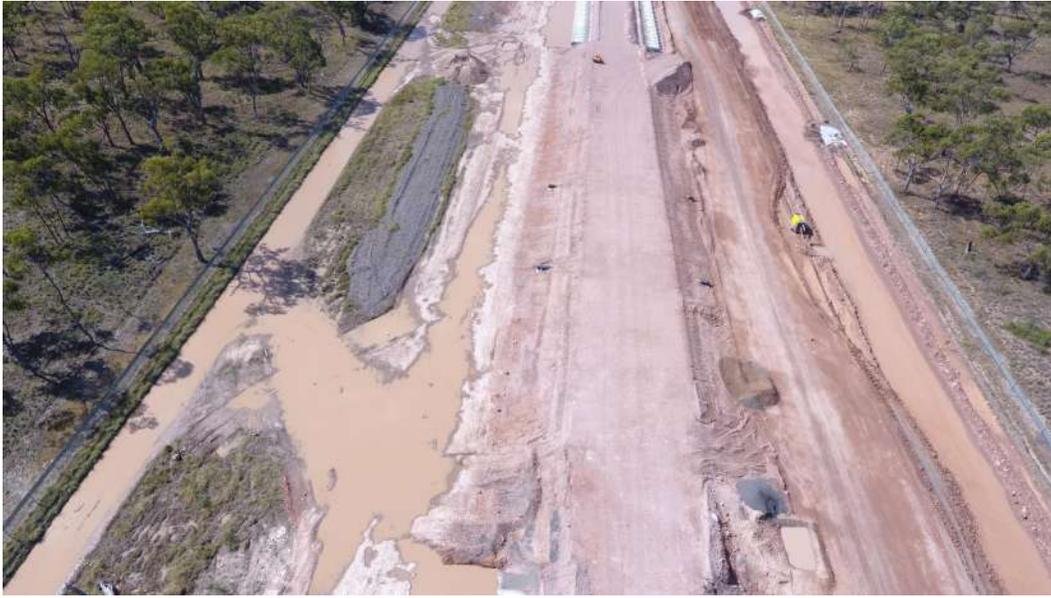
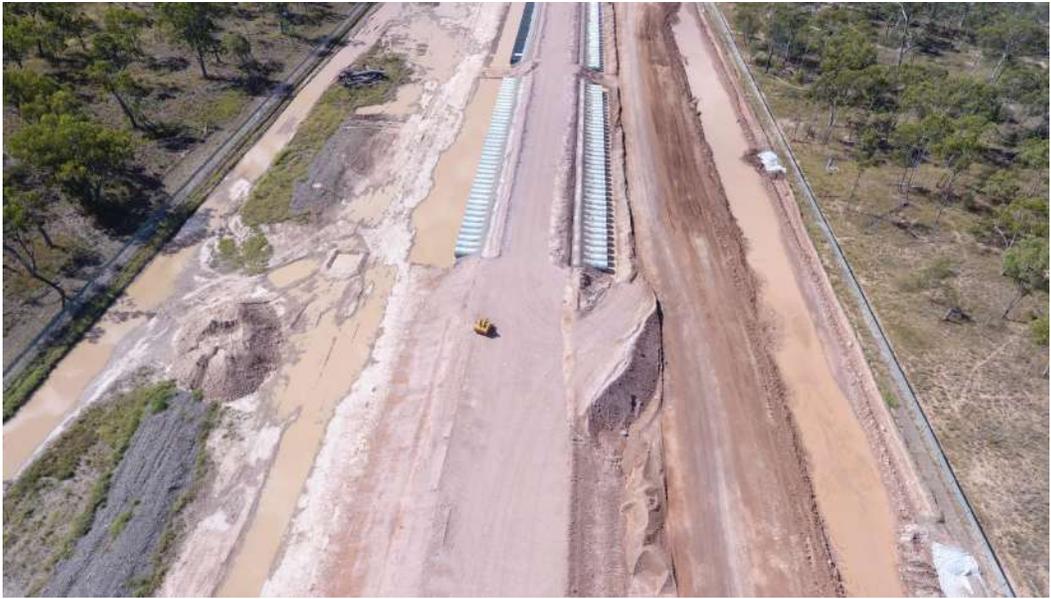
- **Images 60, 61, 63, 64 and 65:** These images show disproportionately small control structures for the size and number of the water pipes in the area.

Further east from 58 showing 4th detention outflow  
These images show disproportionately small control structures for the size and number of the water pipes in the area.

Further east from 58 showing 4th detention outflow

Showing a bit of 4th and all of 5th detention outflow

Showing 5th and 6th detention outflows

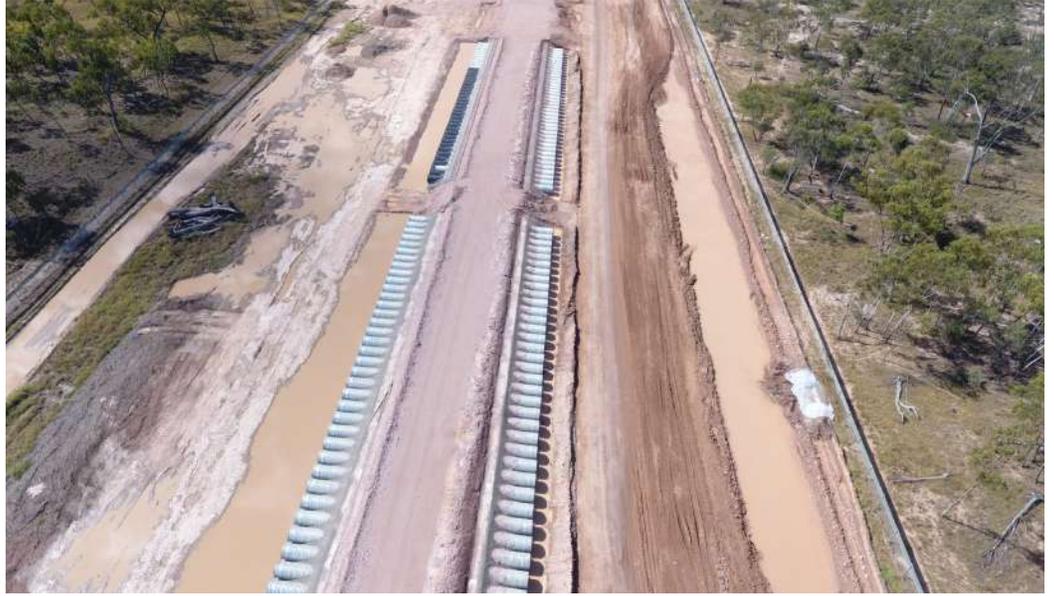
66

- **Image 66:** There is a pond of turbid water in this image without measures in place to allow the fine soils to settle before it discharges.
- **Image 67:** This image shows a large pond of very turbid water without erosion or sediment control works.

Flying east looking east from 64 to 69

There is a pond of fairly turbid water in this image without measures in place to allow the fine soils to settle before it discharges.

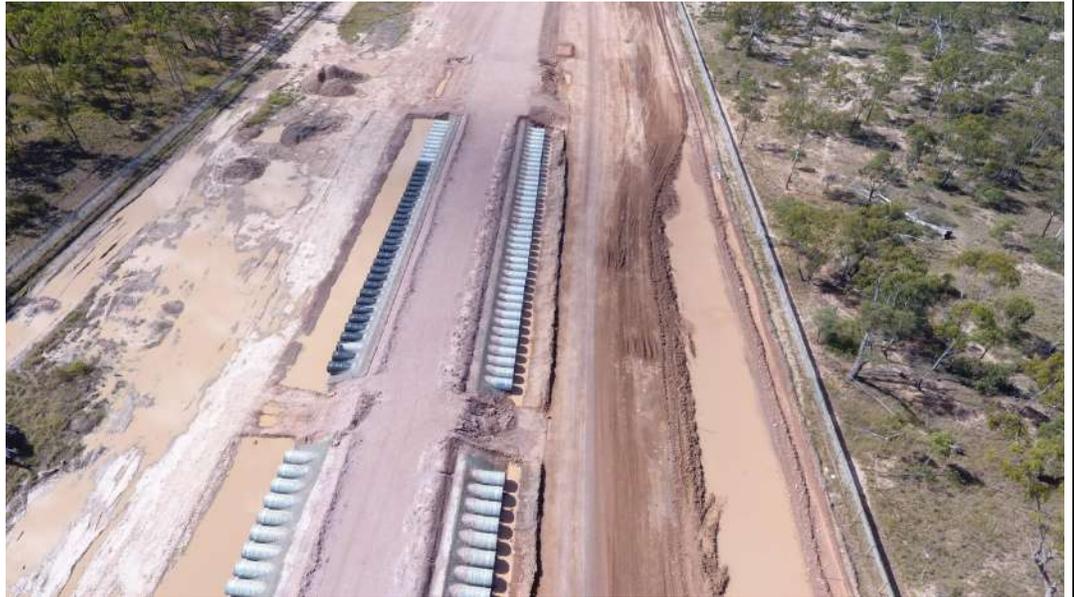
67

This image shows a large pond of very turbid water without erosion or sediment control works.
