Attachment 2: Photo Document

Field Assessment Report and Background Review
CN 2017 Herbicide Application in the Skeena Sub,
Terrace to Prince Rupert, BC

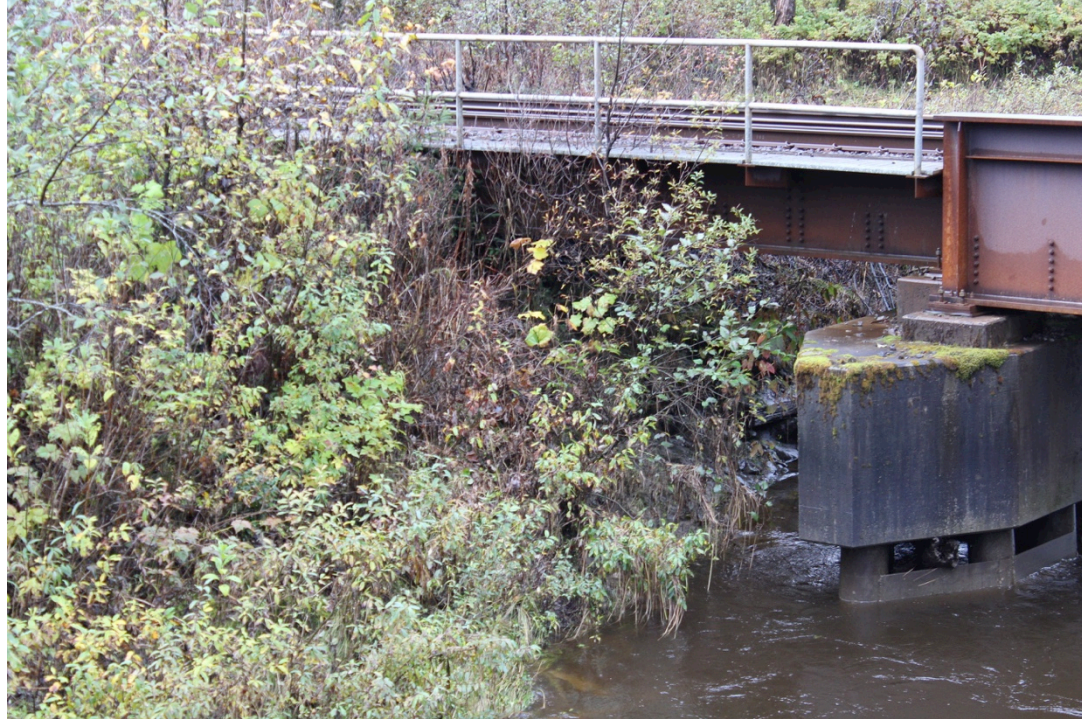
Photo 14. Upstream view of right bank; note defoliation beyond rail bridge abutments, extending to within ~2m of normal HWM.

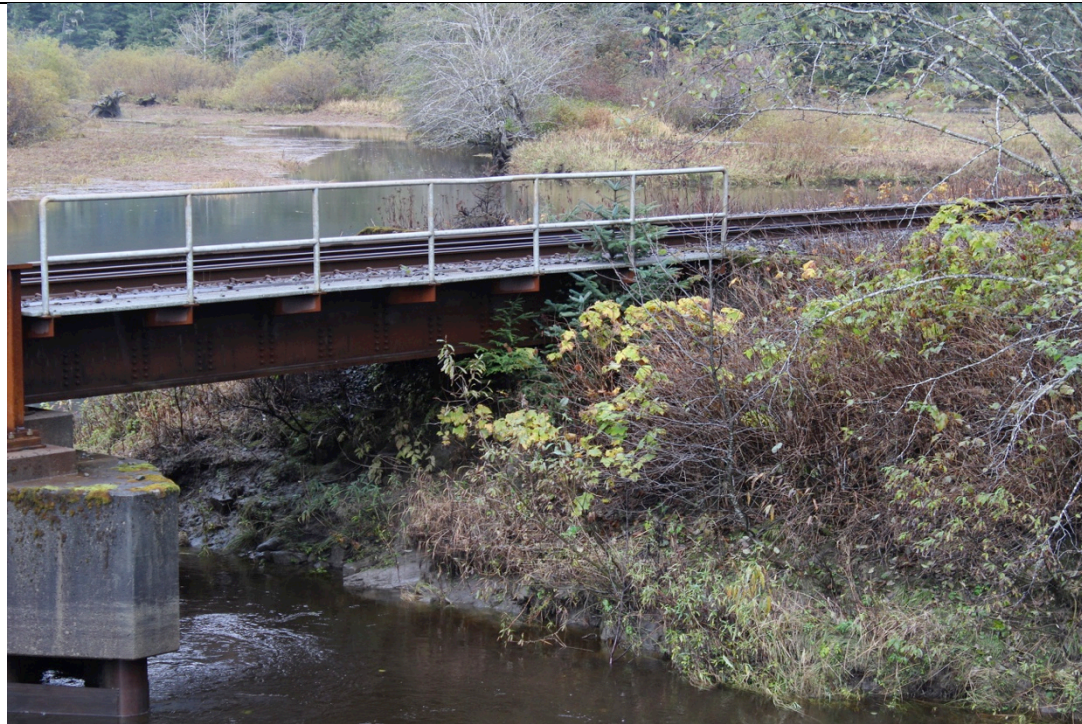
Photo 15. Upstream view to left bank; note damage to Sitka spruce shrubs and other vegetation at top of bank (both upstream and downstream sides of bridge), and apparent proximity of upstream channel and wetland habitat.

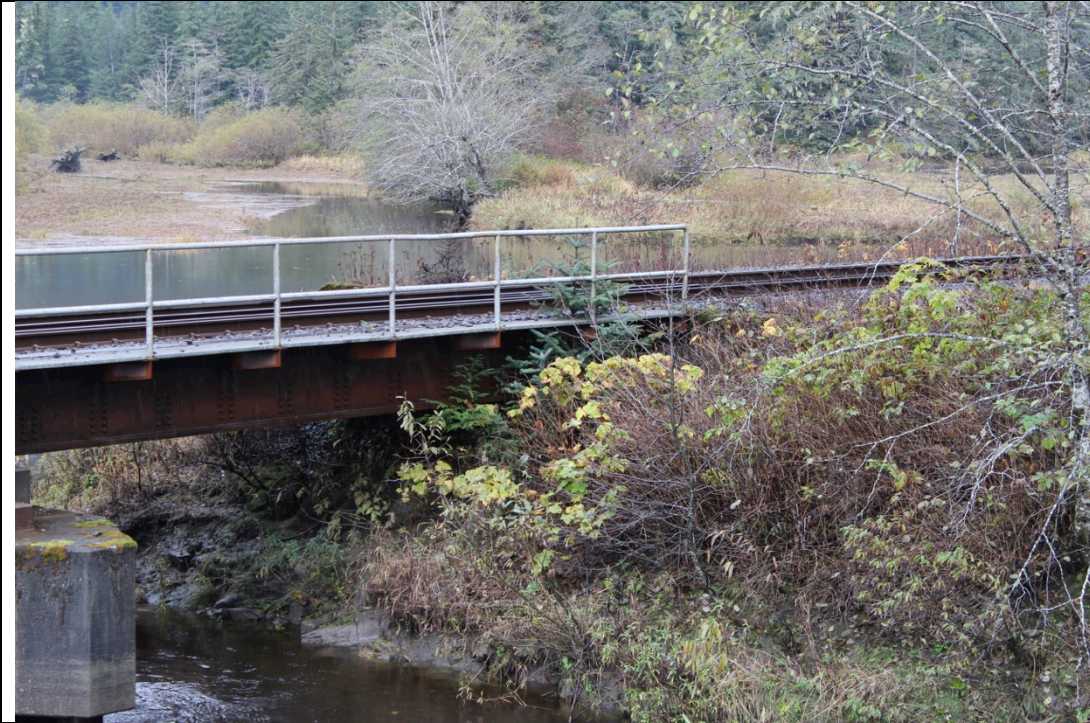
Photo 16. Upstream view to left bank; note damage to Sitka spruce shrubs and other vegetation at top of bank (both upstream and downstream sides of bridge), and apparent proximity of upstream channel and wetland habitat.

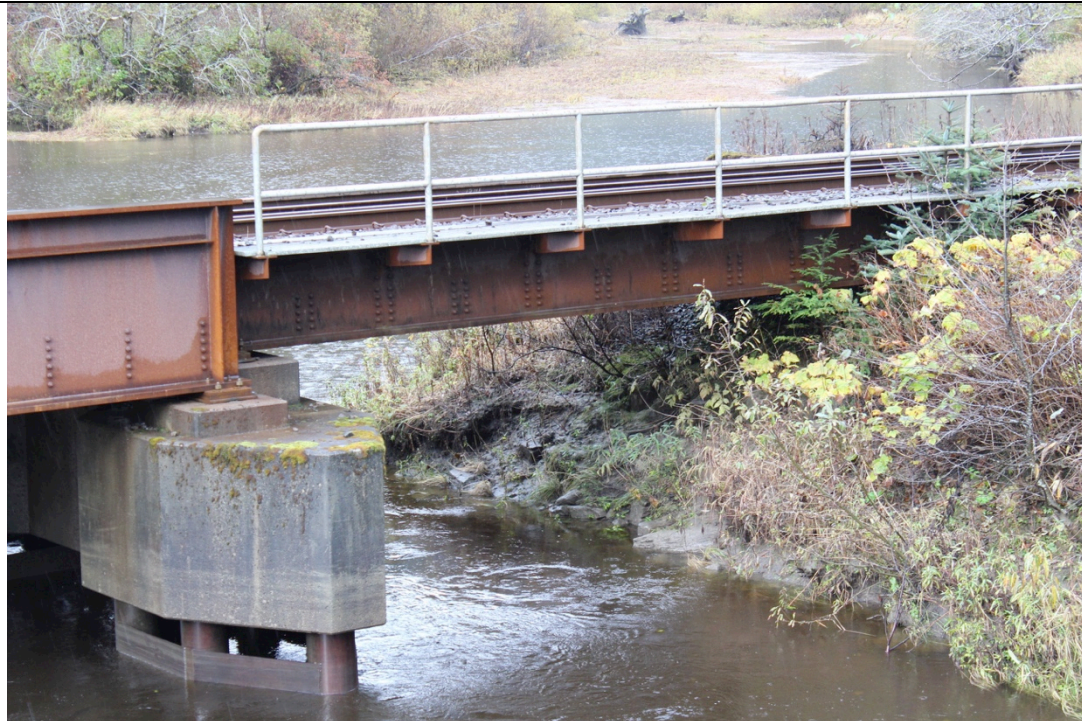
Photo 17: Upstream view to right bank and mudflats/tidal wetland area upriver.

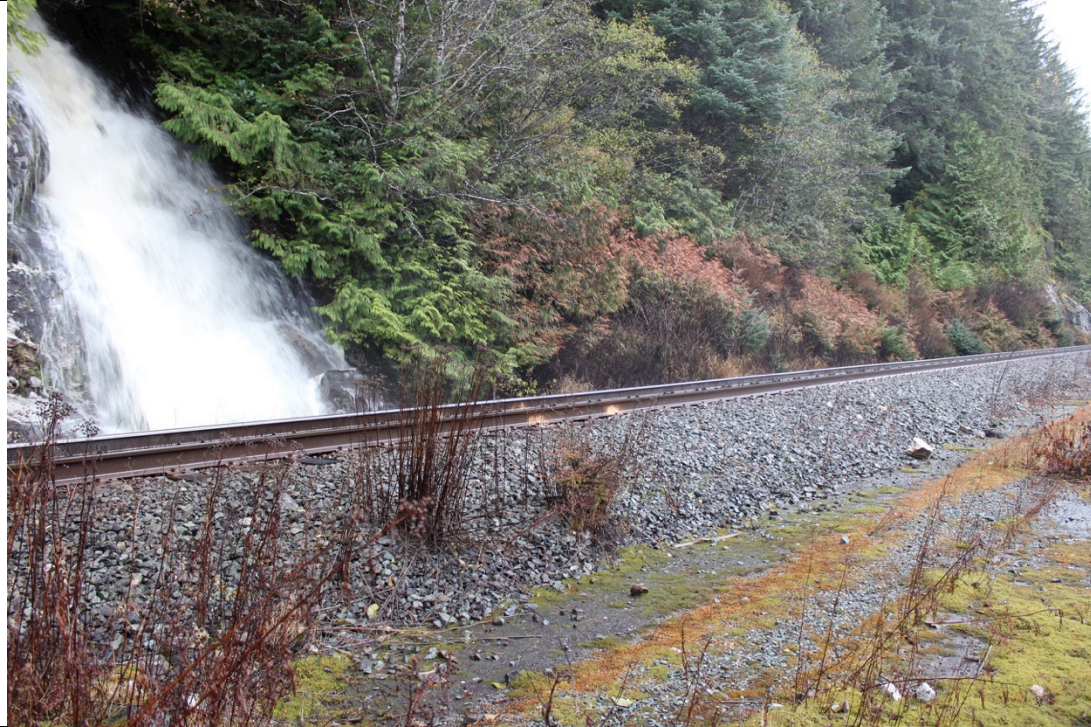
Photo 18. Permanent creek channel at left, with evidence of high spray within one metre of channel substrate/normal HWM.

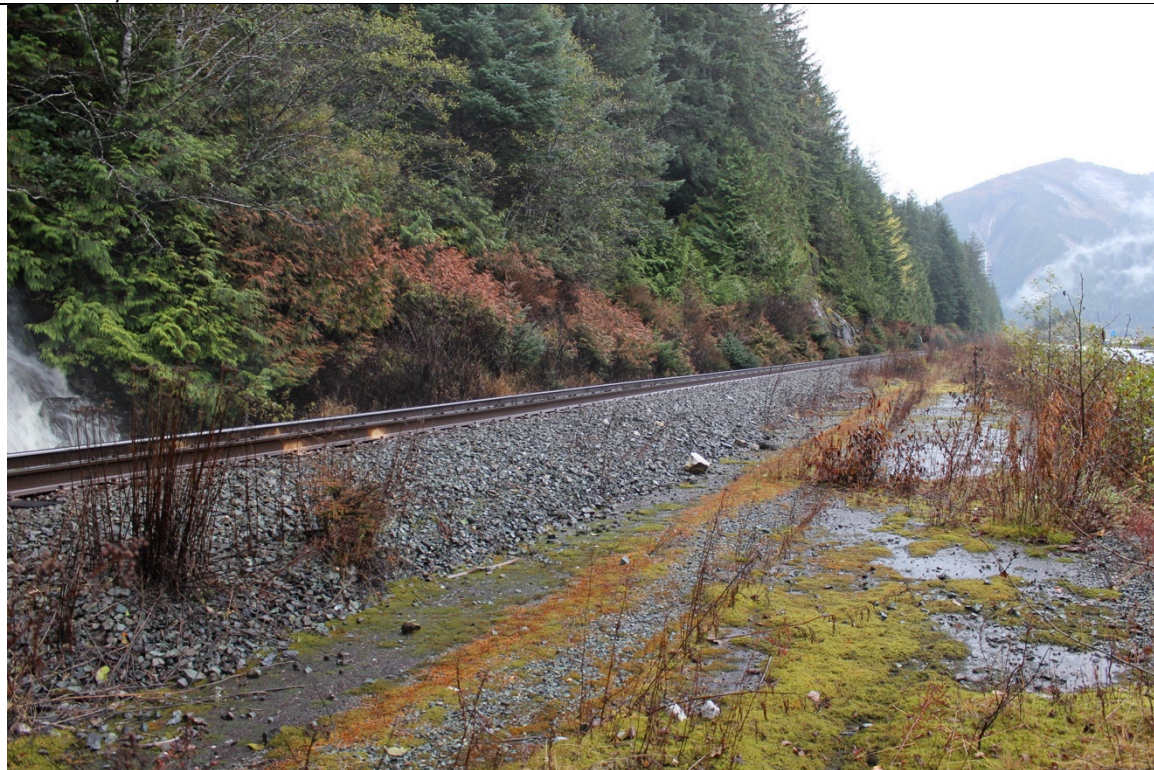
Photo 19. High spray evident for extensive eastbound segment; note that many ephemeral watercourses occur along these slopes, entering fish-bearing waters (Skeena River) to photo right.

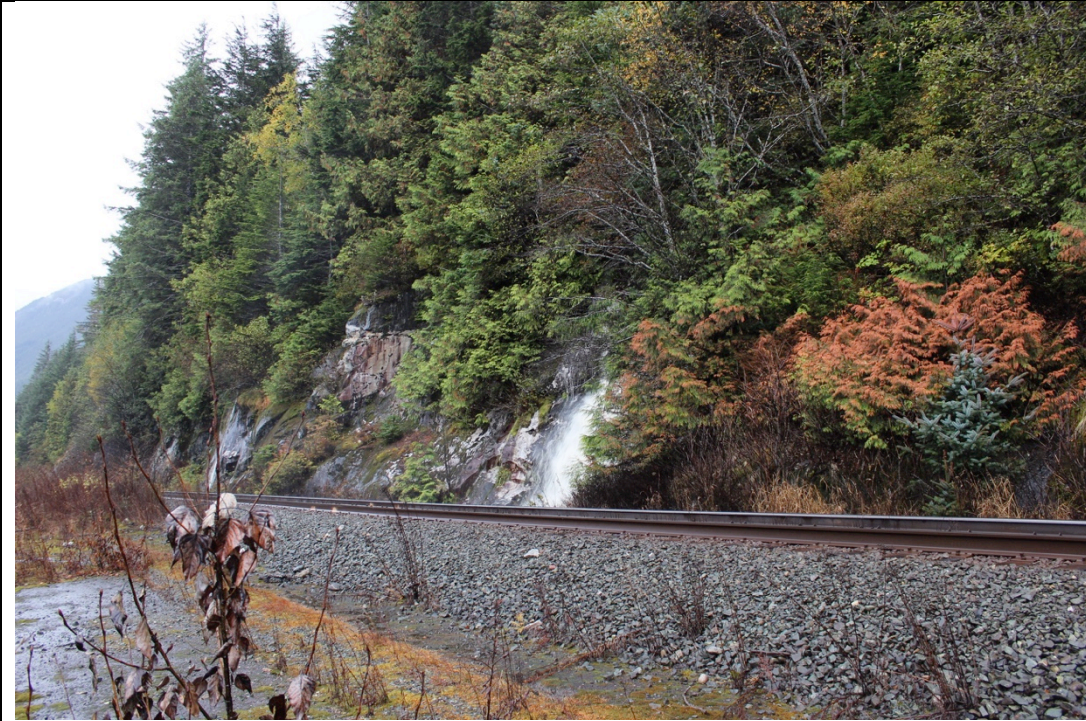
Photo 20. Westbound view, showing continued evidence of high spray on north side (and continuous on south side) beyond permanent creek (center photo).

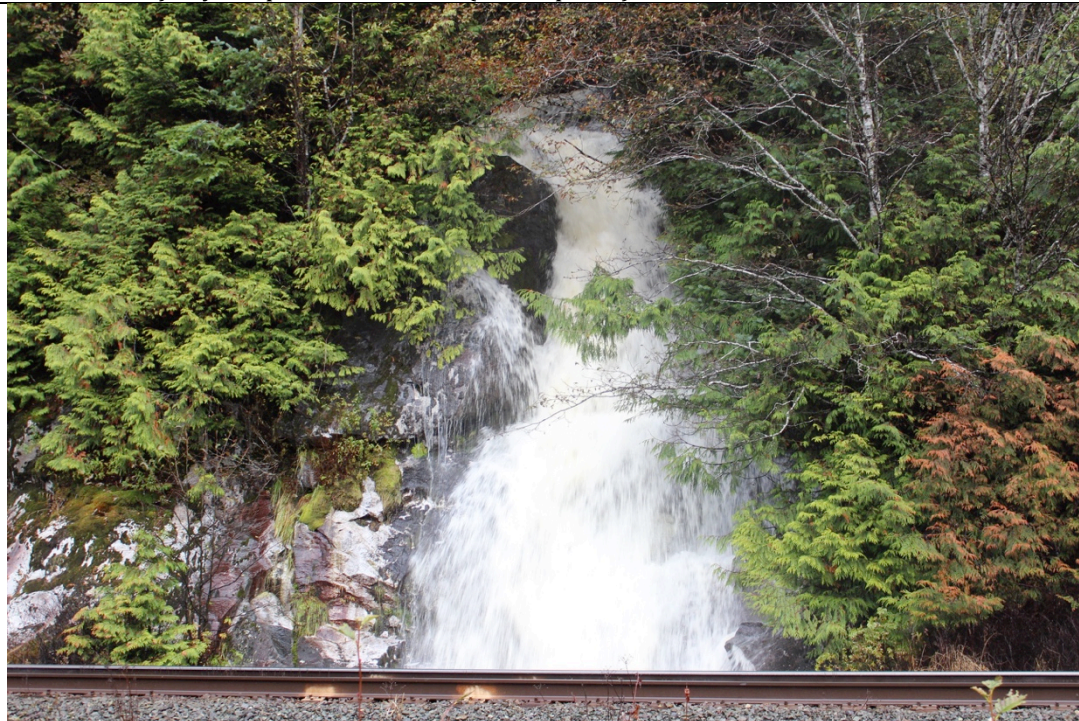
Photo 21. Upstream view of permanent stream channel; Note the damage to foliate on the small cedar shrub to the left, as well as the high spray at photo-right.

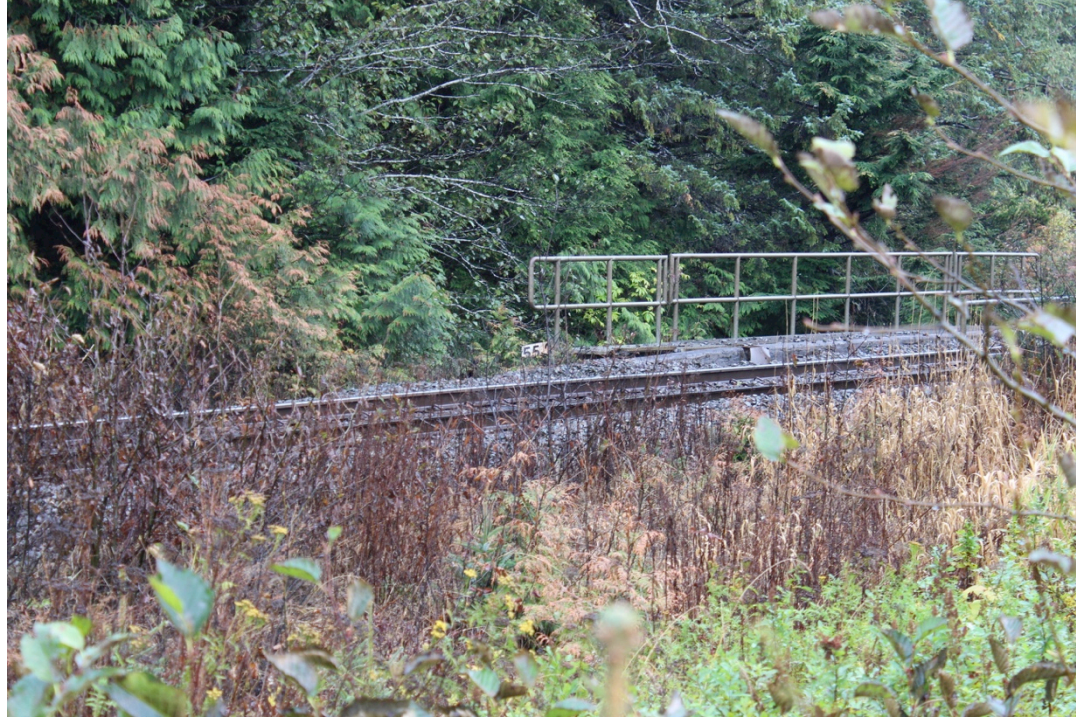
Photo 22. View ~NE above Log Creek; note evidence of high spray on western redcedar (left) up to abutments, and damaged shrubs and herbaceous vegetation in foreground.

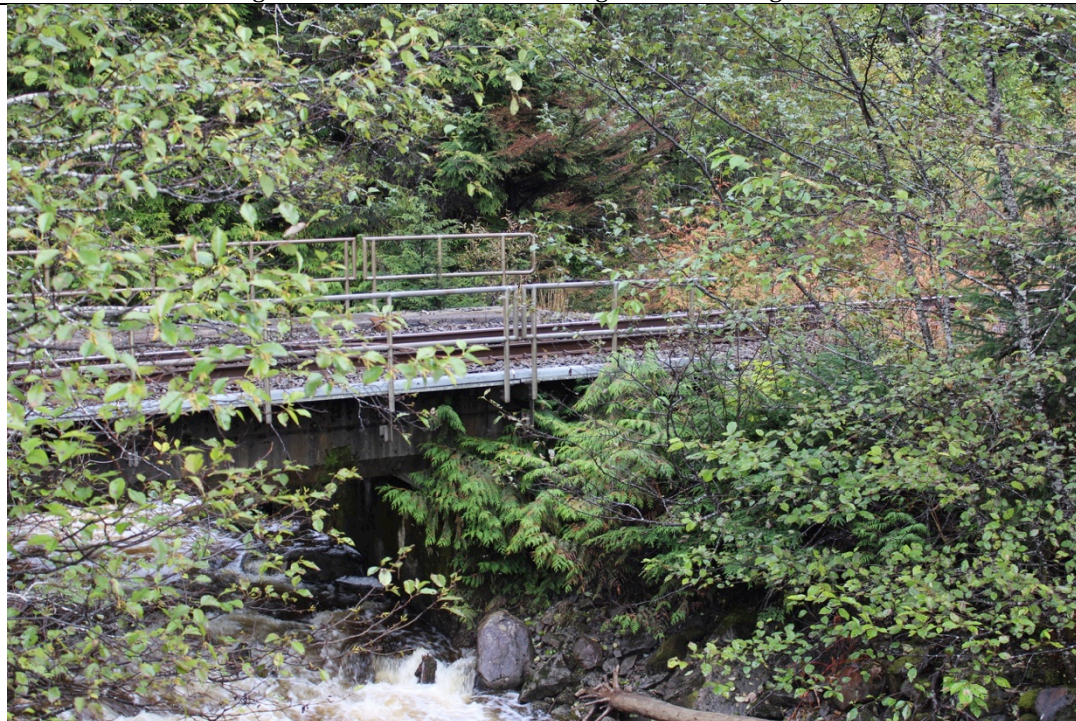
Photo 23. View upstream to left bank; note high spray evident on western hemlock and damaged foliage of Sitka willow at bridge abutment on upstream side of rail bridge.

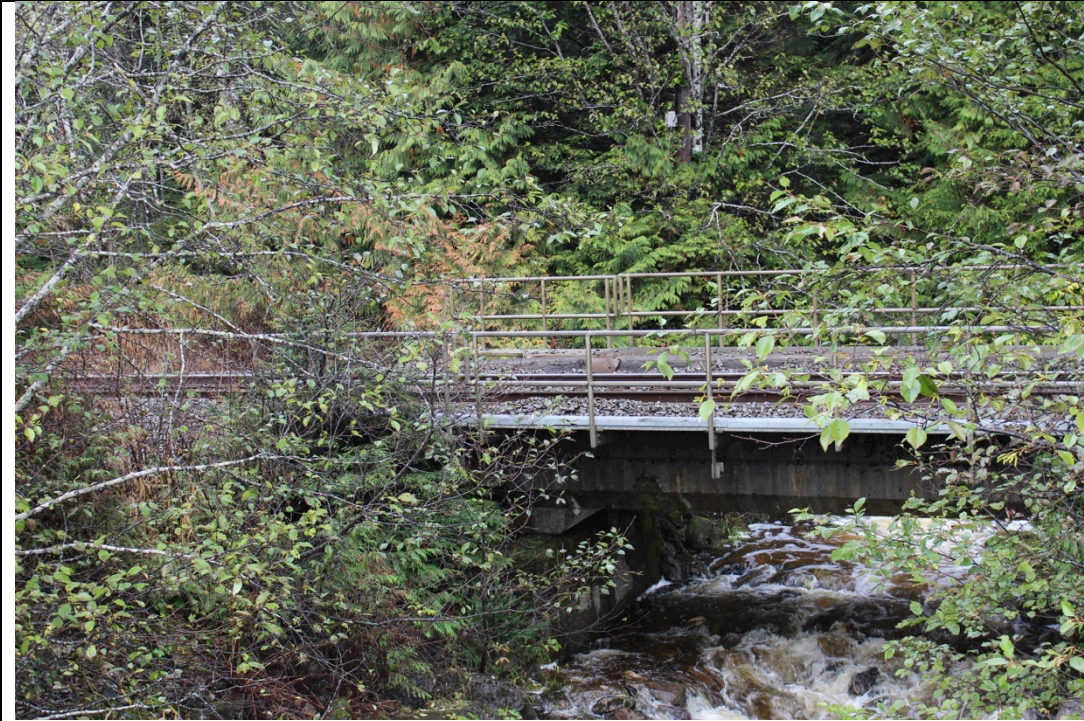
Photo 24. Upstream view to right bank; note high spray damage on western redcedar at bridge abutment.
