Department of Environment, Land,
Water and Planning (DELWP)

Timber Harvesting Compliance Unit (THCU)
Case Management Report

DELWP Case Reference Number: 2015-0006

Coupe: 892-508-0006 (Last Minute) in the Bendoc State forest (East Gippsland).

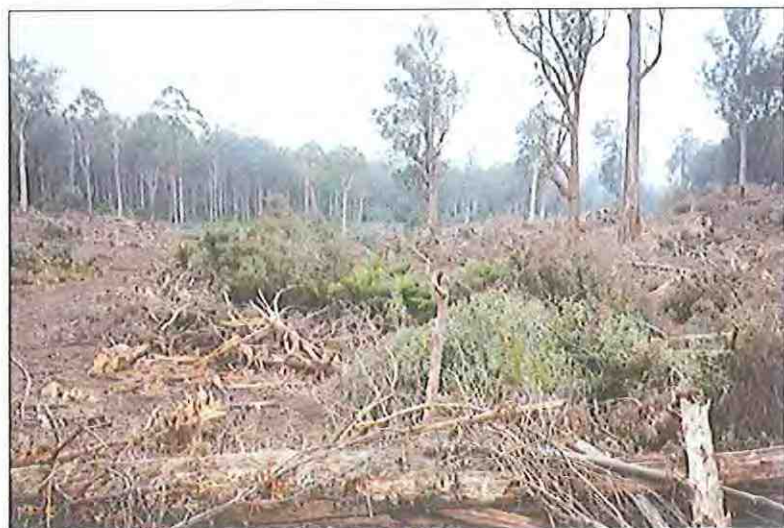
Figure 1. Photograph from within coupe 892-508-0006 (Last Minute) showing the gully containing at least 22 pushed rainforest canopy trees in relation to allegation (i) and the surrounding general harvesting area within the coupe.

The officers noted the presence of a number of Black Olive-Berry and Southern Sassafras trees (East Gippsland Cool Temperate Rainforest canopy tree species) which appeared to have been pushed over with harvesting machinery. A total of 22 large rainforest canopy trees were identified and inspected by the officers. Each was assigned a number and marked with white paint by the officers. [REDACTED] captured GPS data points and photographed the trees and [REDACTED] took tree diameter measurements (breast height over bark) where possible. Due to the high degree of disturbance caused by the surrounding harvesting operation, measuring the trees was not always possible.

Assessing presence or absence of rainforest using the standard "canopy assessment method" in line with the guidance provided in the *Management Standards and Procedures for timber harvesting operations in Victoria's State forests 2014* was not possible at this site because all relevant canopy trees had been pushed over. [REDACTED] determined that the next best option was to attempt to "reconstruct" the vegetation that was likely to have been present at the site using a combination of aerial photography and field observations. To achieve this [REDACTED] provided the GPS data to [REDACTED] who used spatial analysis software to compare the location of the tree crowns observable in the available aerial photography (21 October 2010) to the GPS points taken in the field. This analysis was reviewed by [REDACTED] in line with [REDACTED] field observations and still photographs. [REDACTED] noted that there was a small variation between the aerial photograph location and GPS points but that these were attributed to the usual level of inaccuracy that occurs when using a GPS and the possible movement and rearrangement of pushed trees during harvesting. [REDACTED] concluded that there was sufficient evidence available to suggest that the trees observed in the field were the same that were present in the aerial photograph. [REDACTED] then established two polygons of potential rainforest canopy where the rainforest canopy tree species crowns were closely packed together, and where he assessed that it would be likely to achieve a 70% projected foliage canopy cover. An approximate size of each potential rainforest patch was then calculated by [REDACTED] using the spatial software. [REDACTED] then prepared a map outlining the results of this analysis (see Appendix 2).

Regardless of this, the THCU recommends that DELWP engage VicForests to further discuss the outcome where the 22 large rainforest canopy trees were felled. The THCU officers have determined that although this was not a technical breach of the regulatory rules, this was unnecessary and that similar outcomes should be avoided for future timber harvesting operations. It is not considered best practice for large rainforest canopy trees (such as the one seen in Attachment 3C) to be needlessly destroyed. The officers assessed that the area of interest included significant environmental assets, but had no merchantable value and was unlikely to significantly obstruct the harvesting of the surrounding target eucalypts or impact on future regeneration objectives.

VicForests retains ultimate responsibility for the training and supervision of its harvesting contactors. VicForests is also responsible for planning coupes and establishing appropriate harvesting exclusion zones within its operations. THCU recommends that VicForests reviews the guidelines and instructions provided to harvesting contractors to emphasize the need for appropriate judgment in the selection and felling of un-merchantable tree species, especially when they are large (>0.5m DBH) rainforest canopy species such as the Southern Sassafras (*Atherosperma moschatum*) and Black Olive-berry (*Elaeocarpus holopetalus*).

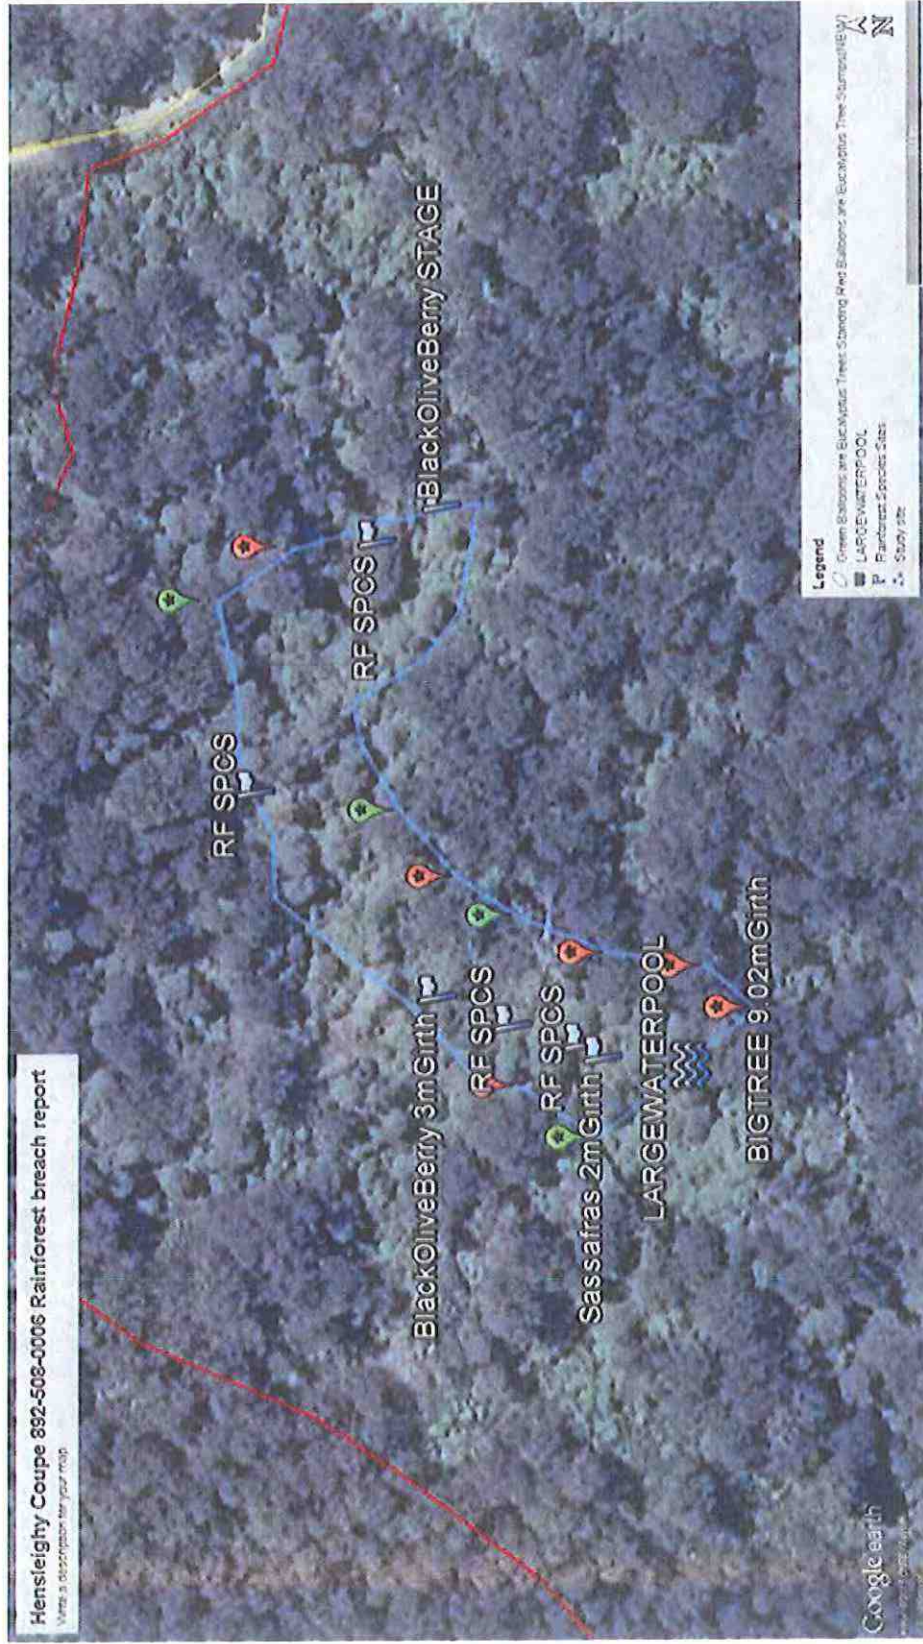
Attachment 1 – Extracted map from [redacted] report showing the site of interest within coupe 892-508-0006 (Last Minute)

Figure 2: Boundary of study area showing logged Eucalyptus trees on boundary as red markers, standing Eucalyptus trees as green markers. RFSPCS represents sites where rainforest character species from the differential key were present. Sassafras 2m Girth and Black Olive Berry 3m Girth indicate location of large pushed over rainforest canopy trees with circumference measurements. Note the clear difference in canopy cover (color and texture) within the study area that was rainforest prior to logging.

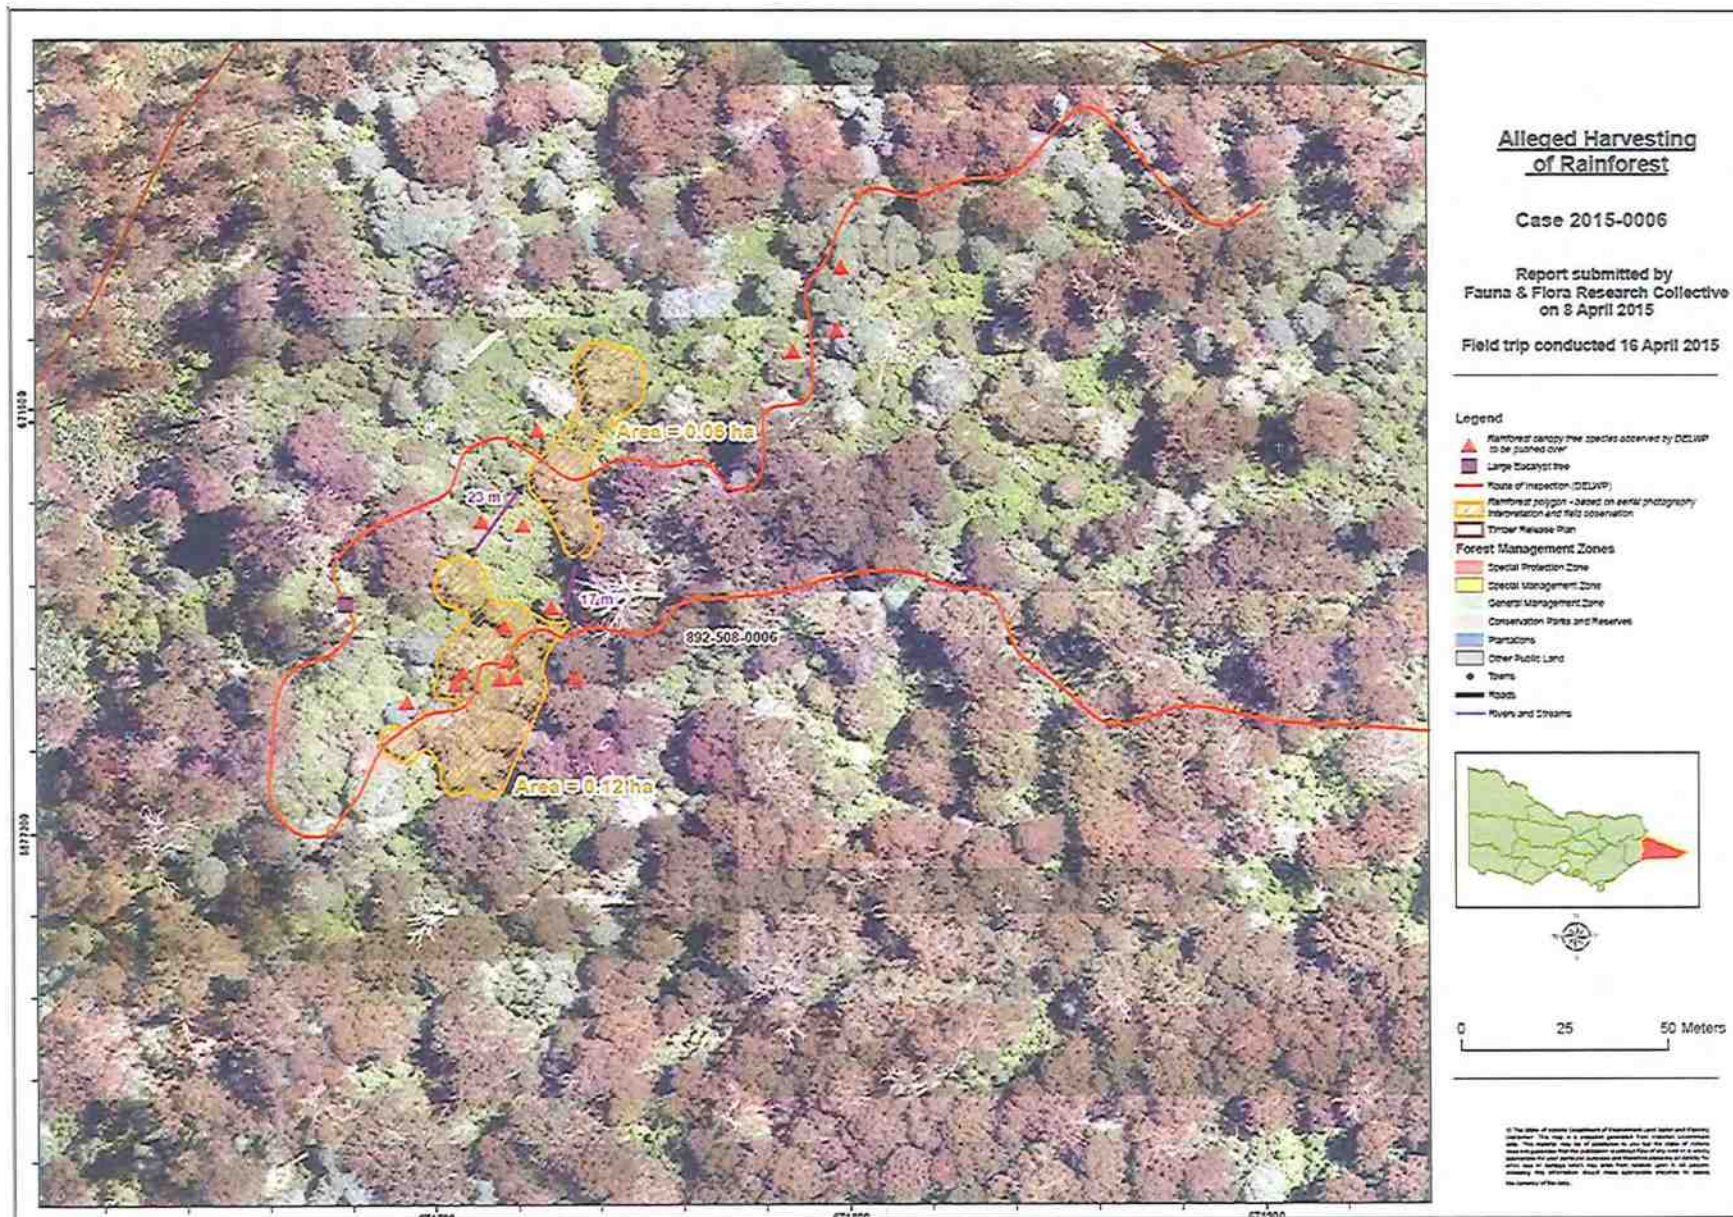
Attachment 2 – DELWP mapping and spatial analysis showing two polygons of potential rainforest within coupe 892-508-0006 (Last Minute) for aerial photograph taken in 2010 prior to the commencement of harvesting

The gap areas between the two potential rainforest patches (see Appendix 2) consisted of scrubby wet gully areas that were dominated by tree ferns. The officers noted that tree ferns are not considered as tree canopy species in the regulatory documents. There was no evidence present to suggest that rainforest was likely to have been recently present in these gap areas. The THCU officers noted that apart from the obvious recent disturbances associated with the timber harvesting operation, there was no evidence of any other recent "disturbance" in the area (such as fire, storm damage or disease) since the last logging operations were conducted in 1968/69. Evidence of the historical logging was observed by the officers in the coupe, with multiple stumps and large remnant logs observed (see Attachment 3D and 3E). The officers determined that a lack of relevant disturbance in the past 10 years, meant that the "differential species technique" for identifying rainforest boundaries would not apply in relation to this coupe.

Based on the field observations made by [REDACTED] the THCU has concluded that it is likely that two potential small patches of vegetation worth assessing for the presence of rainforest were present in the area of interest before the commencement of harvesting. The size of the potential rainforest patches is critical in assessing compliance with the Code. The regulatory requirements for excluding timber harvesting commence after a patch reaches 0.1 ha in size. The estimated size of the two patches was 0.12 and 0.06 Ha (see map at Attachment 2). The distance between these two rainforest patches was estimated to range between 17 and 23m (see map at Attachment 2), with the vegetation in this area comprising a scrubby area dominated by tree ferns. The THCU notes that the regulatory documents do not provide definitive guidance on the treatment of gaps between rainforest but that this particular gap appeared in the field to be of sufficient size to warrant separation of the two rainforest patches.

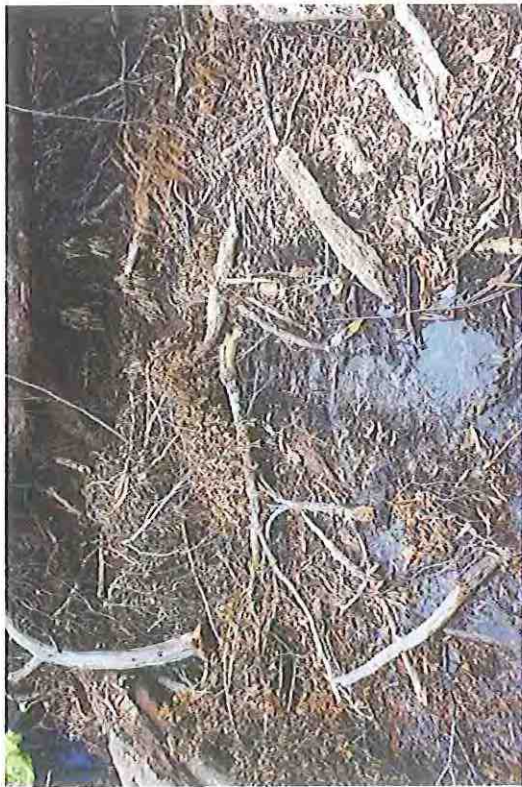
A pool of water in relation to allegation (ii) was located by [REDACTED] in the coupe (see Attachment 3A). The pool was measured by [REDACTED] at 2m in diameter confirming the evidence presented by [REDACTED] in the report submitted. The officer's assessment was that the pool of water (and the nearby running water) was likely formed as the result of the harvesting operation causing soil disturbance exposing sub-surface water flows. [REDACTED] noted that the area was sodden, but found no evidence of formed "channels" suggesting that there was no pre-existing waterway at the site which required protection under the *Code of Practice for Timber Production 2014*.

Selection of photographs from coupe 892-508-0006 (Last Minute): A: Pooling and running water observed in relation to allegation (ii). B: Example of high level of disturbance in the area of interest associated with the pushing of multiple large Black Olive Berry trees relating to allegation (i). C: Very large Black Olive Berry tree that was pushed over relating to allegation (i).

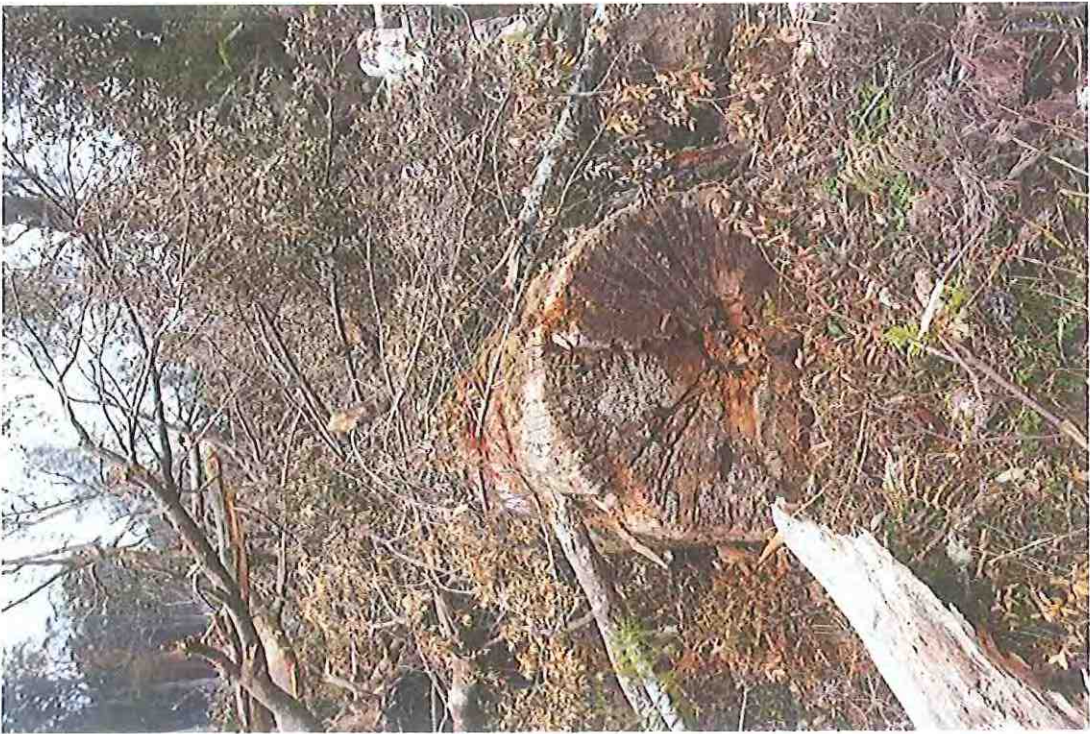
Selection of photographs from coupe 892-508-0006 (Last Minute) Photos D and E: Evidence of old logs and tree stumps from previous 1968-69 logging history.

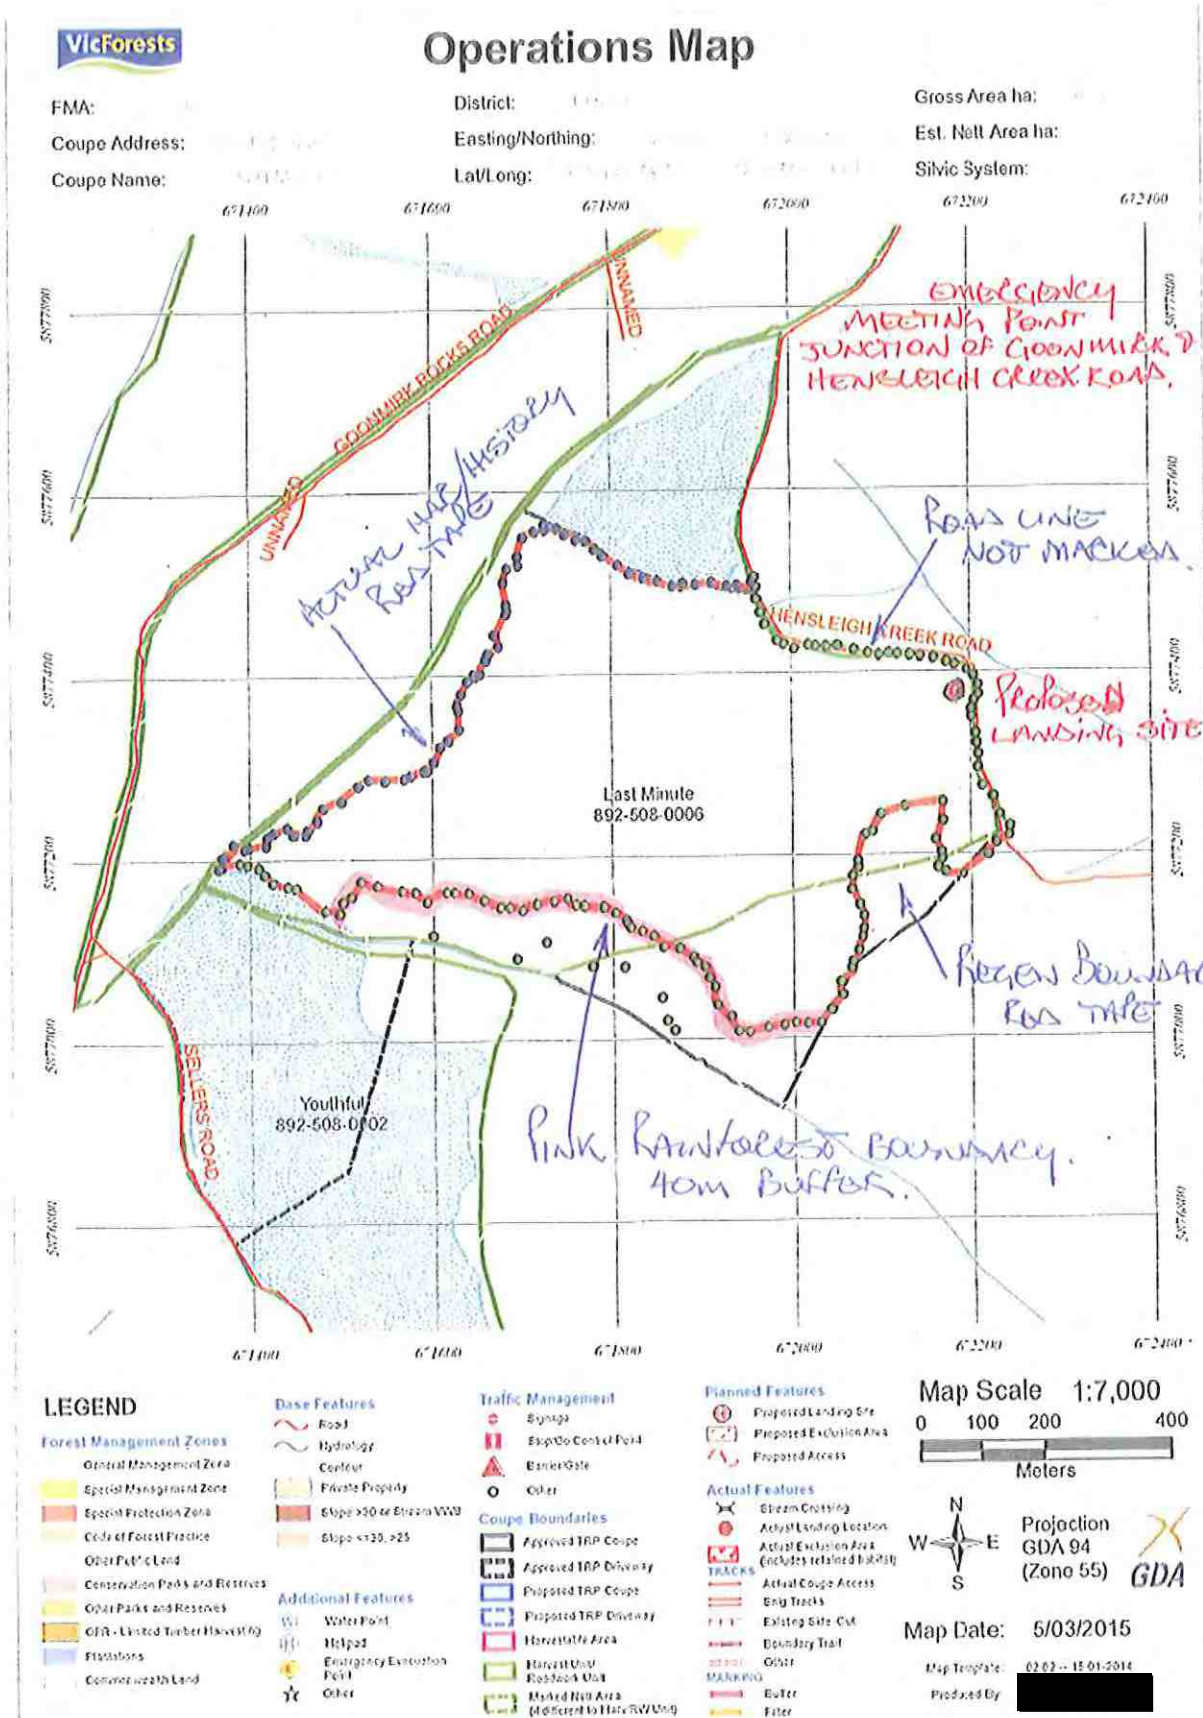
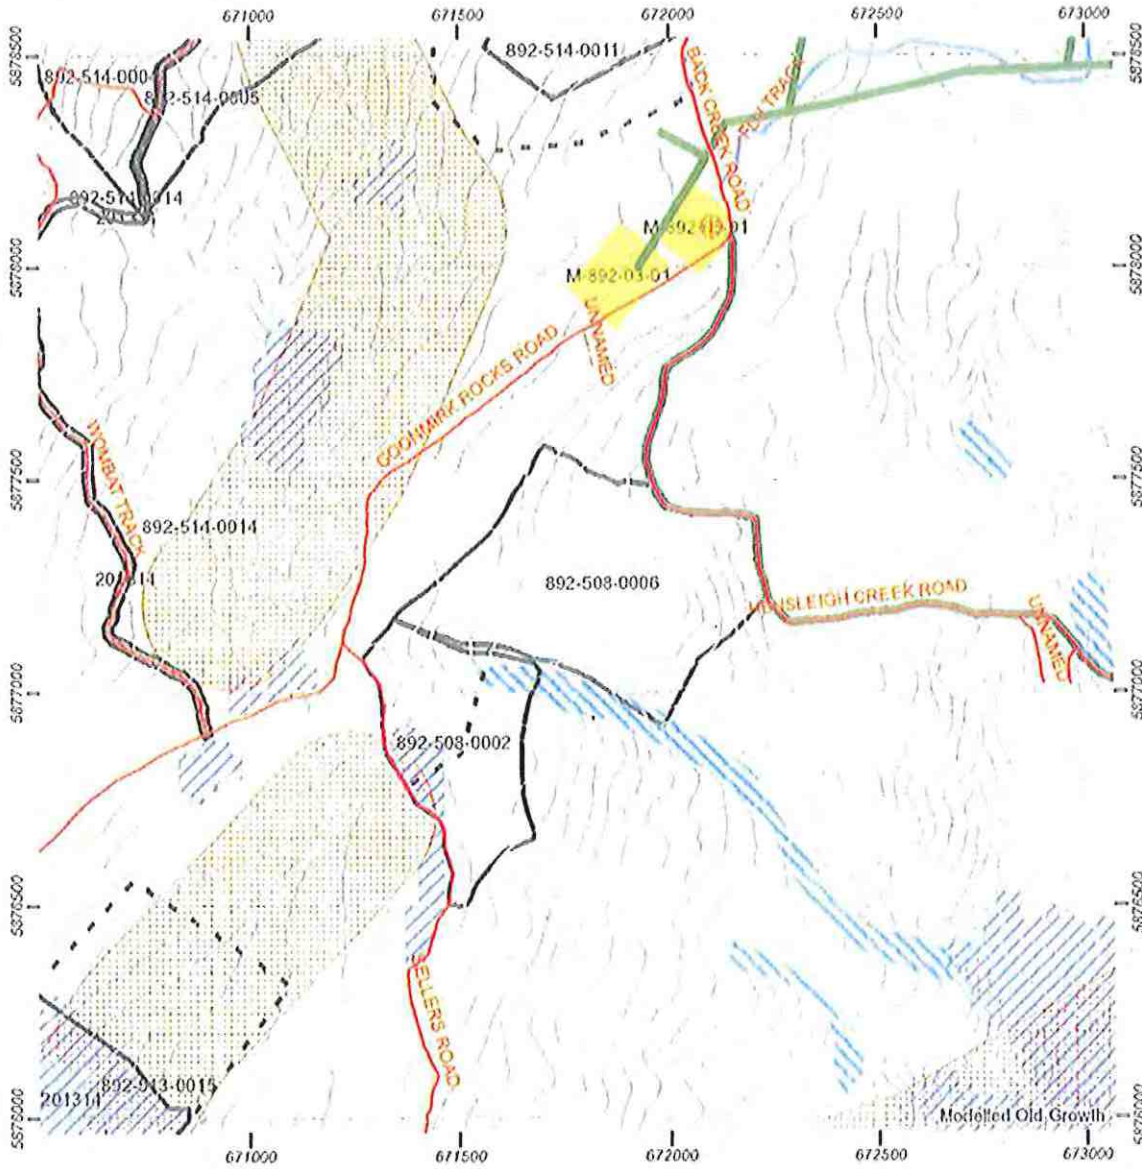
Attachment 7: VicForests Operations and Context Maps (2 maps) showing the location of planned harvesting boundary and 40 meter rainforest buffer applied in southern part of coupe.

The operational plan provided by VicForests clearly showed that the Cool Temperate Rainforest community in the south-eastern part of the coupe was identified prior to harvesting and had been protected with a marked 40m buffer zone. This was sufficiently clear in VicForests' operations map (attachment 4).
