RE: Update on case reference number: 2017-0002 – Basin Creek, East Gippsland

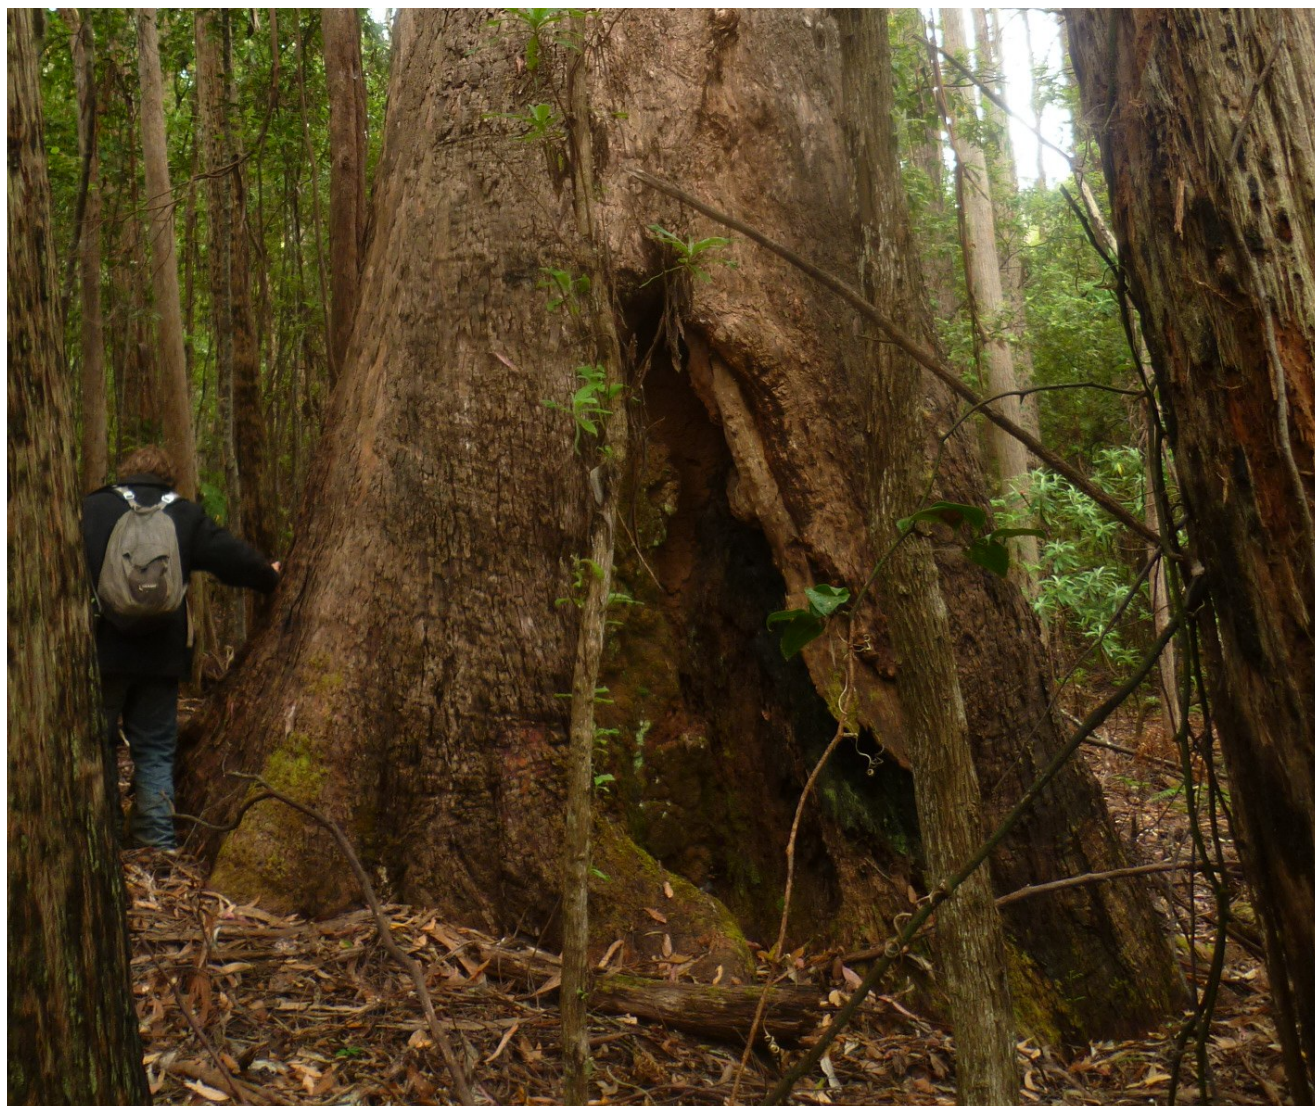
Figure 1 - Search Site 1: Western boundary of VicForest logging coupe 810-501-0009

Crayfish species detected in 'Search Site 1' along the western boundary of coupe 810-501-0009 occur in a stream that is not depicted on the map below. Water and suitable habitat for the species is present in this area despite the absence of a modelled stream in the 'Watercourse network 1:25,000 'Vic Map Hydro' spatial data set. The locations of water pools and the points along the un-modelled stream are displayed on the map below as blue squares. The locations of crayfish species likely to be in the Orbost Spiny Crayfish group are displayed as the blue stars along the course of the un-modelled stream.

Crayfish site 1 (Photos)	55 H 613039 5861108
Crayfish site 2	55 H 613035 5861112
Crayfish site 3	55 H 613038 5861140
Crayfish site 4	55 H 613057 5861142
Crayfish site 5	55 H 613067 5861191
Crayfish site 6	55 H 613092 5861199
Crayfish site 7	55 H 613095 5861229
Crayfish site 8	55 H 613186 5861255

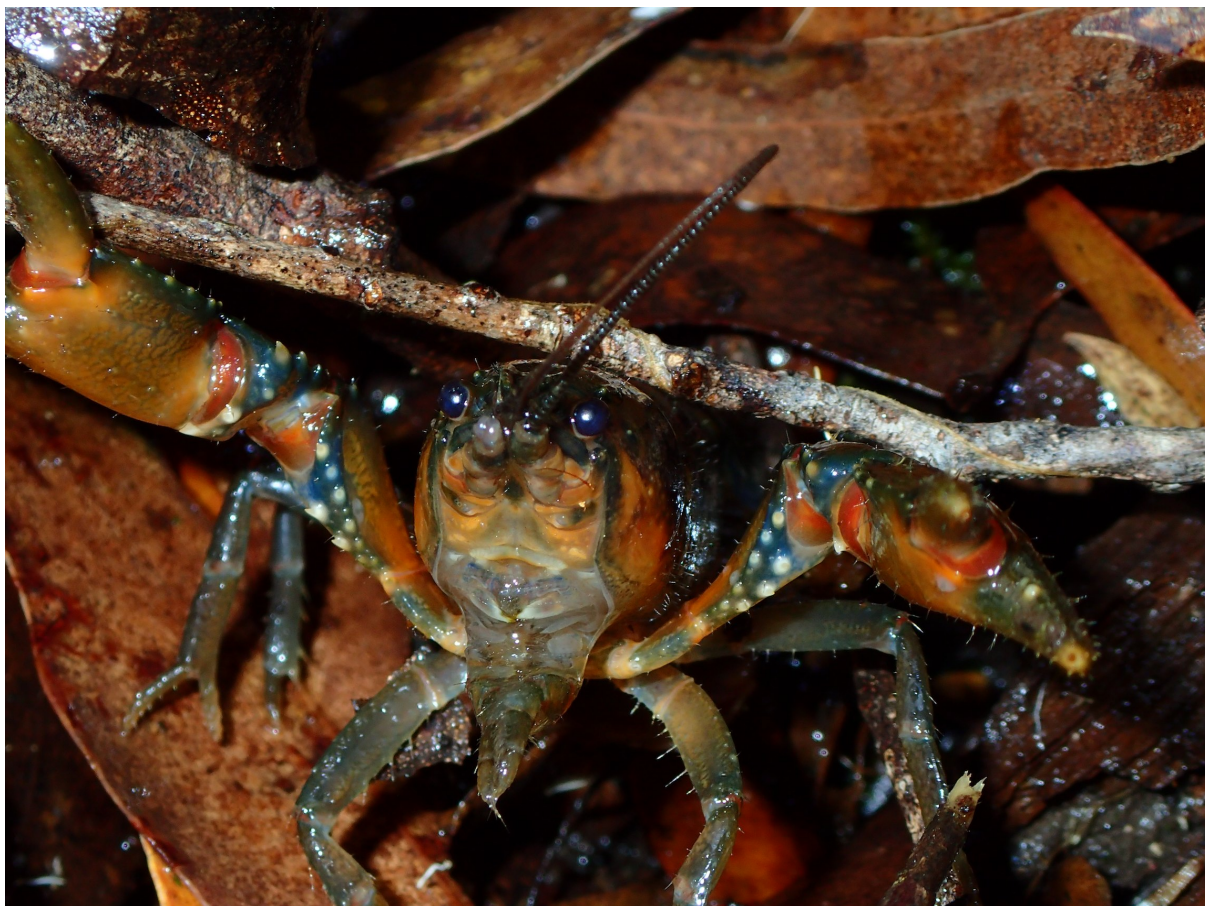
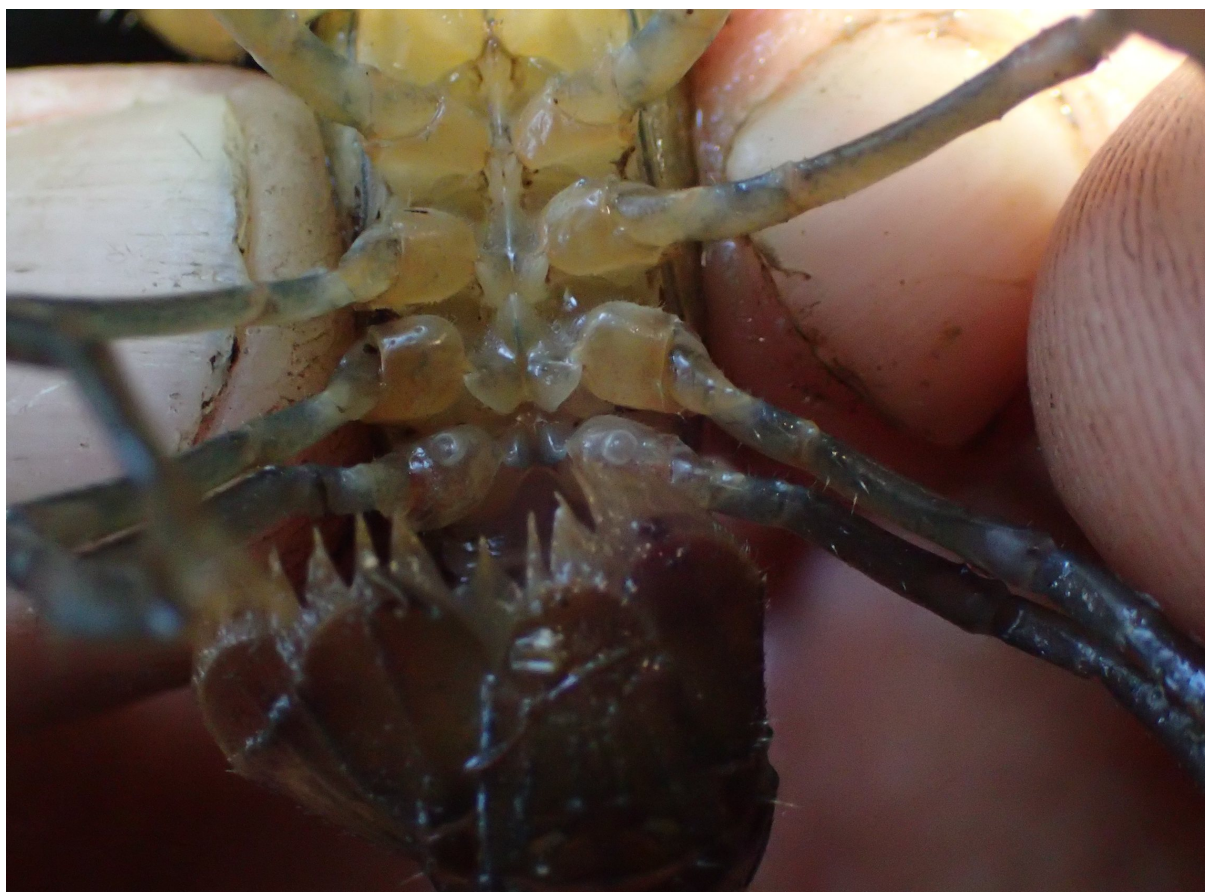
Location: 55 H 613039 5861108

Photos: Crayfish on western boundary of coupe 810-501-0009 (search site 1)

Date: 14/01/17 **Time:** 6:56pm

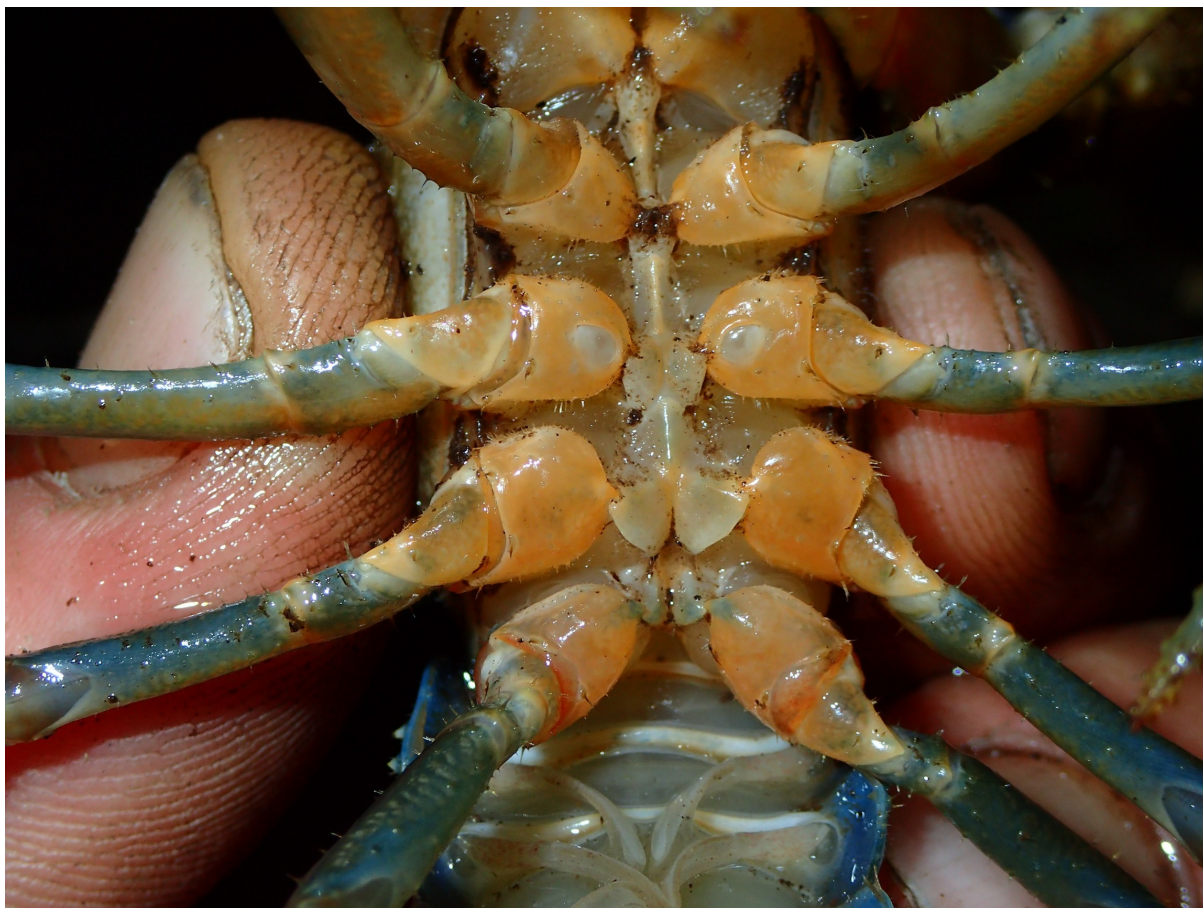
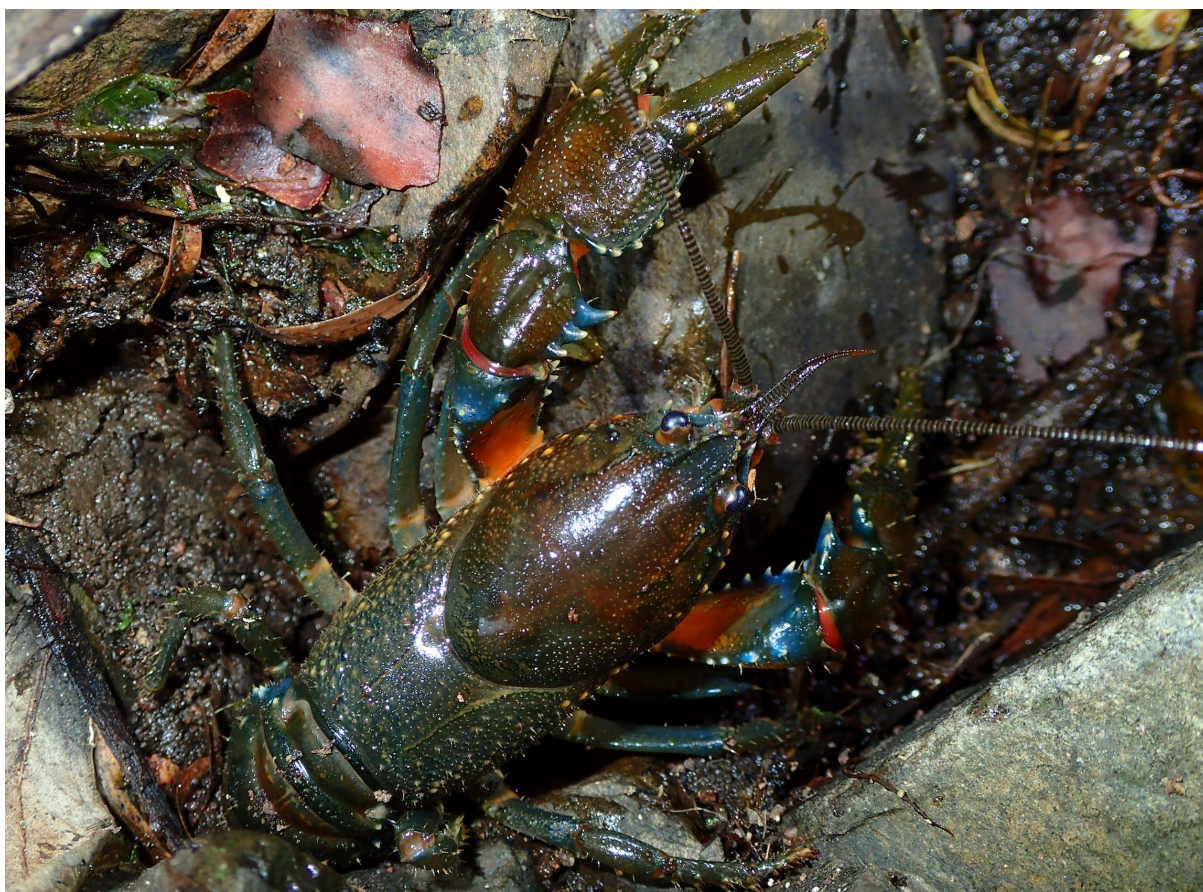
Location: 55 H 612948 5860301

Photos: Crayfish on eastern boundary of coupe 810-501-0006 (search site 2)

Date: 15/01/17 **Time:** 11:36pm

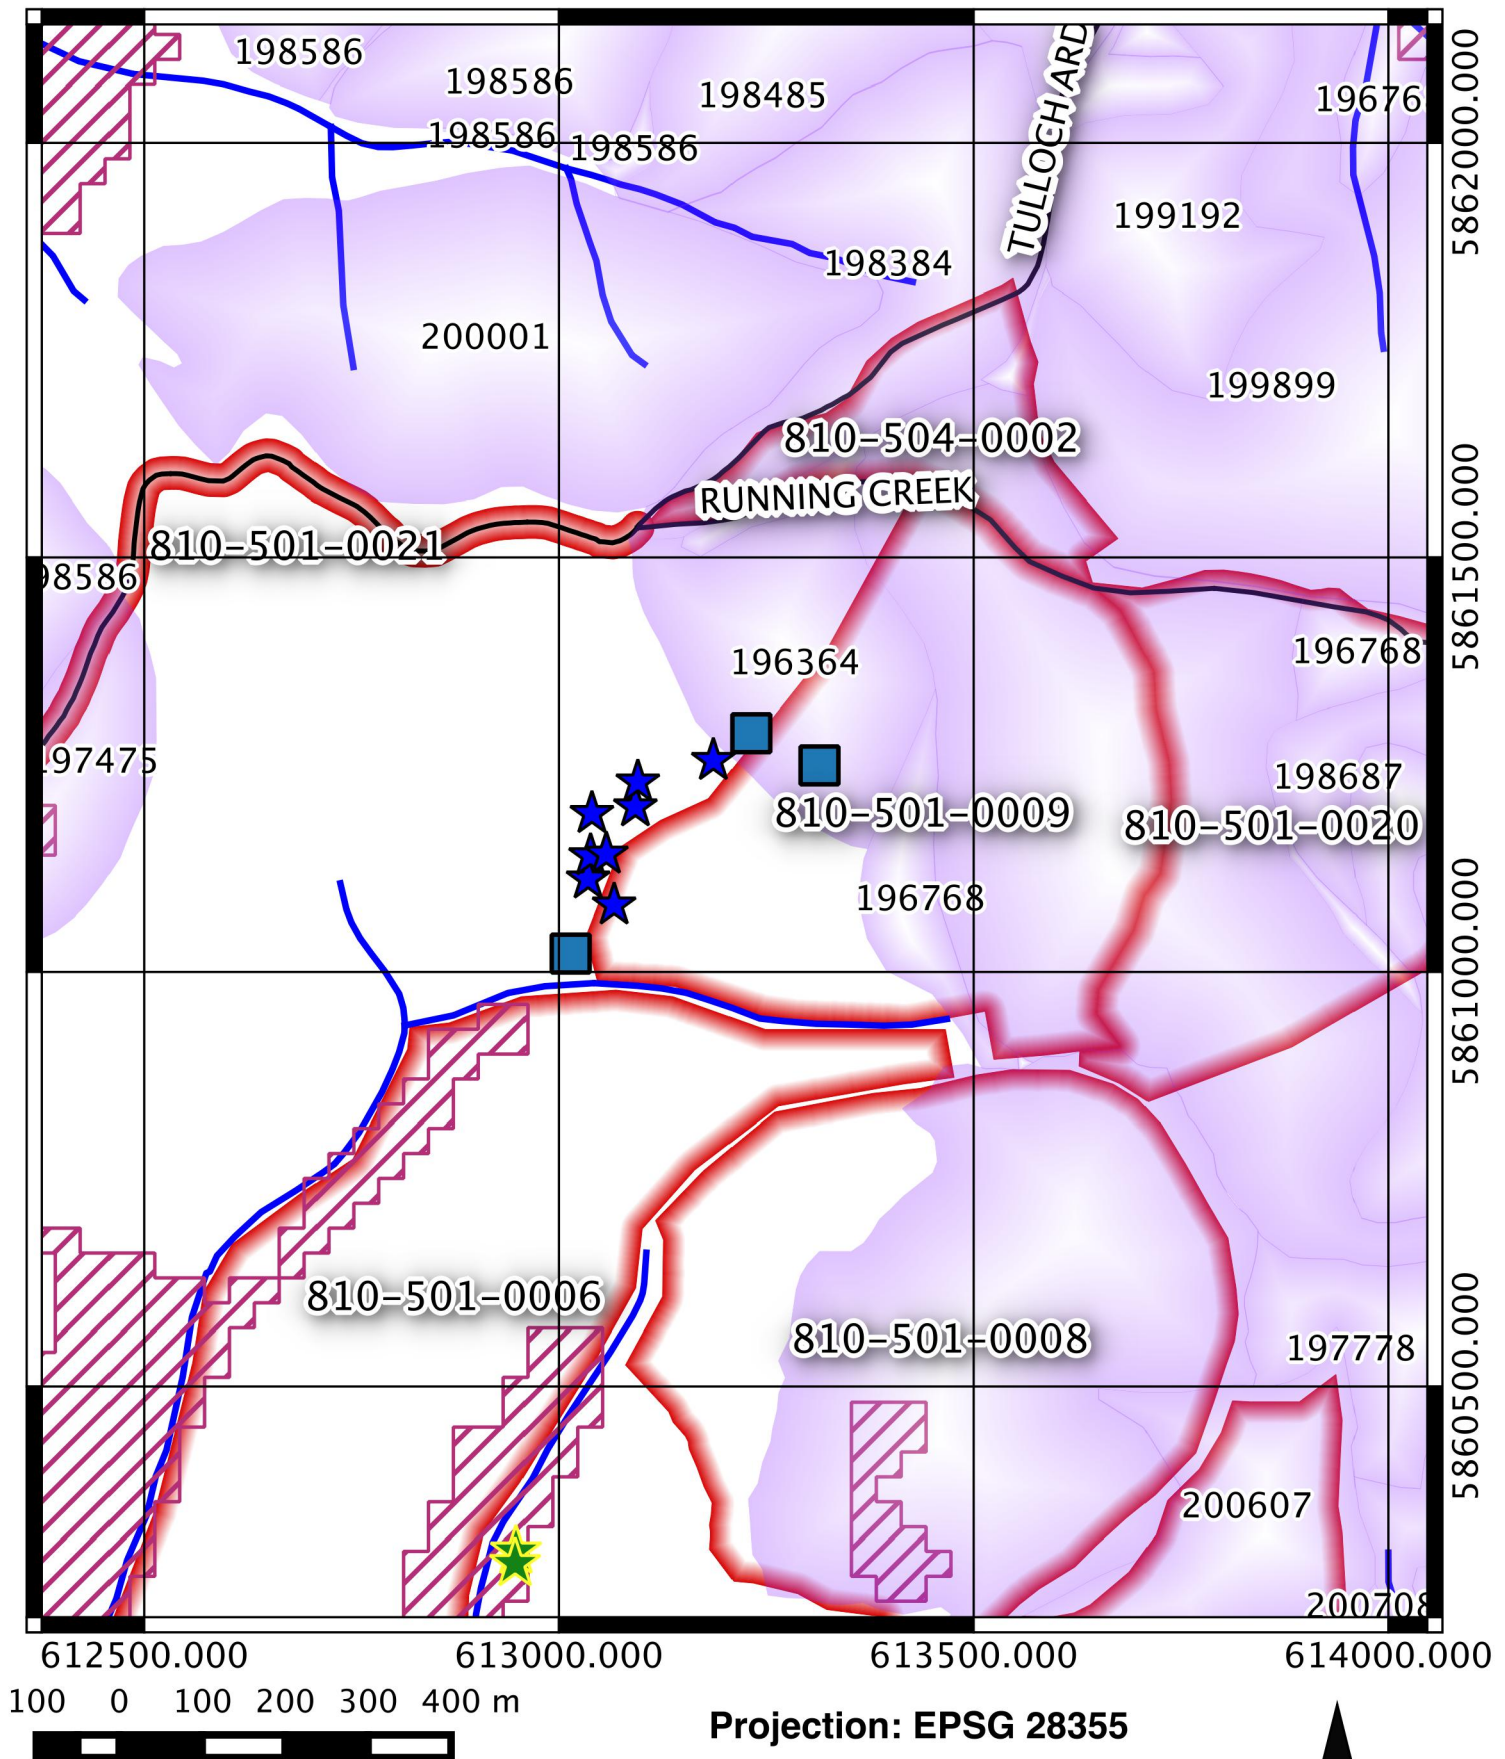
Basin creek coupes 810-501-0009, 810501-0006 context map

The Crayfish locations recorded on the survey in coupes 810-501-0009 and 810-501-0006 are displayed on the map below. Crayfish were unable to be identified to the species level, however physical characteristics suggest they are most likely to be in East Gippsland Spiny Crayfish group.
