DEANS HEAD AND SHAG ROCK RESERVE LAND REMEDIATION

Aurecon for Land Information New Zealand

Project Location: Christchurch

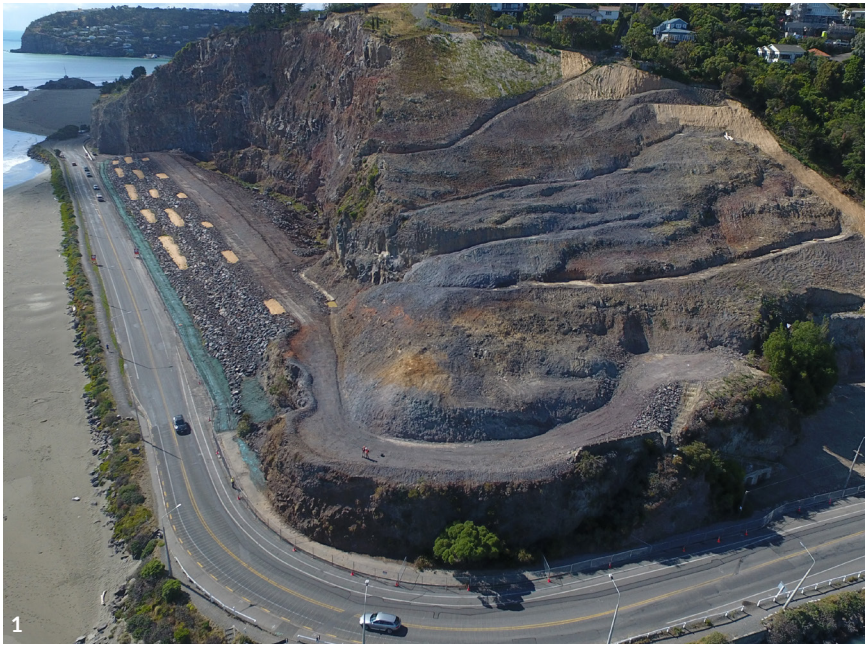
1 Deans Head after works are complete. 2 Wall removal. 3 Deans Head before works.
