## TEMPORARY WORKS FOR THE RECOVERY OF CONTAINER OPERATIONS, THORNDON CONTAINER WHARF

Homes for CentrePort

Project Location: Wellington

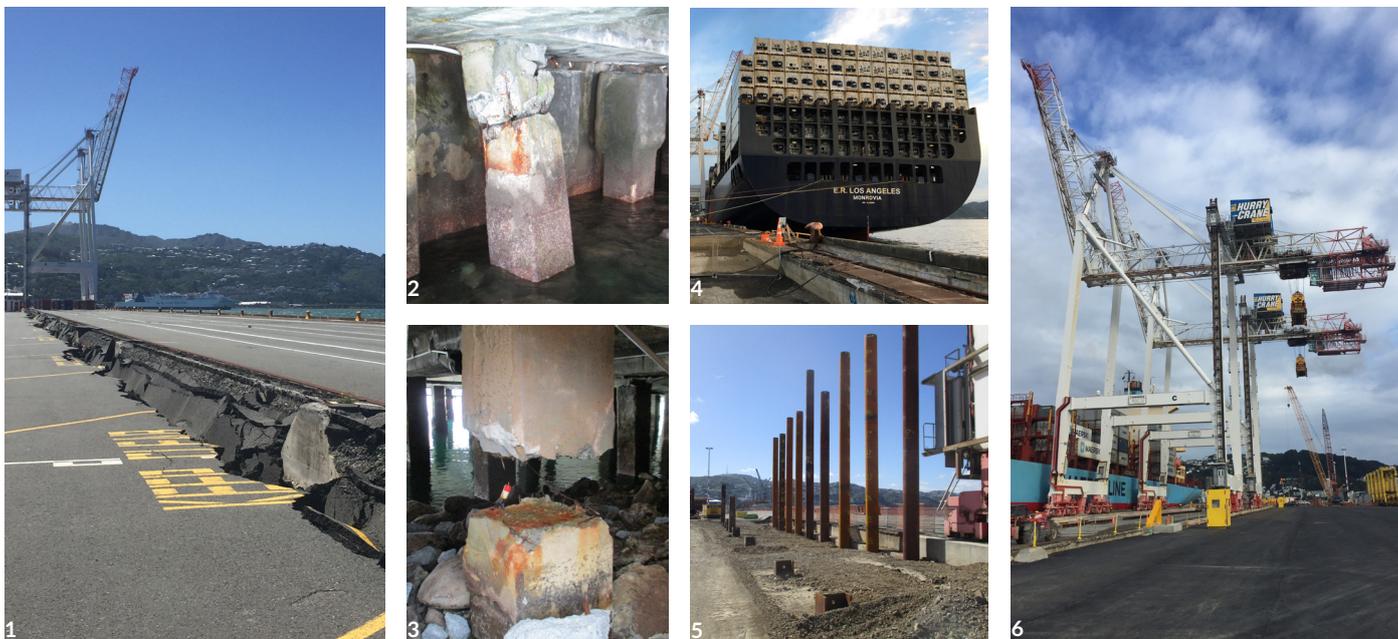
1 Settlement damage behind the wharf. 2 & 3 Damage to landward row pile. 4 Container vessel berthed at Thorndon Container Wharf. 5 Compression and tension pile installation behind wharf. 6 Completed temporary works and pavements.

Following the Kaikoura Earthquake, the wharf and reclamation was severely damaged and declared a destroyed asset. The wharf structure had little ability to resist further gravity or earthquakes, having moved laterally up to one metre in some places. The two STS cranes could not operate or move along the wharf due to damage, including displacement of rails and damage to the wharf below.

With the ongoing potential for aftershocks, temporary works had to take place to the wharf supporting the cranes and had to happen above or behind the wharf deck in a systematic manner. A decision was made to urgently return the wharf and cranes to temporary service as every day out of operation hugely impacted businesses. A wide range of solutions were considered and applied, with most engineering and re-work happening when issues emerged. Procurement and construction progressed with solutions to operate on a restricted platform becoming evident.
