Re: Capital Crescent Trail

We want to share our concerns regarding the maintenance needs of the DC segment of the CCT, which is under the jurisdiction of the National Park Service (NPS). We understand that NPS is aware of the serious maintenance and repair needs of the CCT and that preliminary work is being done to evaluate these needs. This is very positive news, and we welcome this focus by the NPS on the CCT. We also appreciate the work that has been done recently to address the immediate erosion issues in the Palisades section of the CCT. However, there are many other outstanding maintenance issues on the CCT that are long overdue, are chronic, and are impacting the safety of trail users. We hope that the NPS can address them in an expeditious manner.

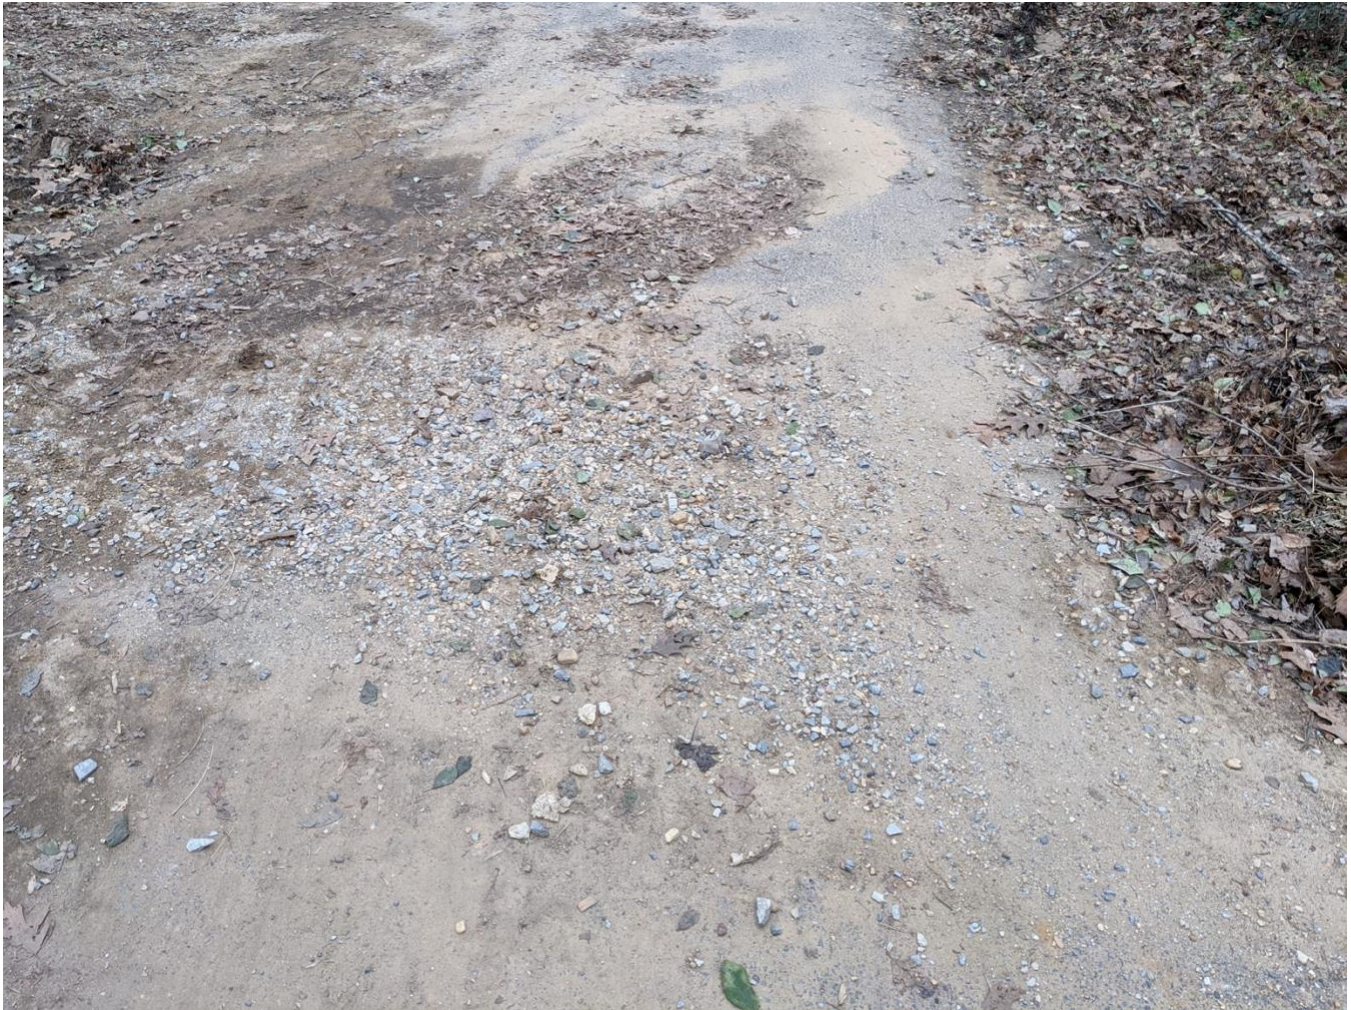
The Norton Street Path. The first access path begins as an unimproved relatively flat dirt path at the corner of Potomac Ave. and Norton St. NW, in the Palisades neighborhood. It travels parallel to the Dalecarlia Water Treatment Plant fence and gradually slopes downward to meet the CCT. It is one of only two access paths to the CCT from far NW DC, and as such is frequently used by pedestrians and cyclists as a link to the CCT from MacArthur Blvd. in NW DC. This path presents chronic serious safety issues whenever it rains. Water runs down the path, carrying mud and gravel which pushes out across the CCT. Last year a cyclist travelling up the trail slipped on the mud and was hospitalized for several days with broken bones and other serious injuries. More recently a runner slipped and fell on the mud as she was trying to stay on her side of the trail to avoid other users. Further, this path is not ADA compliant, making it impossible for persons with disabilities to access the CCT. Persons with strollers also have difficulty. Only skillful mountain bikers can bike it due to protruding roots, stones and gullies. We urge the NPS to work with DDOT to make paving this connector path the highest priority due to safety issues. See photo below of mud and gravel buildup that flowed from the Norton St. path onto the CCT in late December 2020. This buildup repeats despite being cleared multiple times per year.

Paving the Norton Street Path and Expediting the approved Arizona Avenue Connector to CCT. Improving these two paths requires coordination between DC and the NPS, because both have jurisdiction over the parts of these connections to the CCT. The need for improvements for these pathways was addressed in the attached January 6, 2021 letter (see page 2) from the Advisory Neighborhood Commission for DC's Ward 3 to Jeffrey Marootian, who was then the Director of DC's DOT (DDOT). The letter demonstrates strong community support for improving these pathways and urged expeditious action by DDOT to work with the NPS on both paths. When rehabilitation on the CCT takes place, these two paths would be logical access paths for a detour if the CCT needs to be closed. Paving these paths would also improve emergency responder access to the CCT, much closer than the only other existing access points in Georgetown and at Fletcher's boathouse.

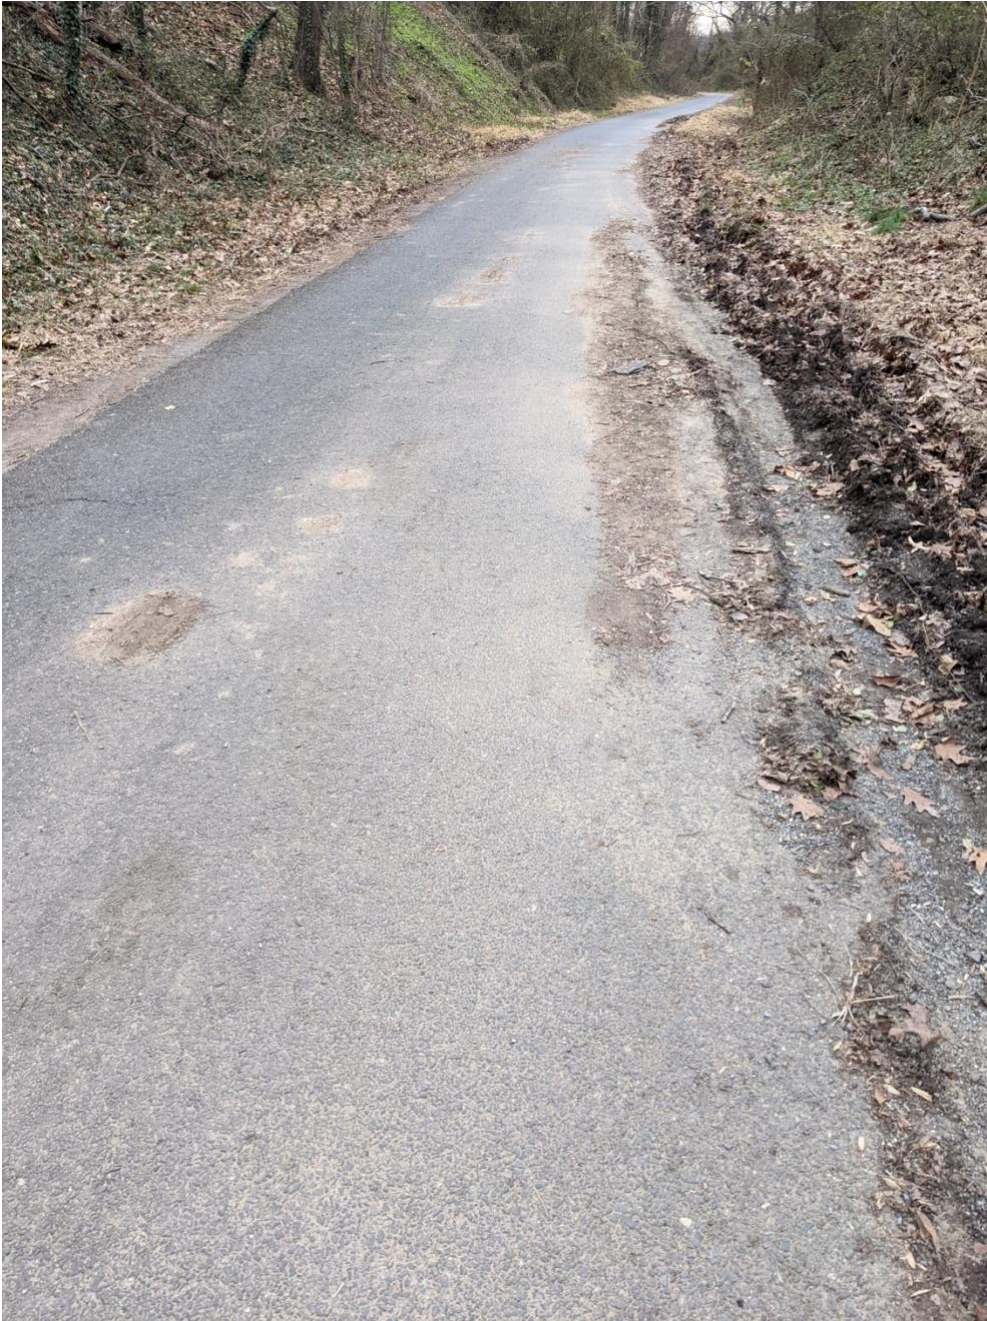
Tree trimming, Mud, and Clearing Trail Overgrowth: We urge the NPS to set up a regular schedule of trimming overgrowth and trees adjacent to the CCT, and clearing mud and gravel from the trail. We appreciate the work done by the Student Conservation Association, and the recent tree trimming contractor. However, the tree contractors' trucks which drove on the trail left deep muddy ruts along the trail edges, and muddy ridges extending 2 ft into the trail. We ask that the NPS require its contractors to remediate these areas before they leave. We receive many requests from trail users to have the overgrowth onto the trail trimmed, which is making the usable trail narrower and narrower, both at ground level and above. Having the crushed stone shoulders, mentioned above under Repaving and Widening the CCT, would impede overgrowth and help prevent muddy ruts and edges, which can be safety hazards for users. See photo below of one of many muddy ruts after tree trimming.
