GREAT LAKES WATER LEVELS

Current Conditions and Outlook

May 10, 2019

Essex Region
Conservation Authority
sustaining the place for life

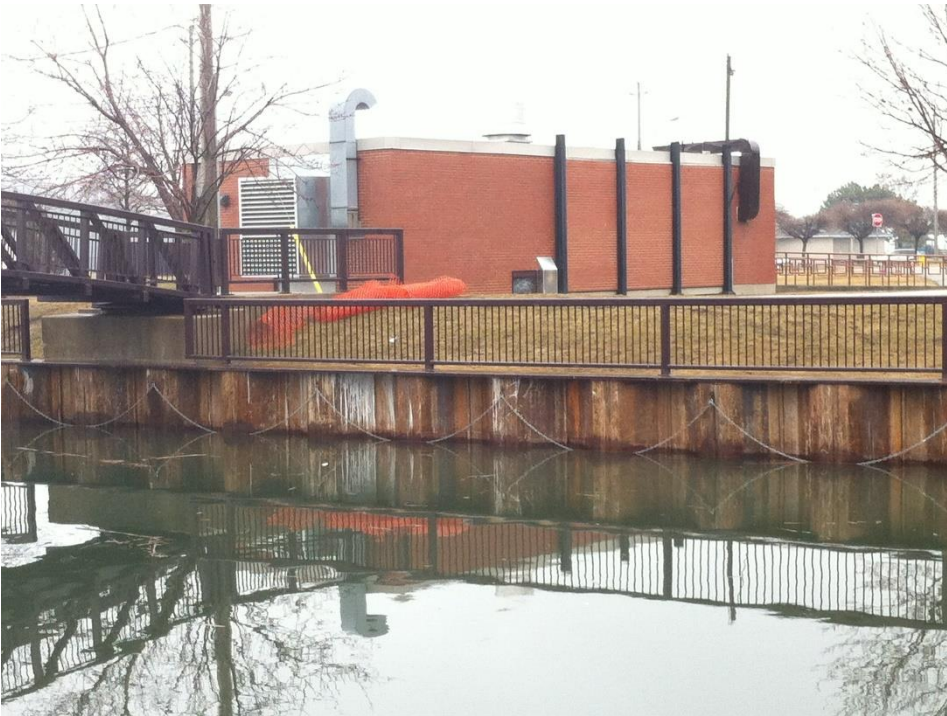
March 2015

Little River – Little River Pump Station at Riverside Drive

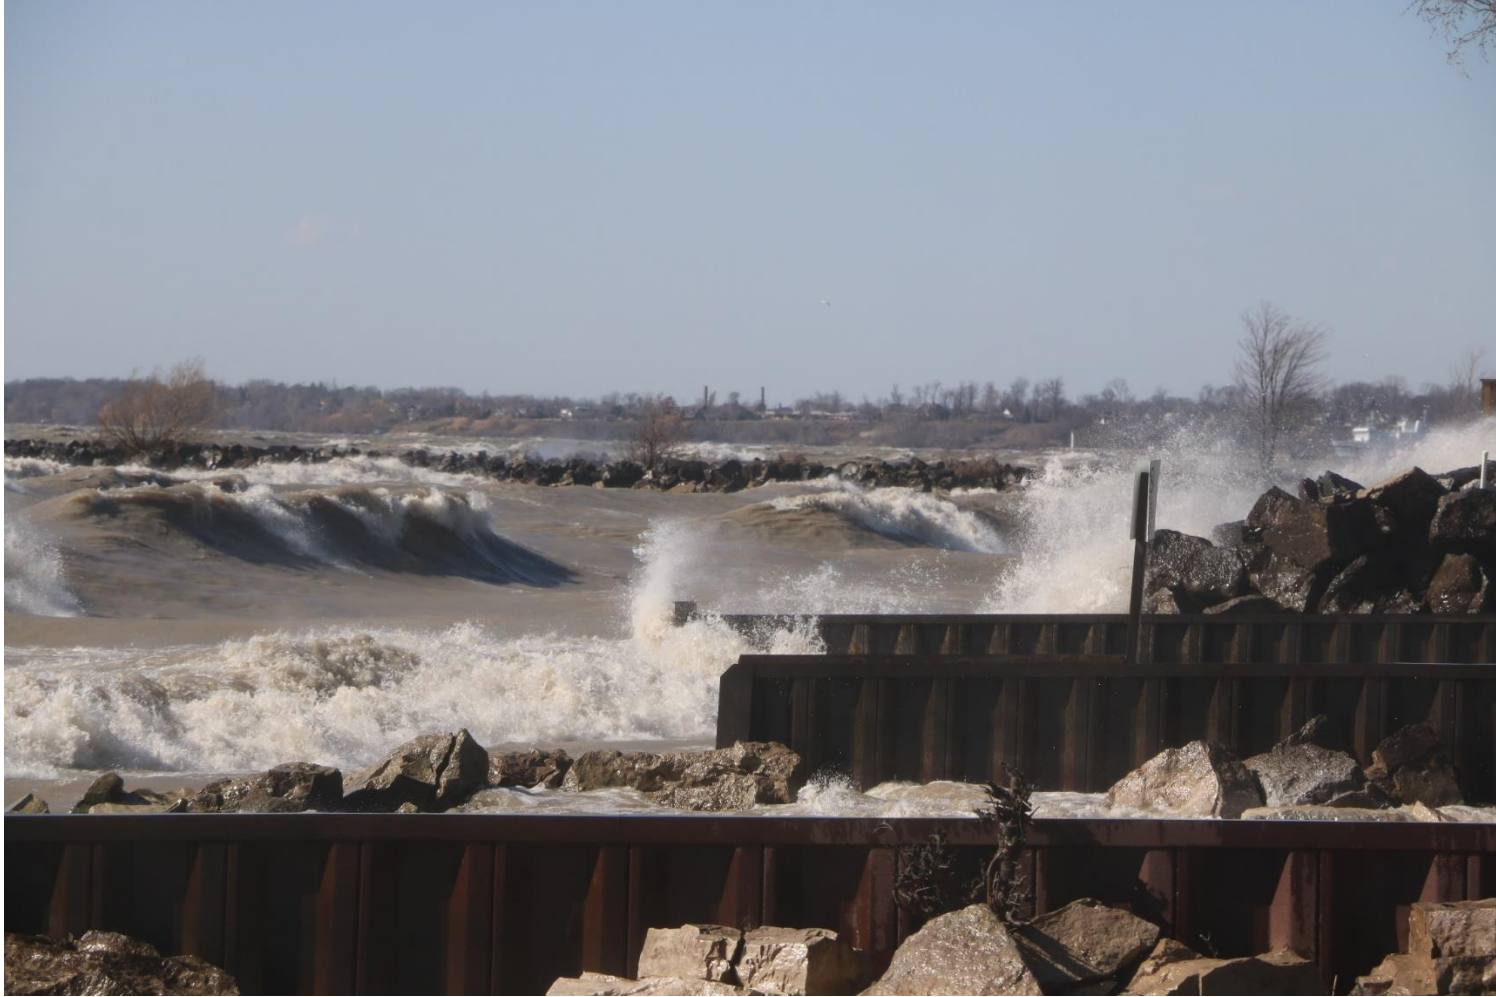
Lake Erie - Sturgeon Creek Outlet

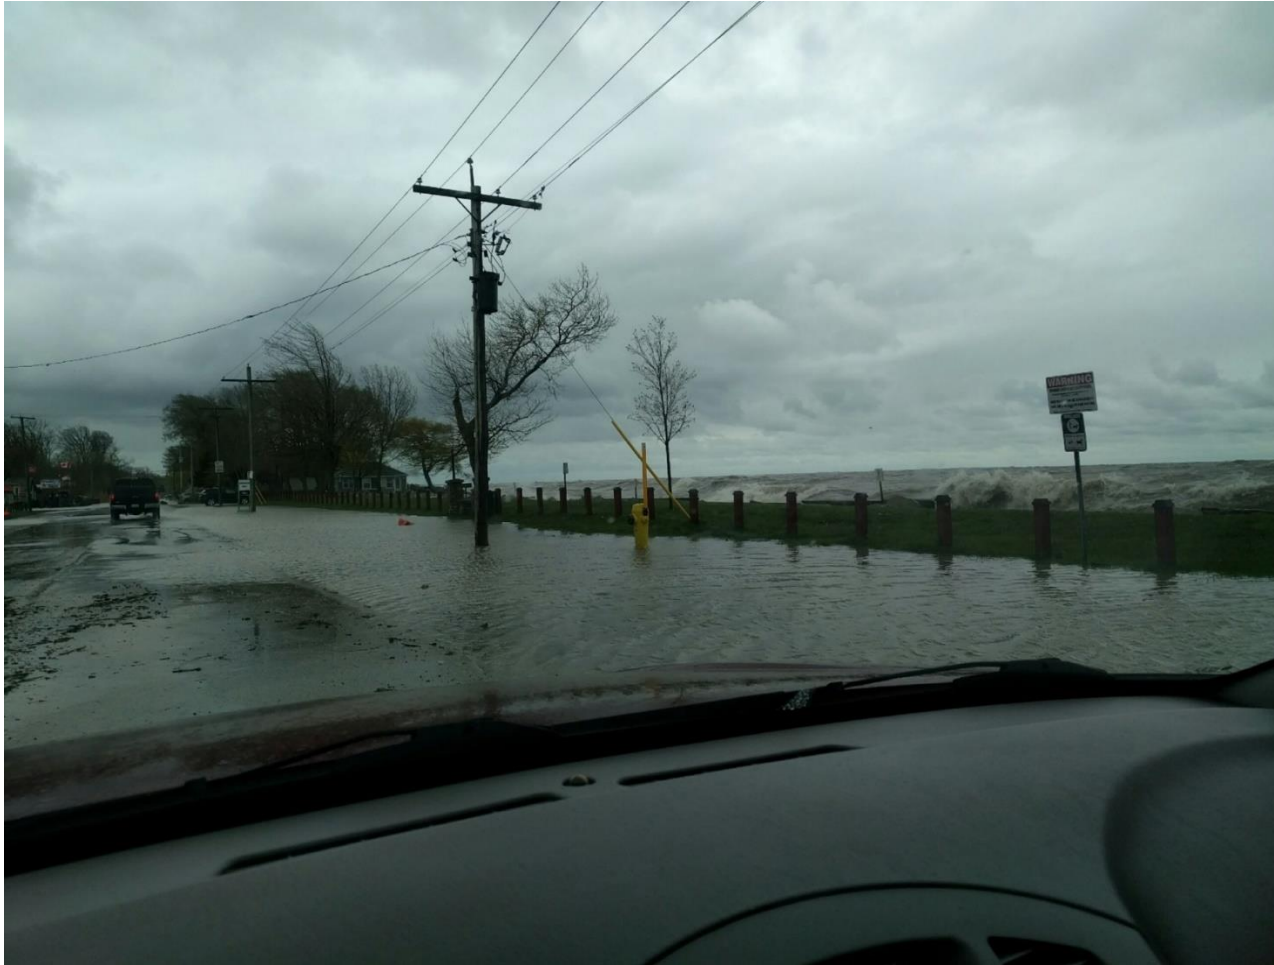
Lake Erie – Point Pelee Drive

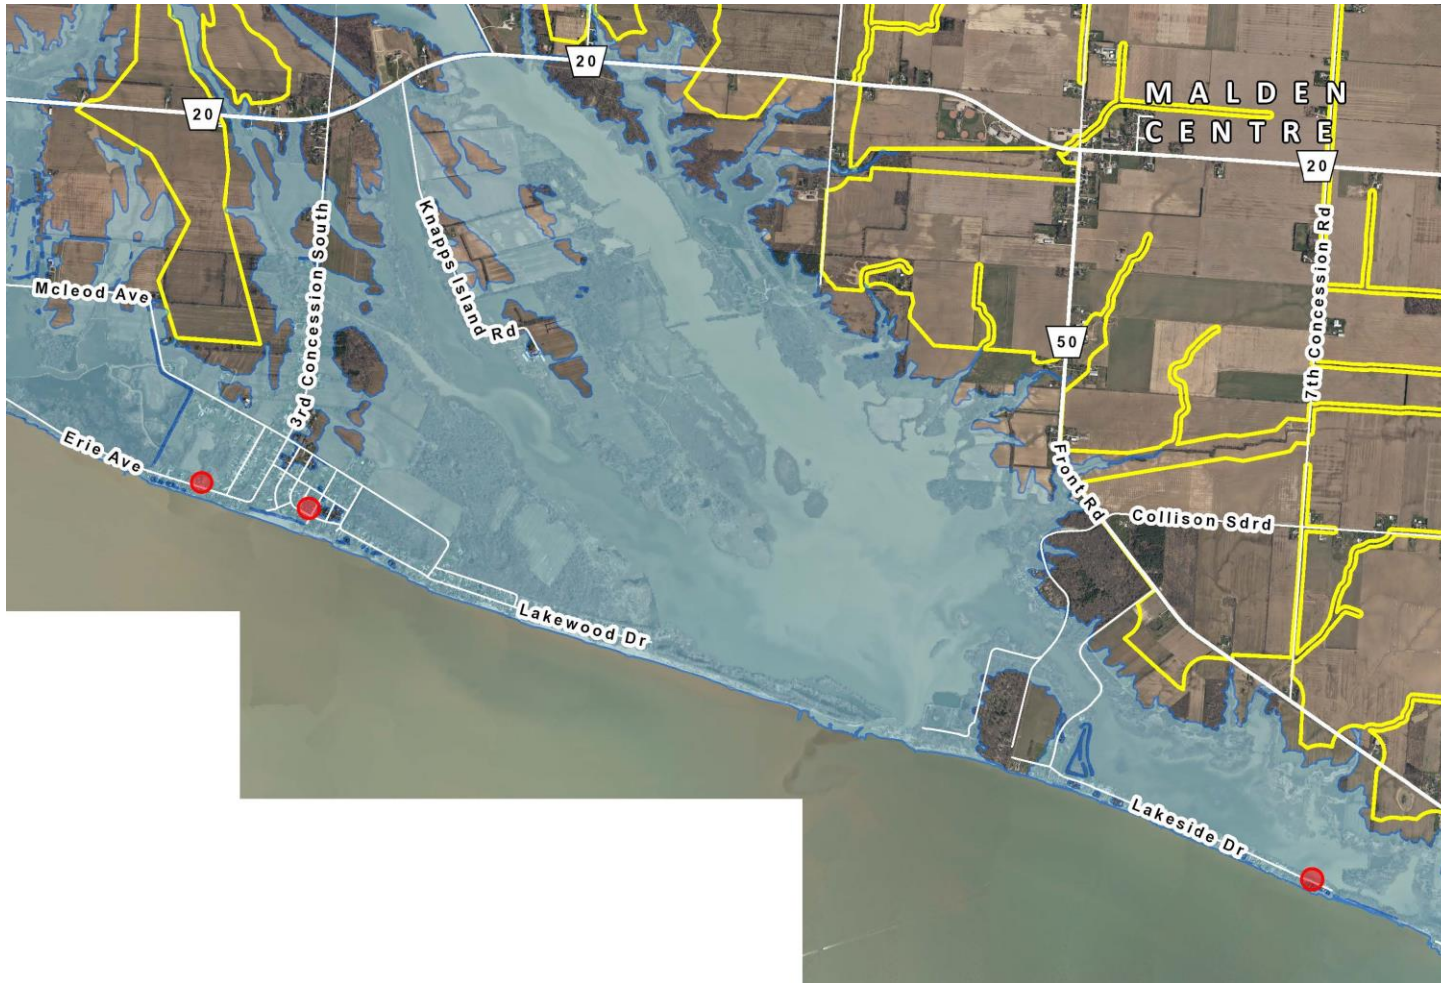
Potential Lake Flooding (key map)

Claremont Lane, Willow Beach, and Lake Erie Country Club

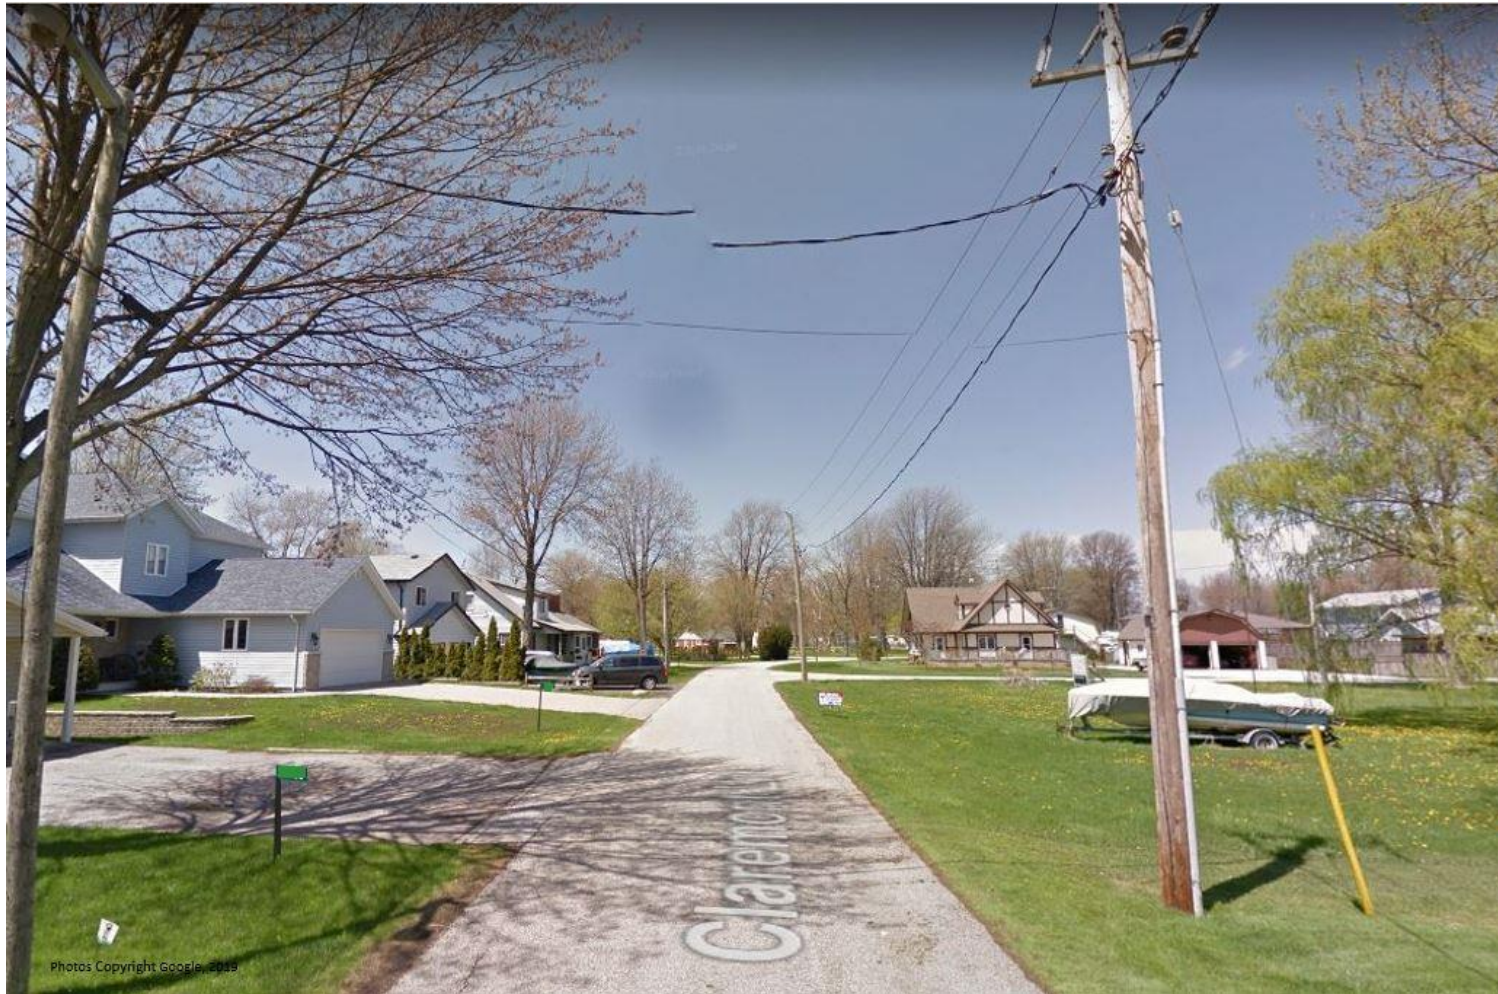
Claremont Lane

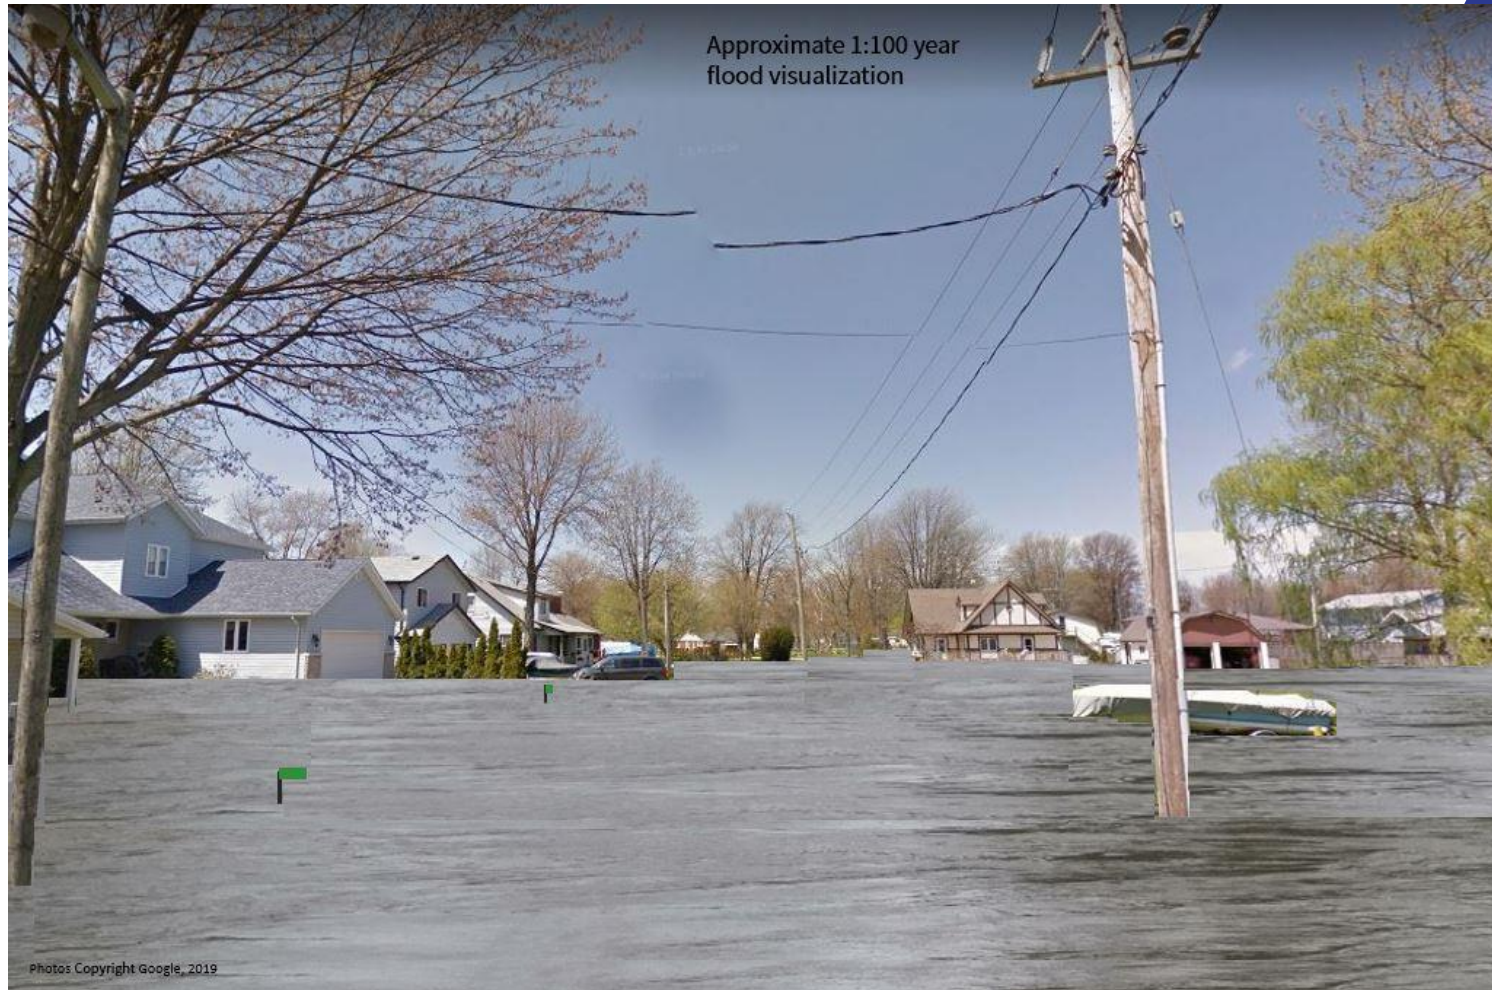
Claremont Lane (visualization)

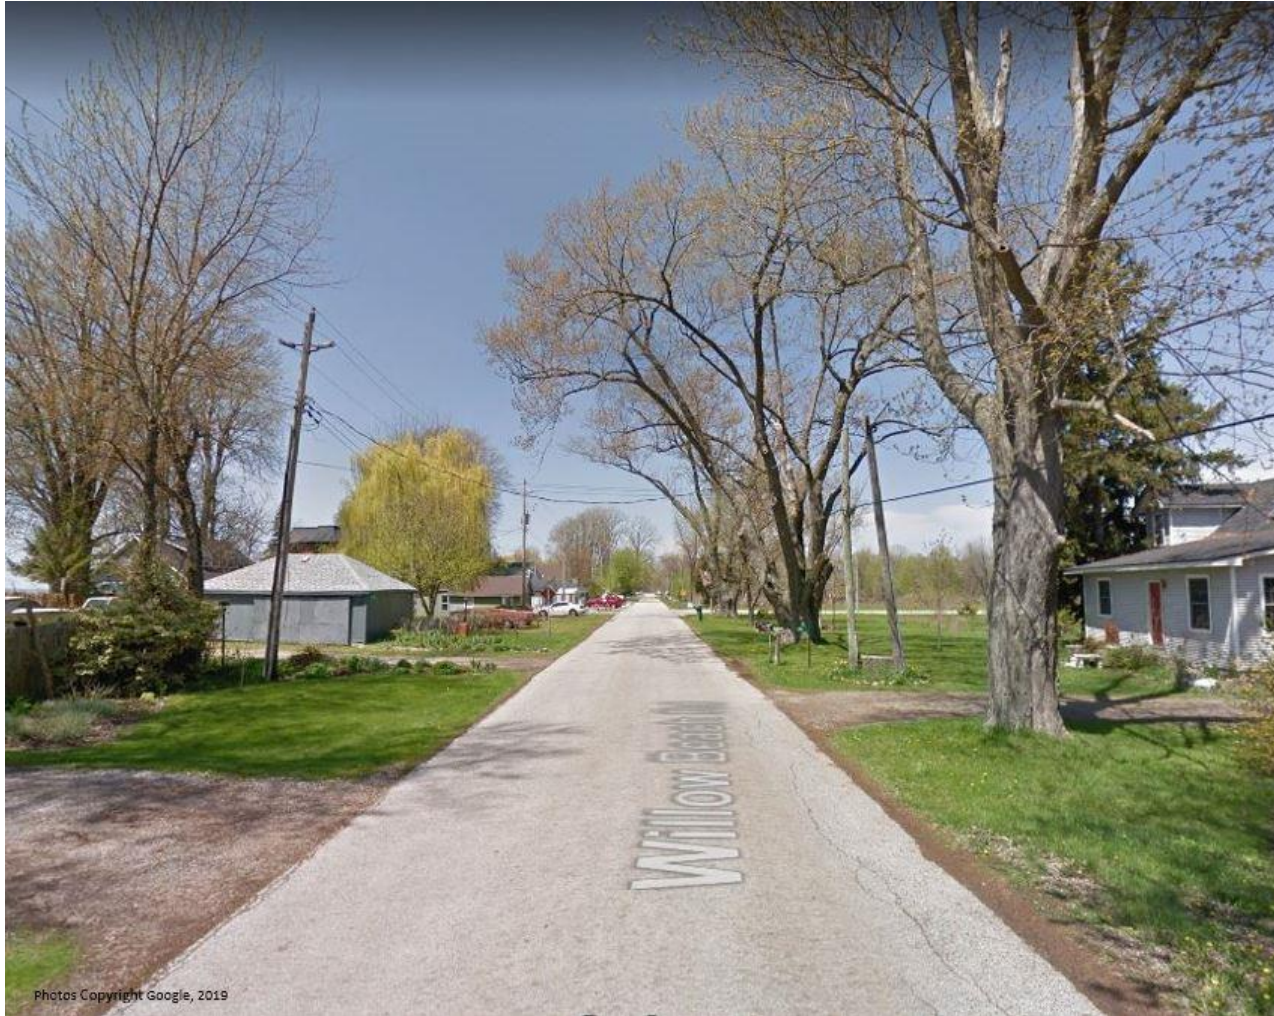
Willow Beach Road

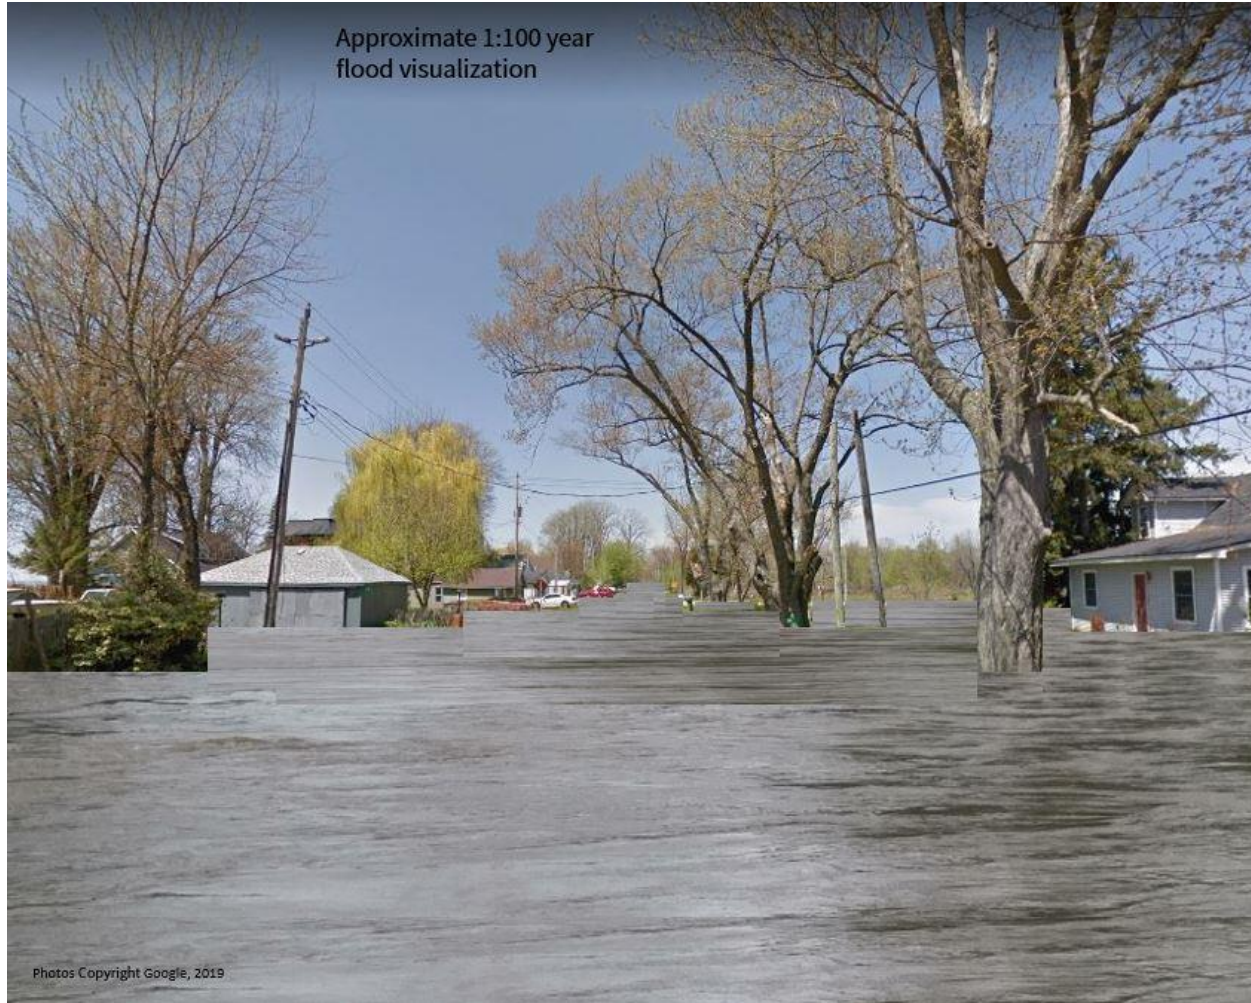
Willow Beach Road (visualization)

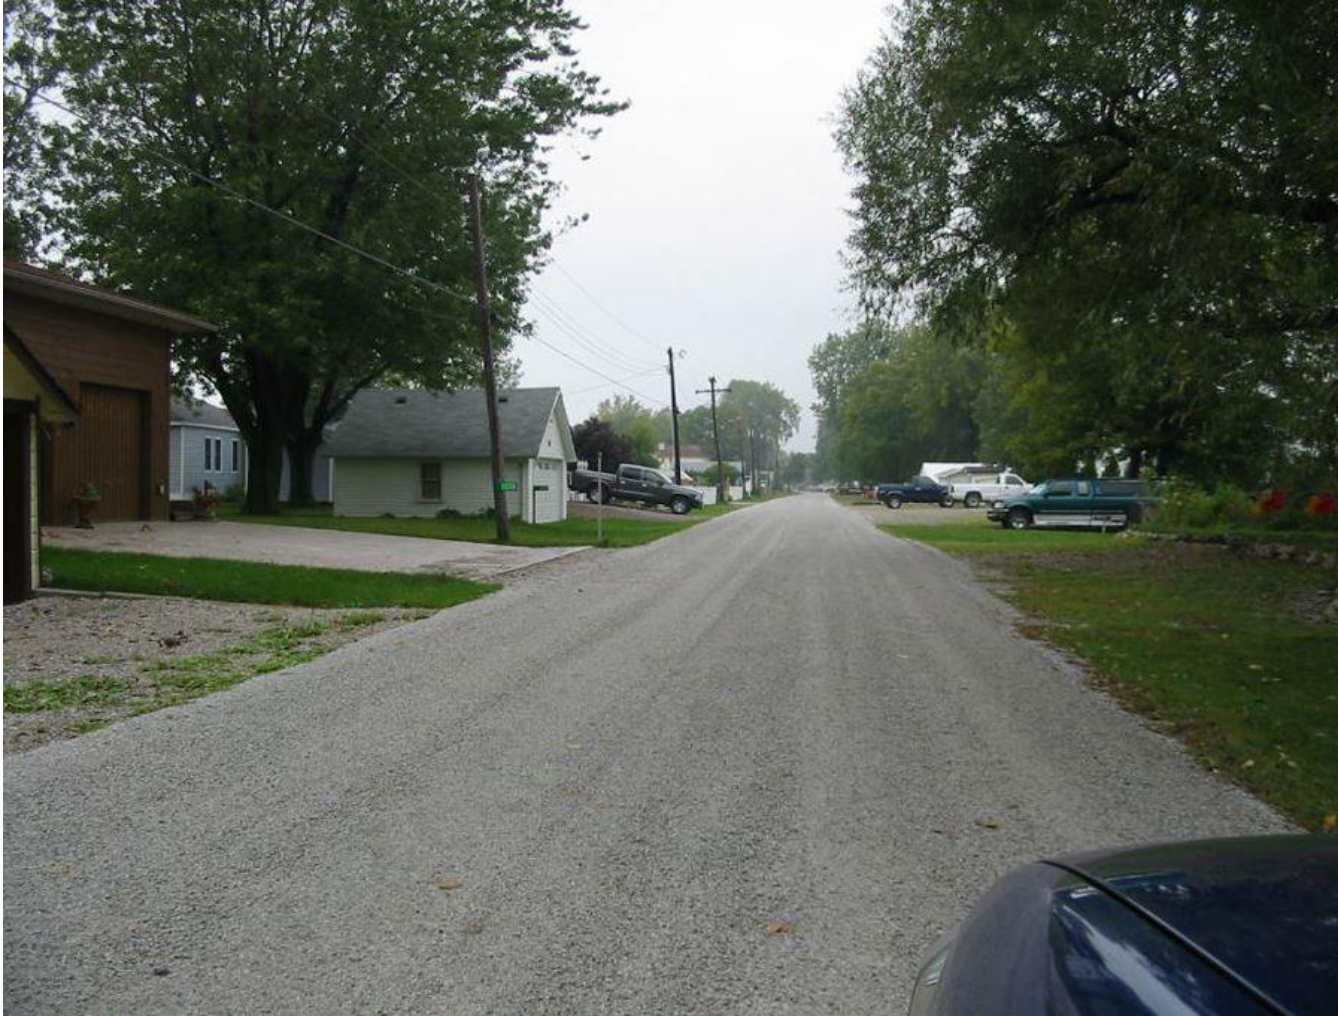
Lake Erie Country Club

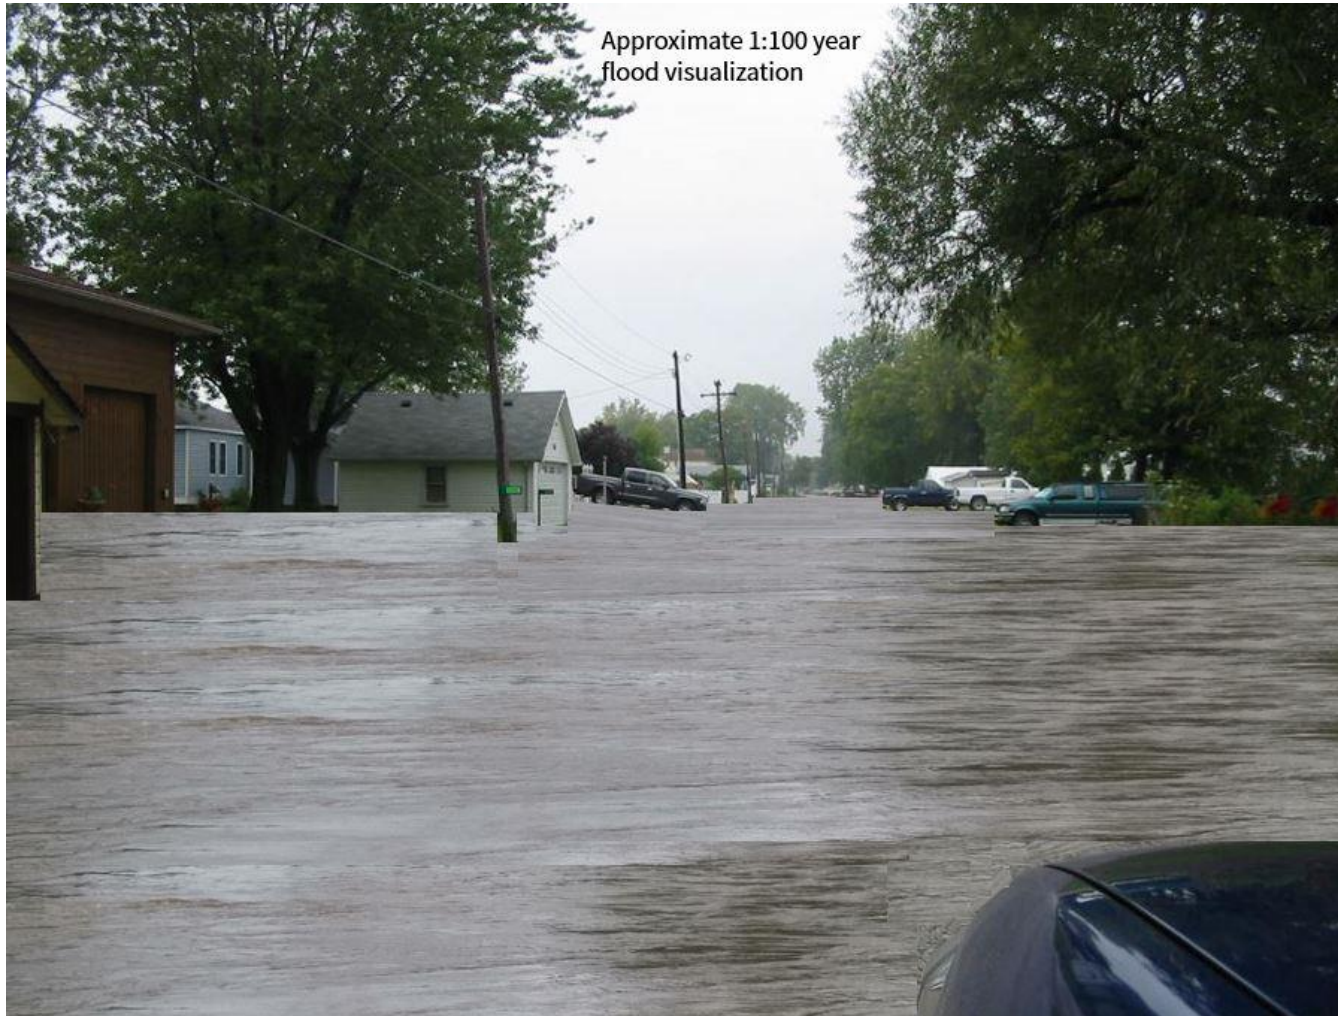
Lake Erie Country Club (visualization)
