THE CORPORATION OF THE TOWN OF AMHERSTBURG

Subject: Bridge 3008 – Project Update - Additional Funding Required

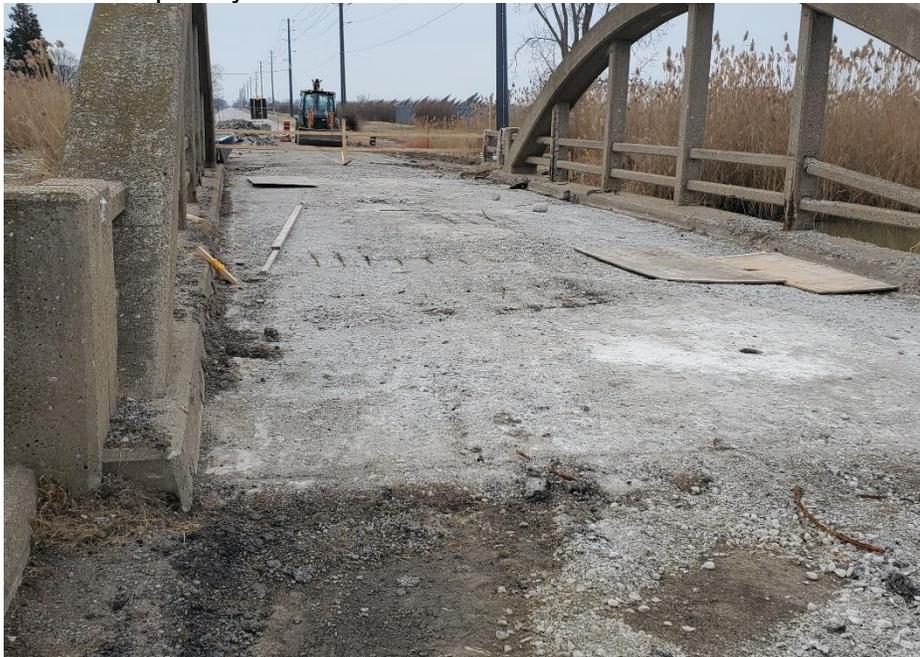
The Contractor commenced demolition of the bridge structure in early February 2020. The first step in the process of bridge demolition was to remove the asphalt surface to expose the concrete deck. Once the deck was exposed it became apparent that the bridge structure was extremely compromised. There were several areas where portions of the concrete bridge deck peeled up with the asphalt, exposing rebar which indicates the top portion of the concrete was completely removed.

As noted above, the extent of deterioration of the bridge deck and beam was revealed via asphalt removal, which rendered the bridge unusable and impacted the demolition methodology and costs of the Contractor. The additional costs related to the demolition are \$181,056.20 plus applicable taxes. The main costs related to this are the additional sawcutting, crane rental, steel truss manufacturing and installation as well as additional time for the Contractor to secure the structure for demolition.

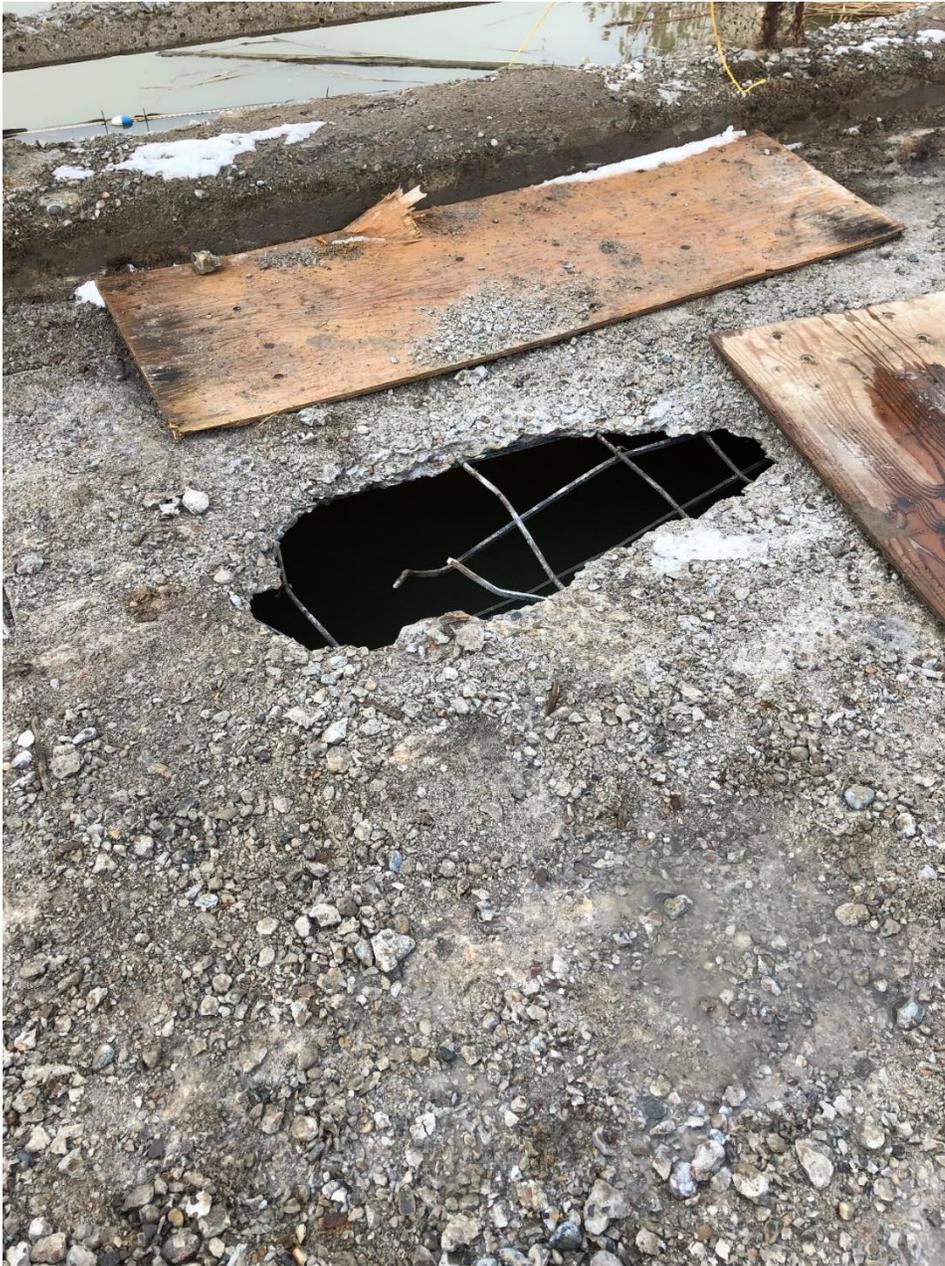
The asphalt removal also left sizable holes in the bridge deck. Considering this would have been a 225mm concrete slab the fact that a hole this large was present indicates the level of deterioration that was present.

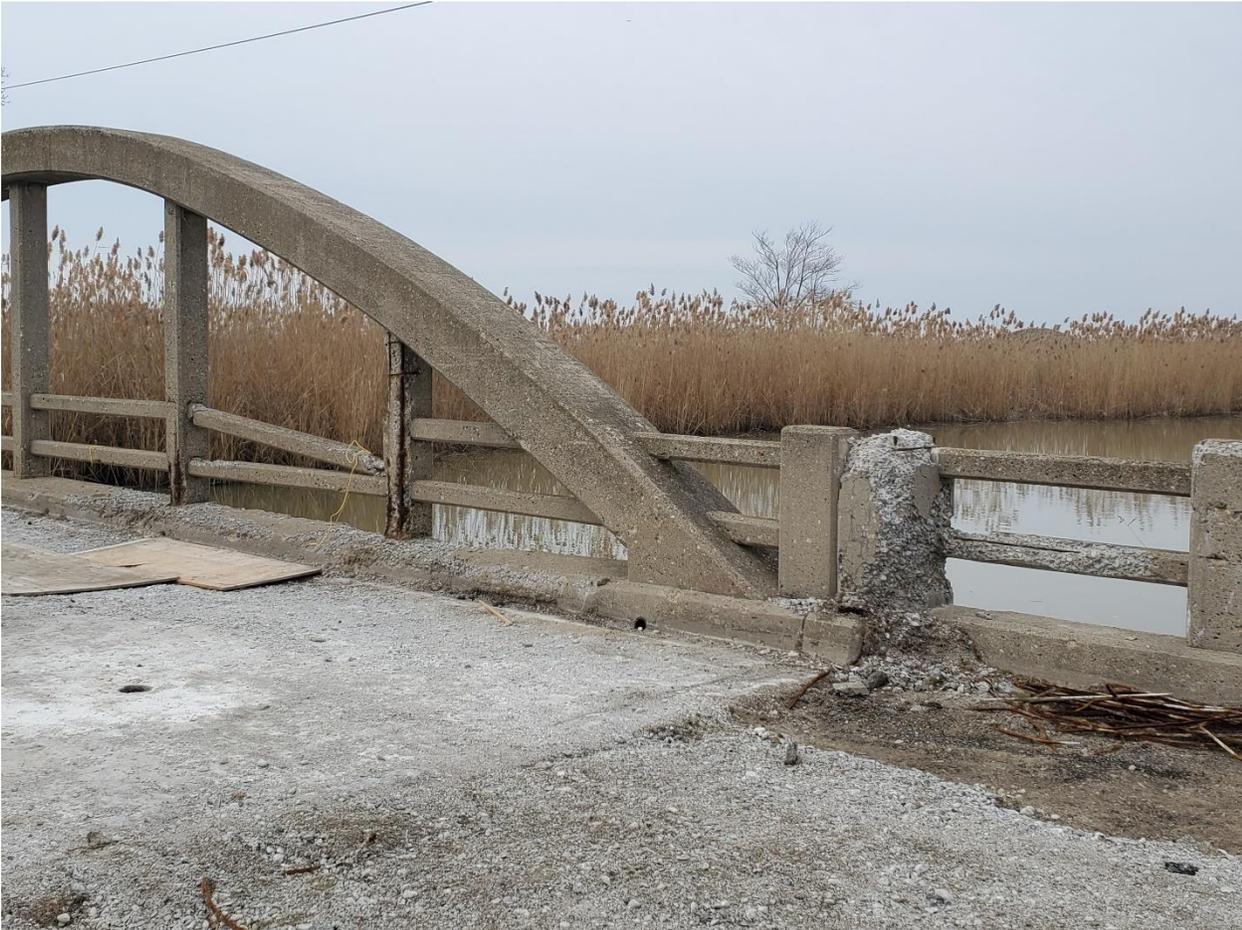
On January 2, 2017 Stantec completed a structural review of the structure that recommended load restrictions as well as structural review every 6 months to ensure no further deterioration. This bridge had not received any documented rehabilitation in its lifetime and had been allowed to deteriorate to the point where the engineer was not confident it could support its own weight. The photo below shows the dilapidated condition the bridge was in prior to demolition starting, including the visible deterioration of arches and rails. Stantec's report was not included with the RFP issued in March 2017; however it did not identify the extensive level of deterioration later found after asphalt removal and through more invasive investigation that followed.

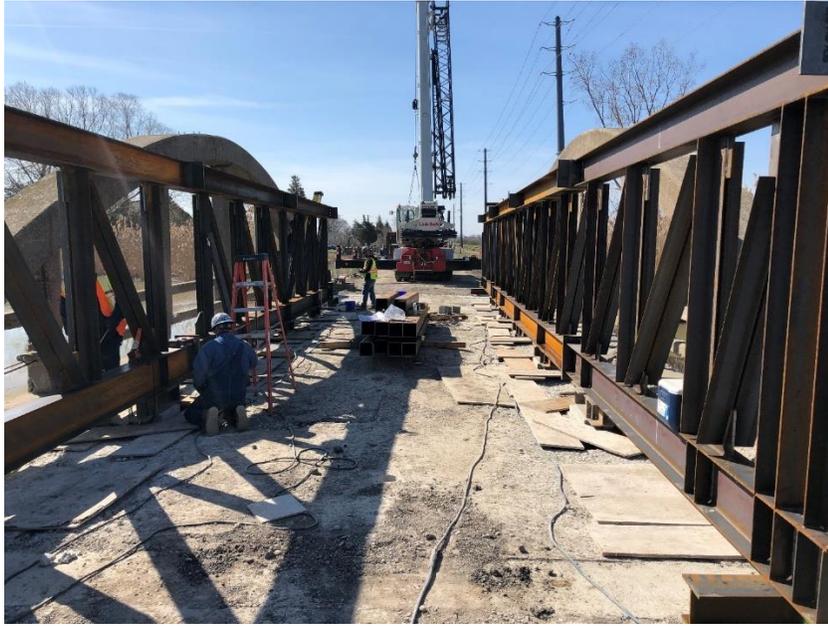
Once it was known that the deck was severely compromised the Contractor's engineer (Haddad Morgan) requested that small holes be cut in the deck so that the beams could be seen. The beams displayed longitudinal cracking indicative of reinforcement rusting and bond failure. At this time the engineer recommended that no equipment be placed on the bridge (see attached letter from Haddad Morgan). The potential for complete collapse was very possible based on the condition of the deck and supporting beams. The engineer recommended that two steel trusses be built and clamps installed to support the beams during demolition for the safety of the workers and to avoid environmental impacts that would have resulted if portions of the bridge fell into the Long Marsh Drain.

The severe deterioration of the bridge deck and beams affected the method the Contractor used to demolish the entire bridge. The Contractor's engineer has advised that the process for demolition of the bridge anticipated in their proposal was to strip the asphalt surface then remove the deck in large pieces using an excavator. Once the deck was removed the contractor would cut and remove the beams and finally lift the arches in one piece to be demolished on the ground.

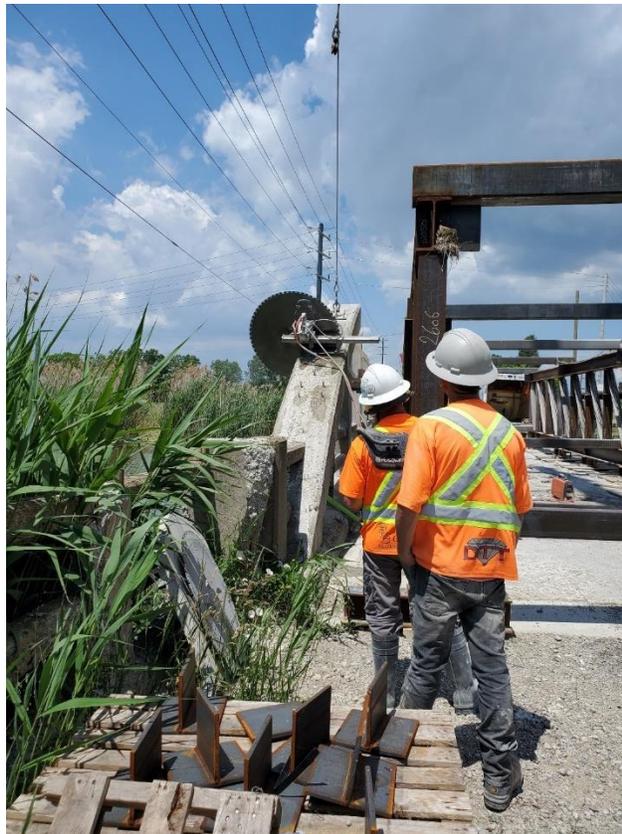
Unable to use their excavator to remove the pieces due to the equipment restriction, the Contractor used a crane to remove all of the bridge pieces, adding significant unforeseen crane rental costs. The pieces of the deck and beams that were removed also needed to be cut significantly smaller than originally planned to ensure their integrity. The need for smaller pieces increased the costs related to crane rental time as well as concrete cutting both in labour hours as well as consumables (blades / fuel etc.). Even the large arches had to be sawcut and removed in pieces due to their condition. This added approximately 4 days of additional cost for the sawcutting, crane rental and labour.
