Xpandable Patches to extend the life of corroded CSG Wells in Queensland, Australia

Full-covered Xpandable Patches successfully isolated bacterial corrosion in coal seam gas wells

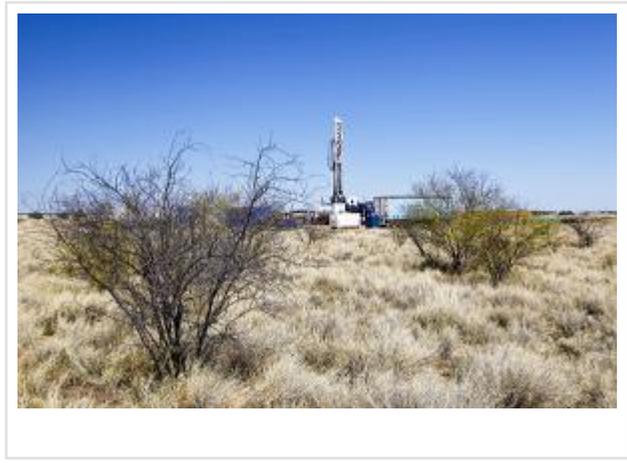
Saltel Industries designed full-covered patches to meet the above requirements. The total sealing concept meant covering the whole external surface of the patches with Hydrogenated nitrile butadiene rubber (HNBR) elastomeric skin, to avoid any contact between the Patch's Stainless Steel structure and bacteria. These patches were tested and qualified in compliance with ISO-14310 V0, to offer internal gas-tight protection. The new patch design, combined with Saltel hydraulic setting method guaranteed the selection for a Field-trial.

Two Xpandable patches were installed in two wells to assess the technology efficiency. The patches, 'full-covered', 19.68 and 26.24 ft [6 and 8m] long, successfully restored integrity in the 7in production casings. The patches were run and installed in less than average 7 hours, capitalizing on a workover rig already onsite before the operations, therefore requiring no additional mobilization costs to the client. The setting went as per job program, and post-setting pressure tests confirmed the new barriers efficiency (1,000 psi [6.9 MPa]), less than 2% pressure loss over 10 minutes).
