# WEST PRAIRIE RIVER RIPARIAN INTACTNESS & RISK ASSESSMENT SUMMARY

## THE REPORT: BACKGROUND, GOALS & OBJECTIVES

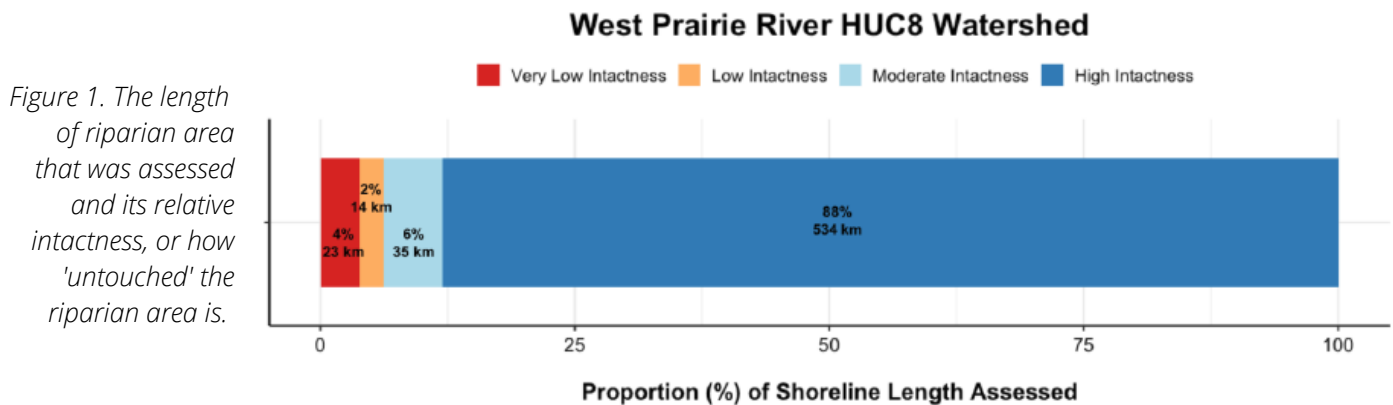
Using the imagery and LiDAR gathered of the nearly 600km of riparian area along the West Prairie River sub-watershed, it was determined that the majority of the riparian area was in good condition (88% or 534km), 6% (or 35km) had moderate intactness, 2% (or 14km) had low intactness and 4% (or 23km) had very low intactness.

23km) had very low intactness. The measure of 'intactness' refers to how much disturbance from human activities or natural events that an area has experienced and how intact the riparian vegetation is. Having a high intactness score indicates good riparian health and function, where as a low score indicates there are issues like erosion, loss of natural vegetation, or bare ground.

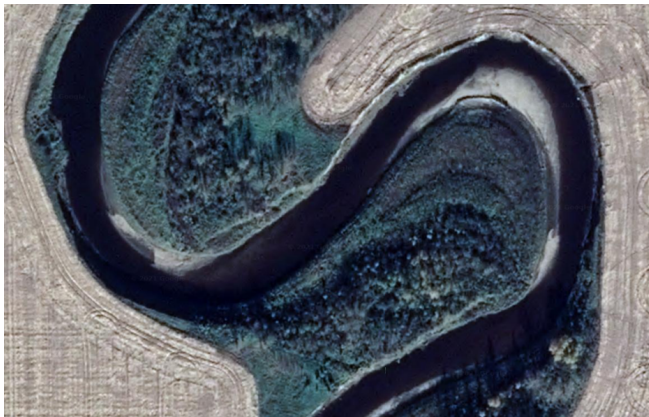
*Figure 2 (above).  
A section of the West Prairie River with low-intactness, just outside of High Prairie. Image: Google Earth satellite imagery.*

Figure 2 is an example of a low-intactness riparian area along the West Prairie River, located just outside the town of High Prairie. In areas like these, there is little to no vegetation present to trap and hold the sediment from eroding away the banks and to prevent the addition of sediment into the river water. The bank is slowly being washed away, and the land adjacent to the river is being reduced away as the river meanders over time (or slithers like a snake across the landscape). In figure 3, there is a diversity of riparian vegetation to stabilize the bank. More animal species are able to use this site as habitat, and the river channel experiences much less meander. The vegetation is able to hold the soil and sediment along the banks and prevent erosion.

The relative intactness of the riparian area is related to different pressures from the surrounding area. In figure 2, agricultural practices have impacted the riparian area, and there has been a loss of vegetative cover. In figure 3, where there are fewer pressures from the surrounding landscape, the riparian hear is vegetated and natural, allowing many plant and animal species to thrive.

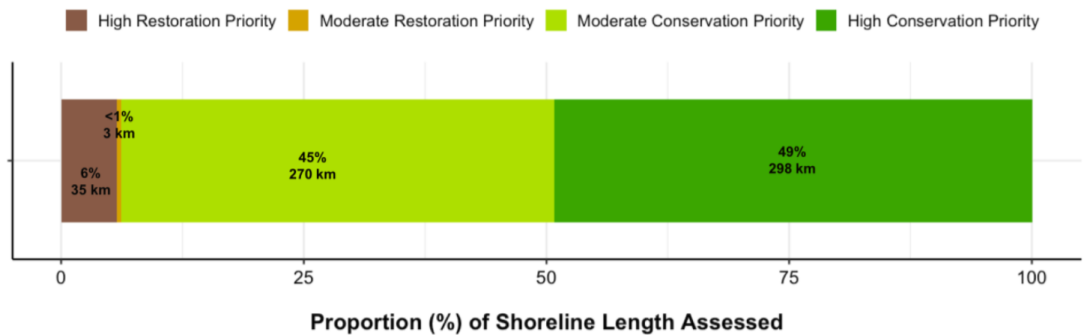
Figure 4. The proportion of riparian area that should be conserved or restored in an attempt to maintain healthy riparian habitat and improve watershed health and resilience.

Using the data collected, FBC created this graphic, which shows 49% (or 298km) of shoreline assessed is virtually untouched and should be a high conservation priority, 45% (or 270km) of shoreline is of good quality and has a moderate conservation priority, <1% (or 3km) of shoreline has a moderate restoration priority, and 6% (or 35km) of shoreline is of high restoration priority.

High conservation priority means that efforts should be focused on keeping the areas natural and intact, preventing a need for restoration work, and aligning with objective 1. High restoration priority means that the riparian area assessed in poor condition and needs help to re-establish through restoration work (like tree planting, riparian fencing, and other bank stabilization efforts), which tackles objective 2, to reduce or mitigate flooding.
