Aerial Videography Assessment for Selected Reaches of the South Heart and West Prairie Rivers, Alberta

Tyler Johns and John Hallett
Alberta Conservation Association
9621 96 Ave
Peace River, Alberta, Canada
T8S 1T4

EXECUTIVE SUMMARY

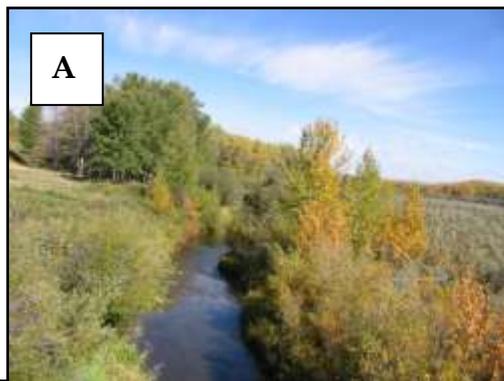
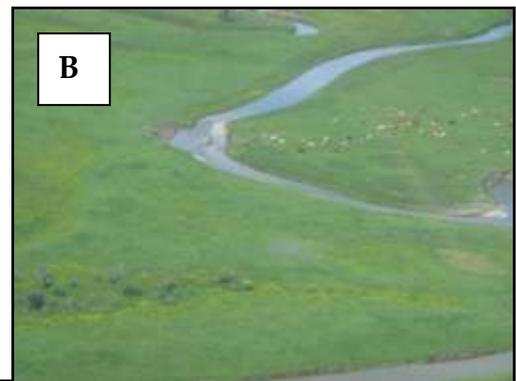
What picture does most of the polygon look like?

Left Bank: **Picture A** (4 pts) **Combination of A and B** (2 pt) **Picture B** (0 pts)

Right Bank: **Picture A** (4 pts) **Combination of A and B** (2 pt) **Picture B** (0 pts)
