# **Aerial Video Assessment of Lesser Slave Lake, Alberta**

**Leanne Osokin and John Hallett  
Alberta Conservation Association  
Box 730  
Slave Lake, Alberta, Canada  
T0G 2A0  
April 18, 2007**

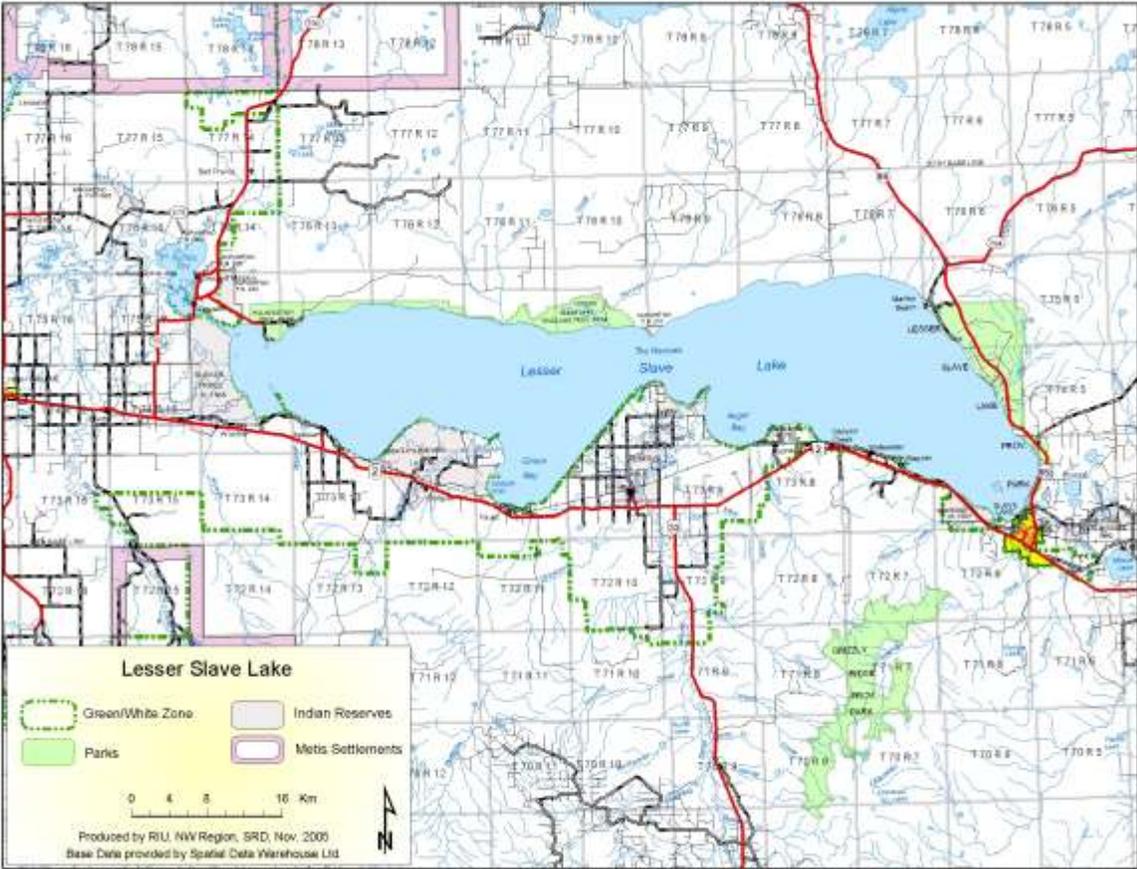
Figure 1. Map of Lesser Slave Lake, Alberta, Canada.

Lesser Slave Lake has a surface area of 1160 km<sup>2</sup> with a shoreline length of 241 km (Mitchell and Prepas 1990). The drainage basin is large (12 400 km<sup>2</sup>) and covers an area about 11 times greater than the lake (Mitchell and Prepas 1990). The lake is defined into two basins by a narrow stretch of shallow water known as "The Narrows". The maximum depth of the west basin is approximately 15.5 m while the east basin slightly deeper at 20.5 m (Mitchell and Prepas 1990). The water levels on the lake have been monitored since 1923, and fluctuate over a range of 2.86 m (Mitchell and Prepas 1990). A weir located at the single outlet of Lesser Slave River maintains a minimum lake level of 575.5 m.

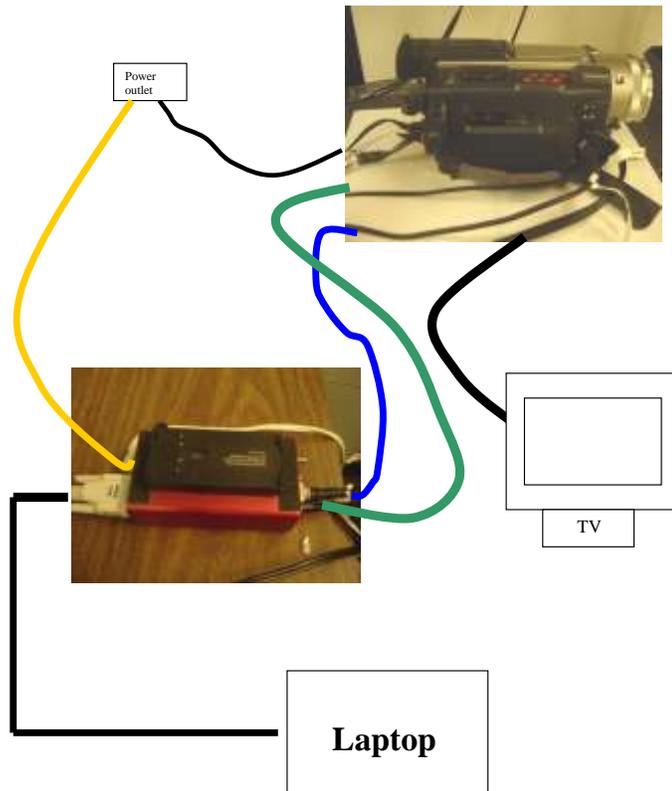
Figure 2. The Sony DCR-TRV 900 digital video camera and Red Hens Systems Global Positioning Systems mapping system used to display the geo-referenced aerial videography.

Aerial videography of riparian zones were captured using a helicopter (A-Star or Bell 206 Jet Ranger) combined with a handheld Sony DCR-TRV 900 digital camera and VMS 200 Geo Mapping hardware, manufactured by Red Hens Systems Inc. (Figure 2). Video was captured when the helicopter was flown at approximately 30-35 knots in a counter clockwise fashion, at the height of approximately 45-60m (slower speed at areas of higher interest, such as shoreline cottage areas). The height provided the best balance between aircraft height and camera zoom capabilities (i.e., decreased zoom coincides with increased stability of the video footage). Global Positioning System (GPS) flight line information obtained from the camera and the VMS 200 system and subsequent assessment information derived from the videography were mapped as individual Geographic Information Systems (GIS) data layers using the VMS 200 Media-mapper GIS software. These layers were then exported to ESRI ArcGIS software and included with other standard GIS data layers (IRS imagery). Captured information was used to generate data outputs including ESRI based map layers.

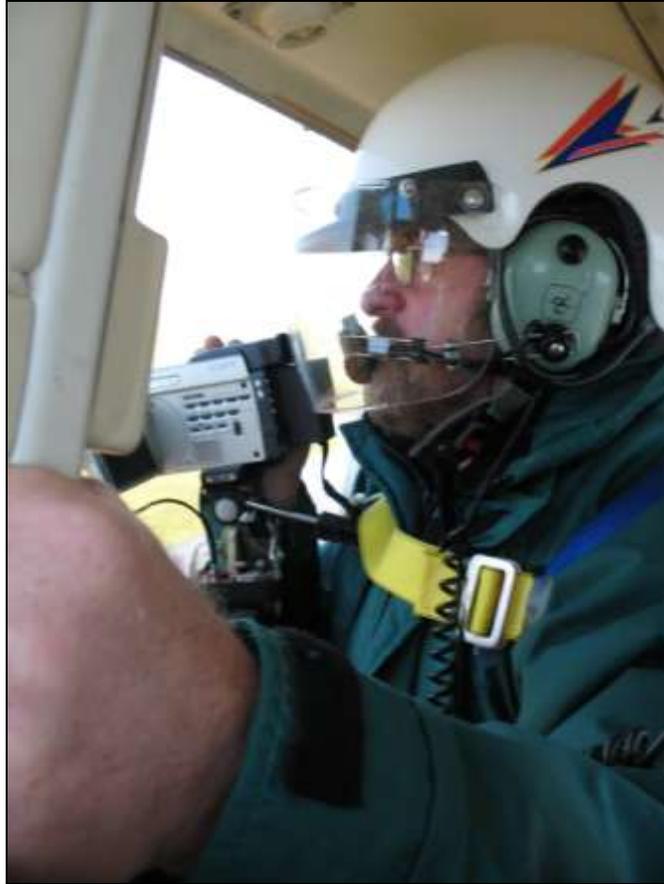
Figure 3. Aerial videographer George Walker recording the shoreline during the flight.

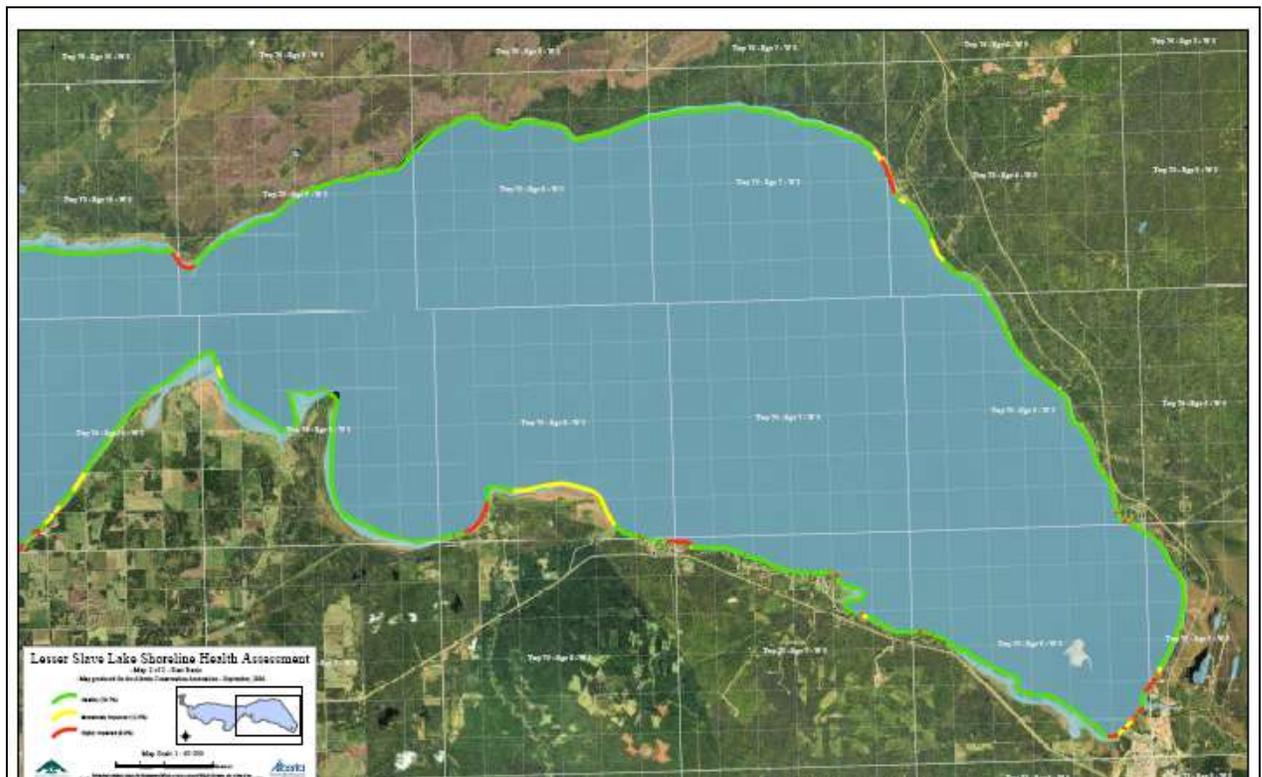
Results from aerial videography combined with the application of the riparian health scorecard showed that the majority (78.7%) of the riparian zones adjacent to LSL are healthy (in green on a colour map) with 12.5% and 8.8% of shorelines defined as moderately impaired (yellow) to highly impaired (red) respectively. The vegetation and human disturbance categories used to generate these riparian health values are described in Appendix 1, although some scores were revised when ASRD provided additional information. (Figures 4 and 5).

Figure 4. Riparian health scores for the east basin of Lesser Slave Lake.

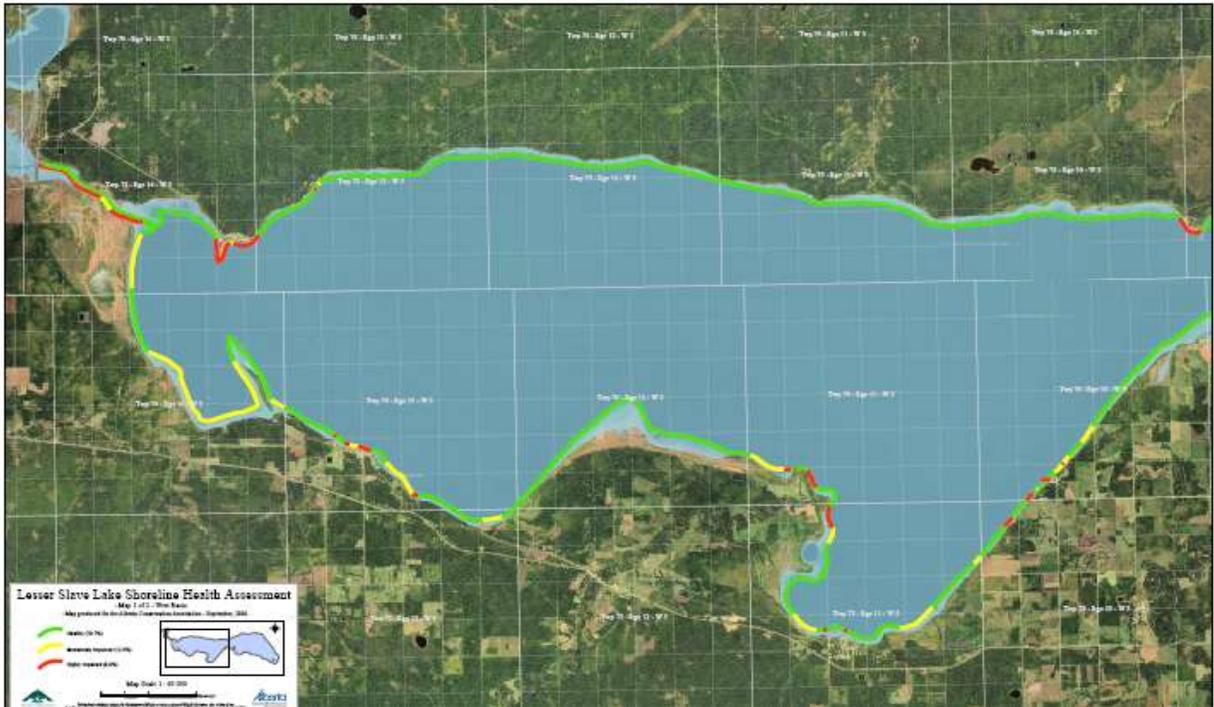
Figure 5. Riparian health ratings for the west basin of Lesser Slave Lake

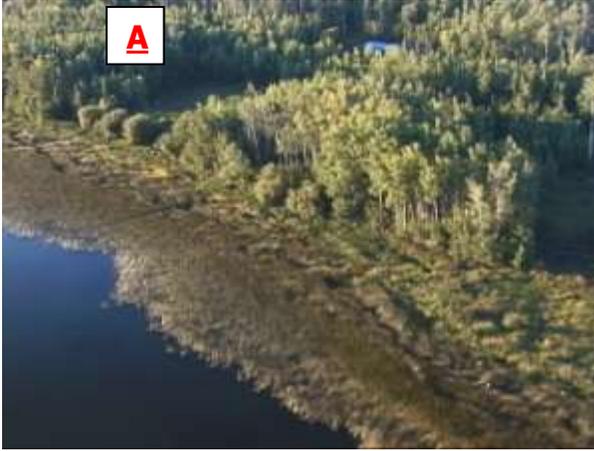
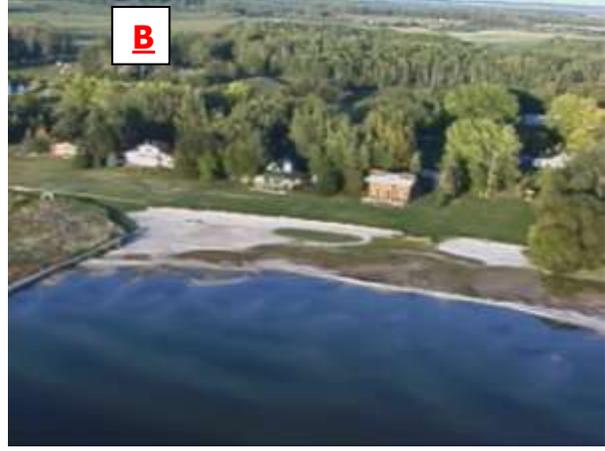
7. What picture does most of the polygon look like?  
**Picture A?** \_\_\_\_ (1 point) **Combination of A and B?** \_\_\_\_ (0.5 points) **Picture B?** \_\_\_\_ (0 points)
