# Resiliency & Restoration in the Lesser Slave Watershed

## Watershed Resiliency and Restoration Program

This report showcases the projects completed and in progress from 2016-18 in the Lesser Slave Watershed. The LSWC and our partners will continue to support these landowners and monitor project successes over the long term.

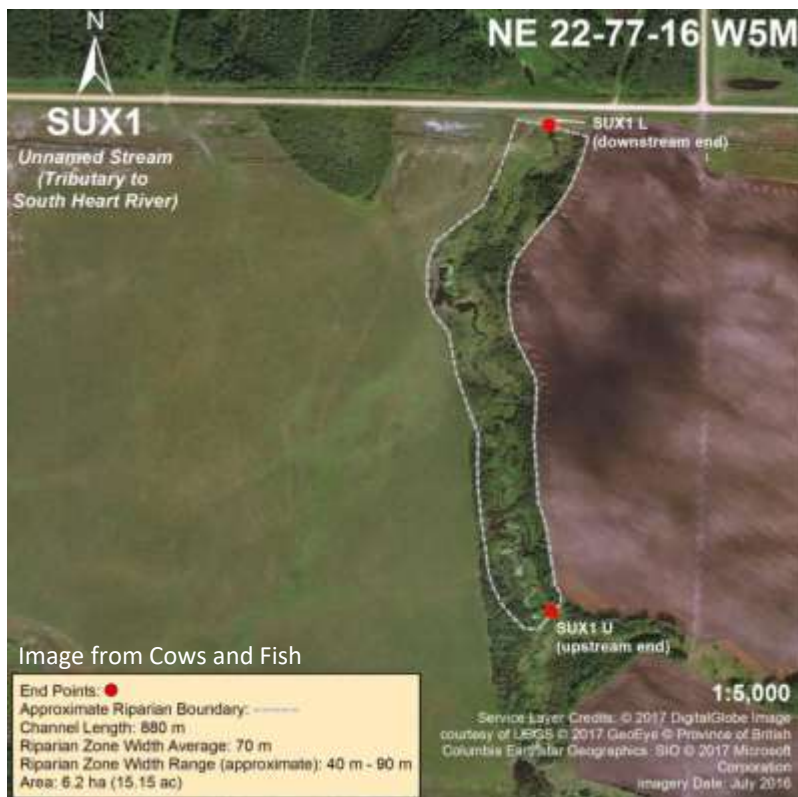
On August 26, 2016 Cows and Fish Field Technicians completed a Riparian health Inventory along a representative segment of the creek shown below. The overall score was 63% which is healthy but with problems. With some management changes there is the potential to bring the health score up to 80%

Some of the items contributing to the health score include:

- Invasive weeds are present
- Removal of woody trees by beavers.
- Moderate browsing and grazing of riparian area.
- Some soil compaction from livestock traffic.

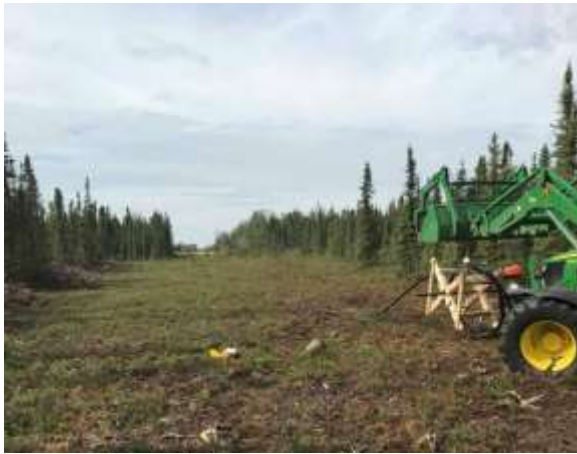
*The waterline being strung in fall 2017. The landscape changes from grassland to muskeg closer to the pond.*

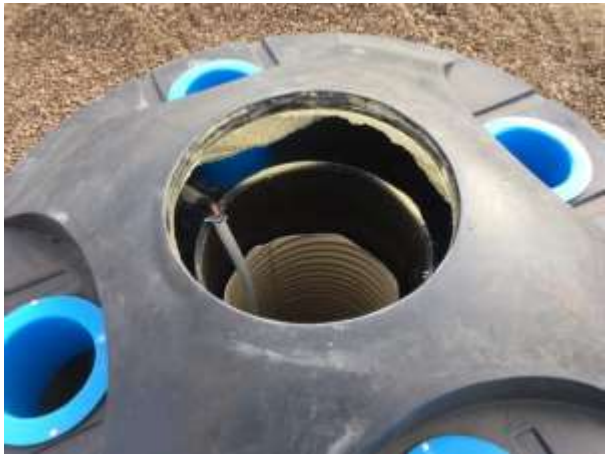
At the pasture end of the line they brought the line up through a 24 inch culvert about 16 feet in the ground.

Blackhursts purchased a CAPsule from CAP Solar with the capacity for 700 head and installed it over the culvert and connected the four insulated drink tubes.

*This image from CAP Solar shows how the CAPsule fits over the culvert and connects to the water line.*

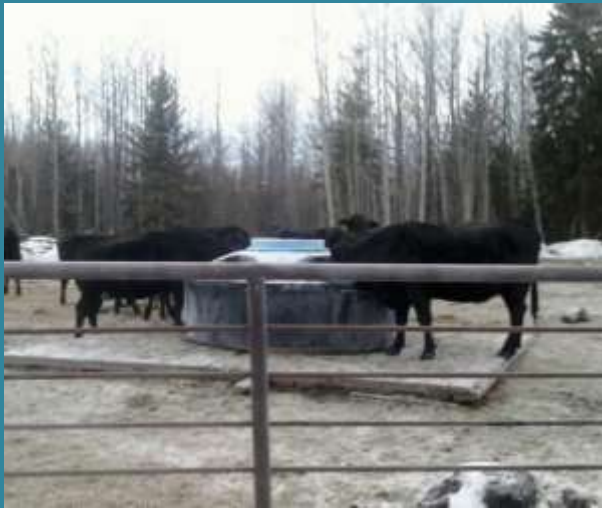
Happy cattle utilizing their new watering system in December 2017 are pictured on the left. Temperatures dropped to -38 C in December 2017 and the system did not freeze up as long as cattle drank continually throughout the day. Blackhursts had to break the ice on the bowls a few mornings during the extreme cold.

No pump, no power and the lay of the land make this system a great solution for this remote area.

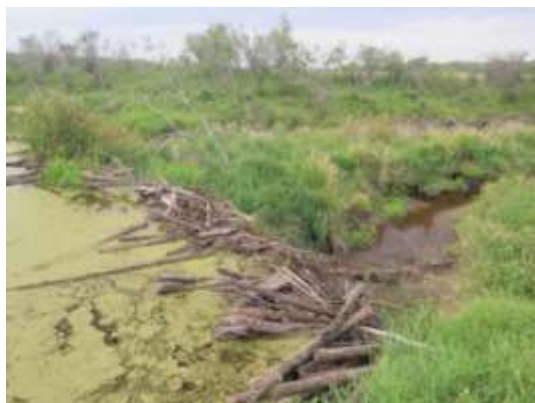
While beavers may be difficult to deal with, in the long run their dams play an important role in riparian function. This dam on the creek running through the pasture holds back water in the summer months when the rest of the creek is dry.

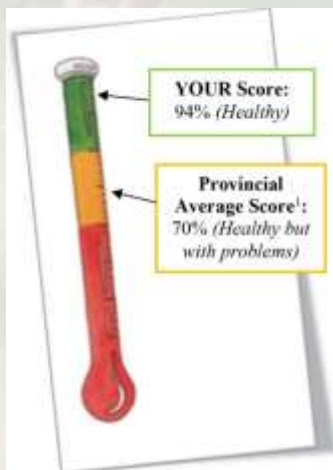
On August 24, 2016 Cows and Fish staff completed a riparian health assessment along the East Prairie River. The segment that was surveyed had an overall score of 94% healthy. Some of the management

Considerations include: maintaining existing tree and shrub cover, monitoring invasive species (Canada Thistle), and minimizing any bare ground that encouraged weeds and invasives to establish. Fencing out the riparian area will prevent disturbance and protect stream banks.

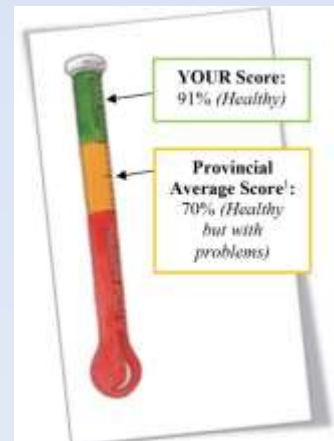
A second assessment was completed at another location bordering an outside bend of the river. This reach also had a high score of 91% healthy. This stretch along the river is too steep for livestock to graze and fencing out the area is a

good strategy to protect existing tree and shrub cover that will aid in bank stabilization during high flow periods. Perennial Sow Thistle is the only noxious weed found in this reach and should be monitored and controlled so it does not spread. Another recommendation is to limit spring grazing in this area while soils are wet and erode easily.

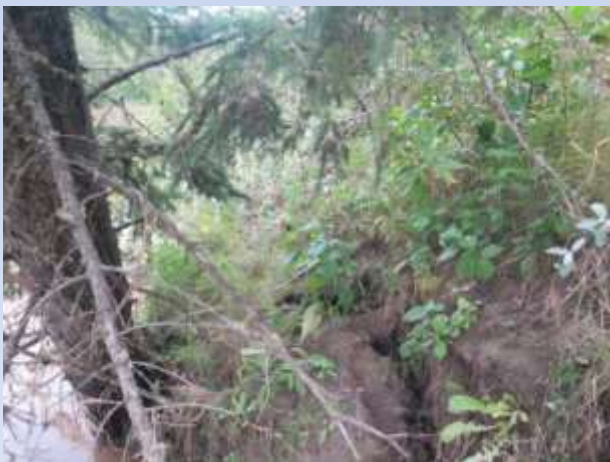
Despite having deep binding roots along the bank erosion still occurs along steep banks, especially during high water events.

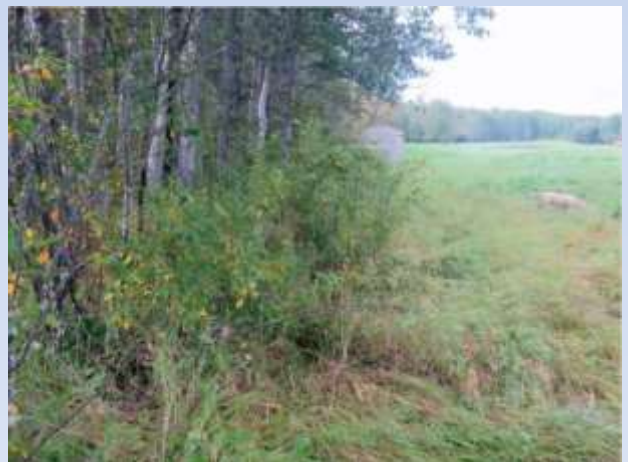
This image shows the transition area between riparian area and upland pasture. Fencing along this divide will maintain riparian health.

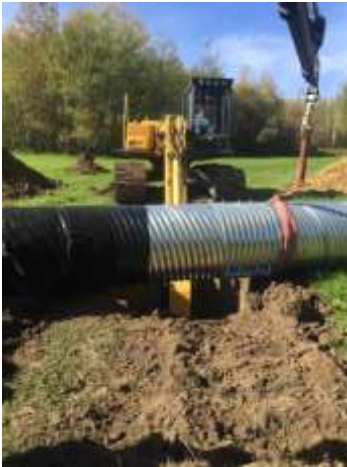
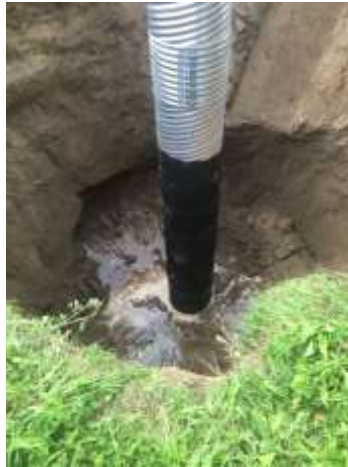
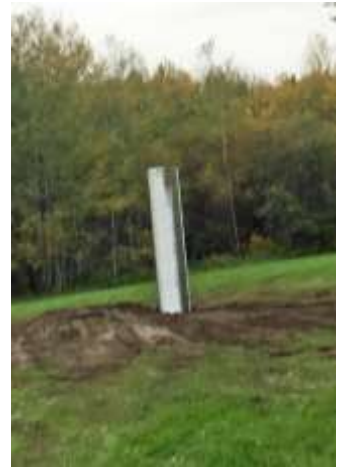
A backhoe was hired to dig down to the water table at about 16 feet below surface. Once they reached water a load of rock was put in the hole before a 24 inch culvert was placed. The bottom portion of the culvert was coated with plastic to prevent erosion over time. Once the culvert was placed correctly it was held in place by a skid steer while the backhoe filled around it.

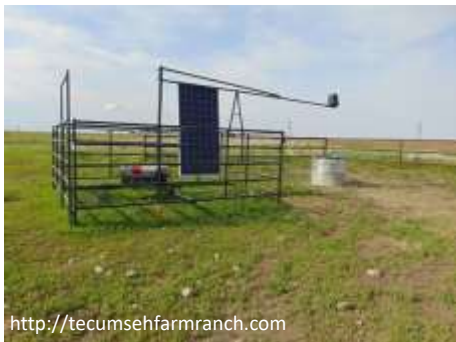
*The complete system looks like the one above. There is a submerged pump in the well that, when triggered by the motion eye pumps, water into the bowl. Once cattle drink and move away from the motion eye the water drains from the bowl back down the well, preventing freezing. The solar panel keeps the battery fully charged.*

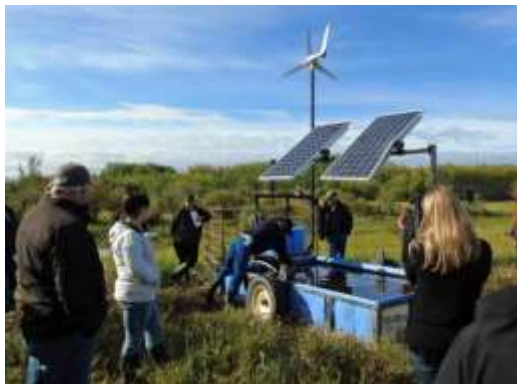
Marvin Jackson of Sundog Solar explains operation of a solar and wind powered unit.

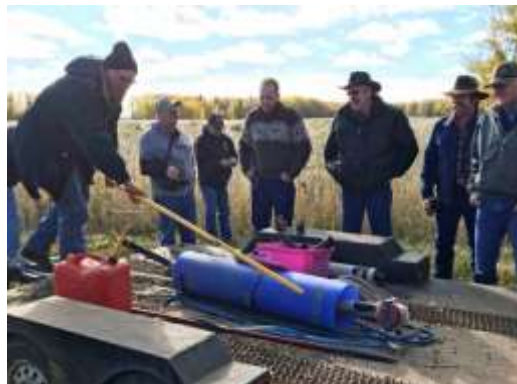
Producer John Prinse shows the group his winterized solar powered system.

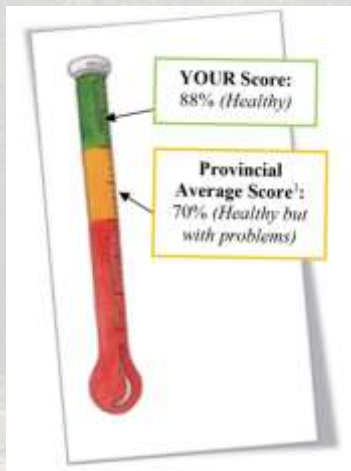
On August 25, 2016 Cows and Fish Staff conducted a riparian health assessment on a representative segment of the West Prairie River. The overall health was scored at 88% healthy.

Some challenges were identified including:

Invasive weed species, some disturbance cause plants, erosion from high flows, and some impacts from OHV's but these are limited to existing trails. The fence that Beamish's have installed will protect the riparian area and maintain its health. There is potential to raise the health score up into the 90th percentile.

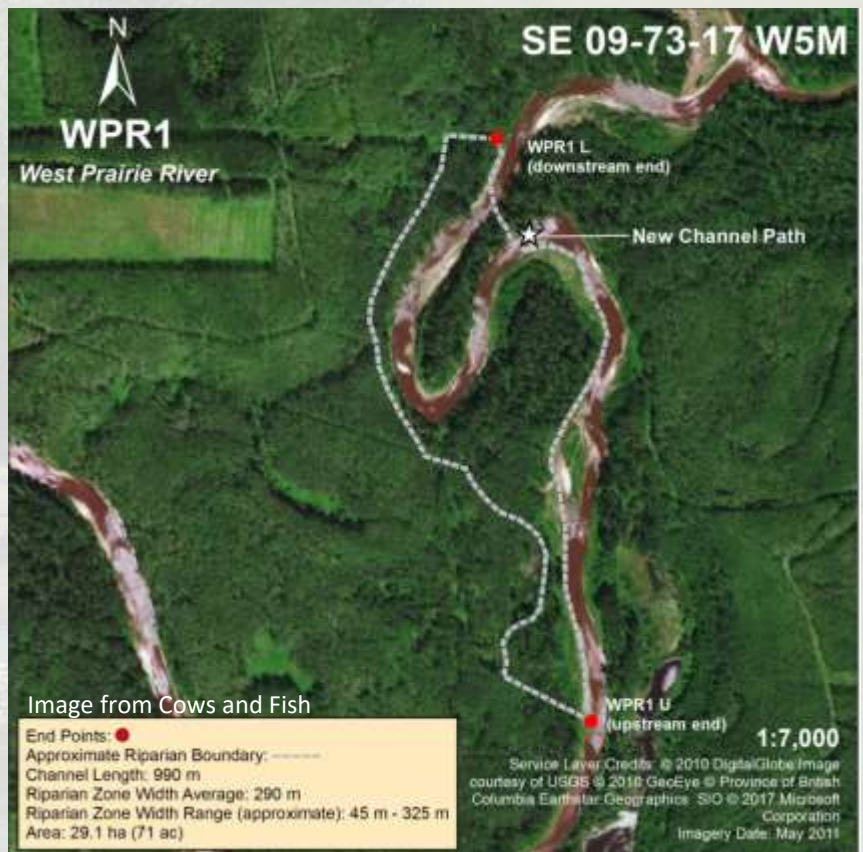
The boundary of the grazing lease is shown on the map in purple. Beamish worked with Public Lands staff to plan the new fence line for this parcel (yellow) and obtained approval for the installation permitting fire hazard was low enough not to cause significant risk. Travis also planned to install an OHV friendly gate that will deter people from cutting fences to gain access. This metal pole gate is

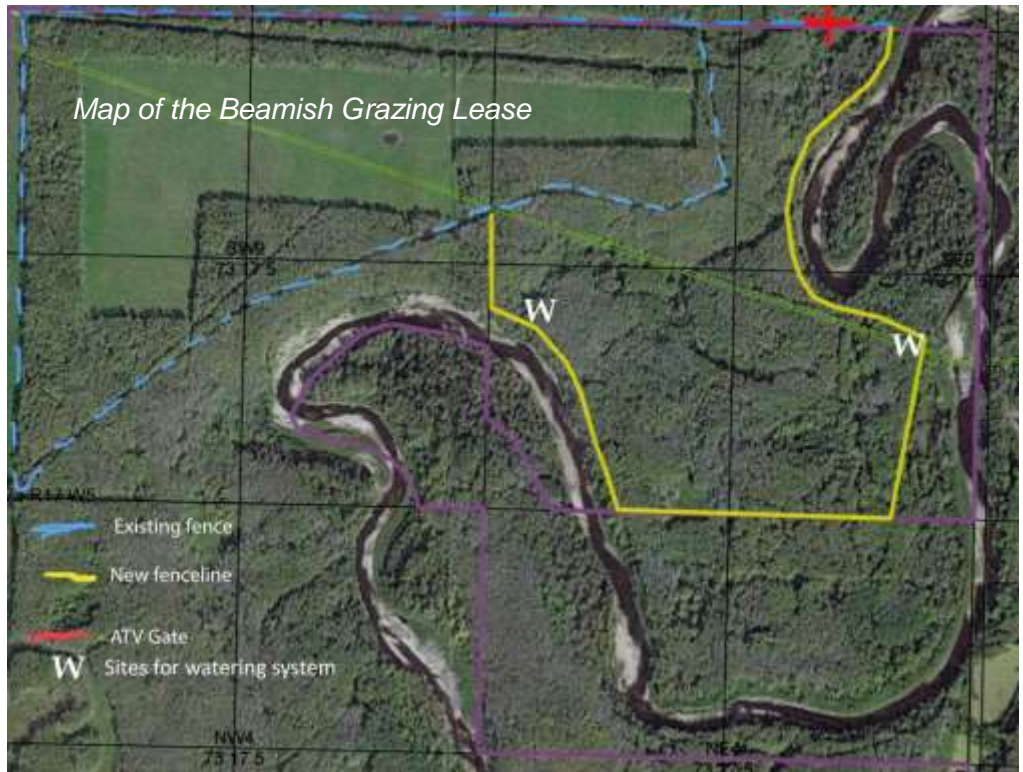
Designed for OHV's to drive over but restrict cattle from going across it. Beamish have purchased a solar powered off stream watering system that will be utilized along the river in at least 2 locations. The system will be on the upland side of the fence and eliminate the need for cattle access to the river for watering.

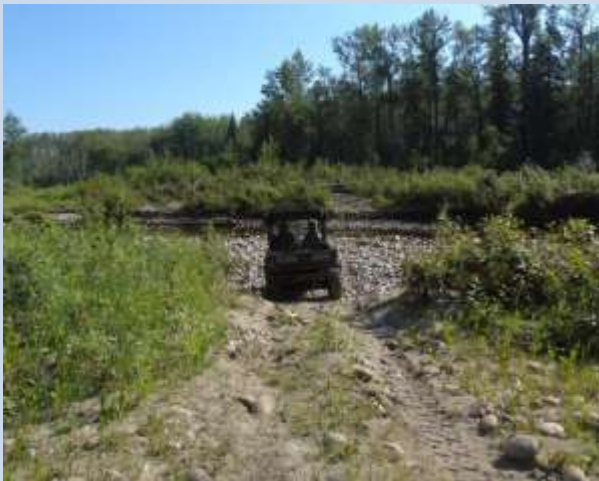
OHV trails are present throughout the grazing lease, mainly along the fence line. The majority of users are respectful and stick to existing trails and crossings.

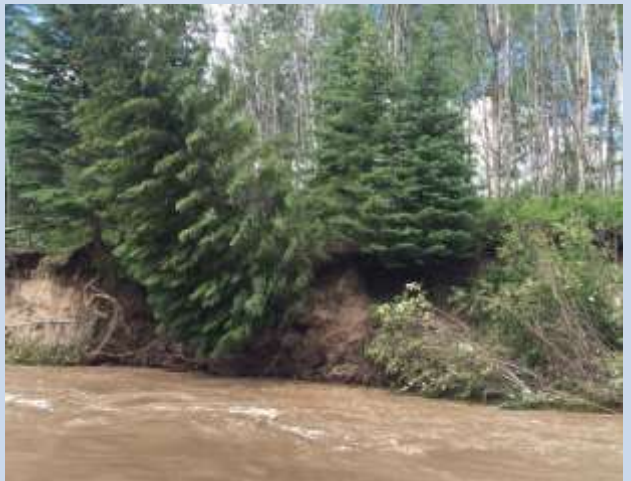
High flows in June 2016 cause large scale erosion along the banks of the river despite the health vegetation and root mass present. This high water event cause the river to incise a new channel and cut off a new oxbow.

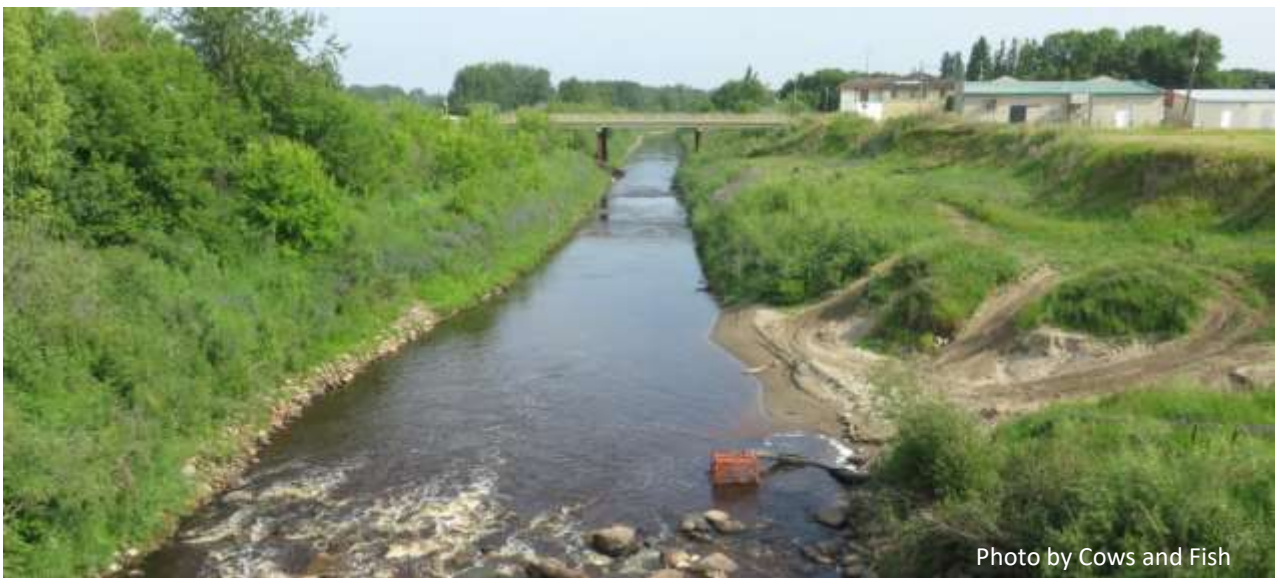
Photo by Cows and Fish

This image captured by Cows and Fish staff is taken from the rail bridge facing north (downstream) and shows the riparian areas on both sides of the West Prairie River.

- **Balsam poplar regeneration is absent** but there is a strong potential for establishment and regeneration.
- **Other native trees are not abundant**, but regeneration is present. Manitoba maple and green ash are the only trees present and cover < 1% of the site.

- Preferred shrub species are present and have excellent regeneration. Sandbar Willow is the most abundant
- **There is a high amount of woody vegetation removal by human activities.** Burning of the site to reduce woody vegetation has resulted in most of the site being covered by invasive forb and introduced grass species.

- **Invasive plant species are abundant.** Tufted Vetch and Canada Thistle are abundant.
- **Disturbance-caused undesirable plant species are abundant.** These are typically non-native grasses and forbs that tend to aggressively displace native plants once the soil surface has been disturbed.

- **Human-caused structural alterations to the rest of the site are extensive.** Approximately 50% of the floodplain area away from the riverbank is also altered due to recreational use.

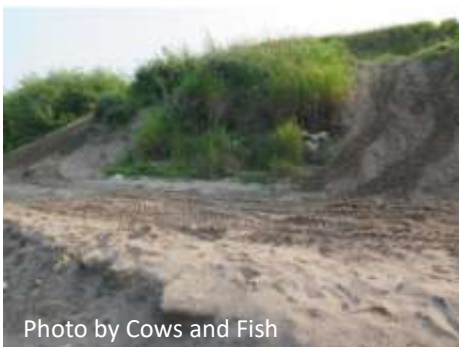
Photo by Cows and Fish

On the left you can see the bare ground caused by ATV use in the riparian area. On the right you can see the abundance of tufted vetch. This vetch covers about 20% of the site.

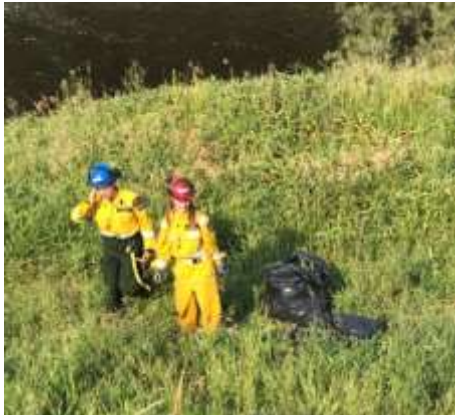
In August of 2018 the local Junior Forest Warden group joined the LSWC and Town of High Prairie staff for a day of work along the West Prairie River.

10 garbage bags of weeds were removed by the group of girls. This was only a fraction of the extent of the weeds present. Working on weed control will be an ongoing challenge at this site.

With 2 staff and a backhoe from the Town of High Prairie fence posts were installed along the river bank and the Junior Forest Rangers installed and painted the fence boards. Because of the need to have vehicle access to the meters that monitor gasses from the buried garbage dump below we were not able to extend the fence as far as we would have liked.

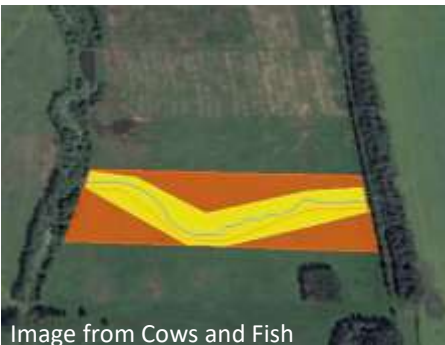
Image from Cows and Fish

The image to the left shows conservative, moderate and generous riparian fencing options. Mr. Prince chose the moderate scenario, leaving space for vegetation to thrive, and keeping his cattle out of the soft wet soils. The riparian area may be grazed from time to time when conditions permit.

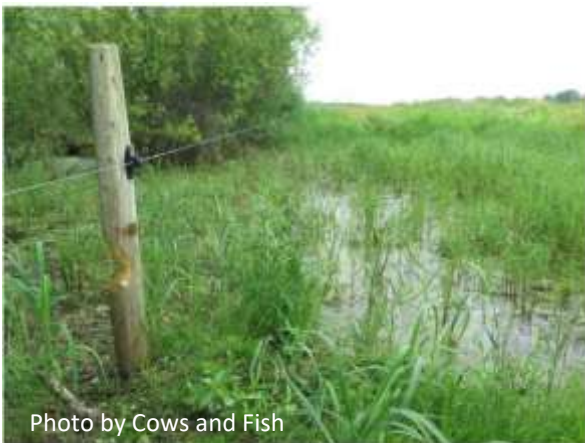
Photo by Cows and Fish

*The Beavers in the downstream channel are active and moving out into the pasture. In addition to this post, some of the woody shrubs have been browsed.*

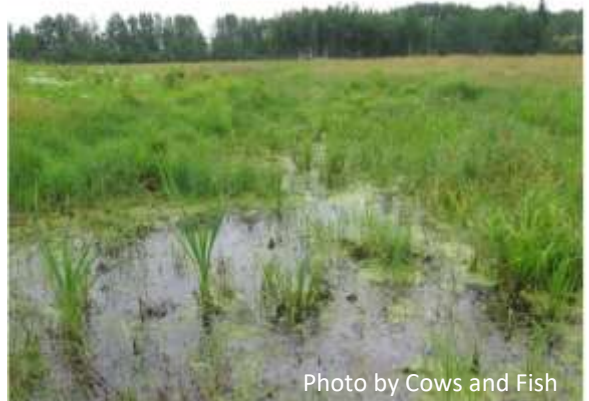
Photo by Cows and Fish

*This photo was taken in the middle of the channel. Cat tails and some species of sedges are present in the wettest areas.*

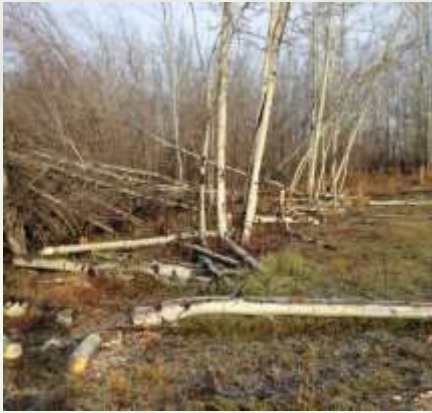
Beavers along Mud Creek love to chew. They have fallen many poplar trees over existing fences and have even taken to chewing treated fence posts. John is willing to try new tactics to deter them from certain locations.

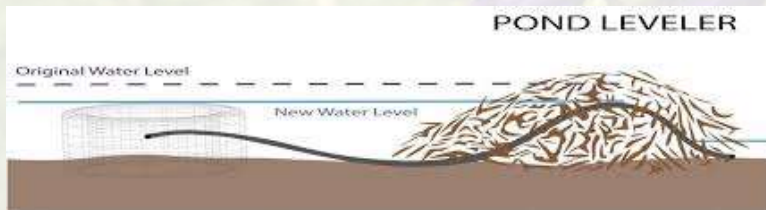
The intent of a pond leveler is to let water flow out of the dammed area while still maintaining enough water behind the dam to keep Beaver happy. Learn more at [www.cowsandfish.org](http://www.cowsandfish.org)

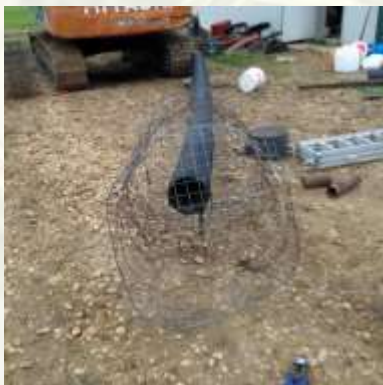
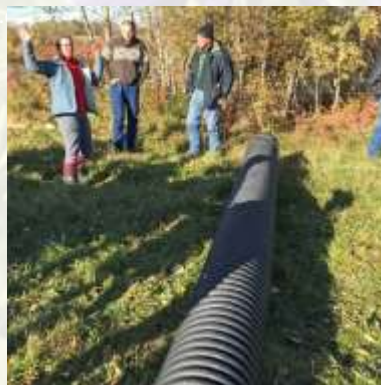
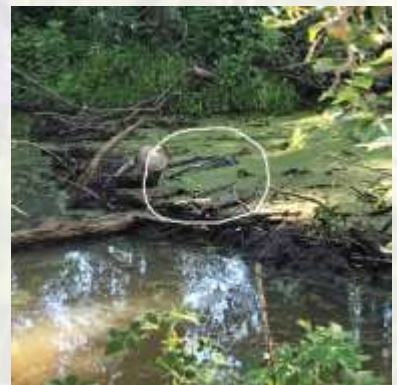
Mr. Prinse has constructed and installed three different pond leveling devices on his property. He learned that if the device is too short the beavers can find the outflow and block it. They are triggered by the sound of moving water so the further from the dam it can be located, the better. The image above, left shows the wire cage that is put around the perforated pipe to prevent the beavers from blocking it with mud and sticks. Above, center, Tanya with Cows and Fish explains the concept of pond levers to our October 2018 field tour participants. The image on the left shows the end of one of John's pond levelers on the upstream side of the dam. One of the installation challenges was making the pipe sink. John made holes in the underside of the pipe with a grinder so that water could seep into it and let it sink below water level. We will continue to work with John to monitor the effectiveness of these devices and whether or not they are "vandalized" by the Beaver.
