# FISH KILL IN BISCAYNE BAY: A REPORT

MIAMI  
WATERKEEPER

# SCIENTIFIC AND TECHNICAL FISH KILL DATA AND OBSERVATIONS

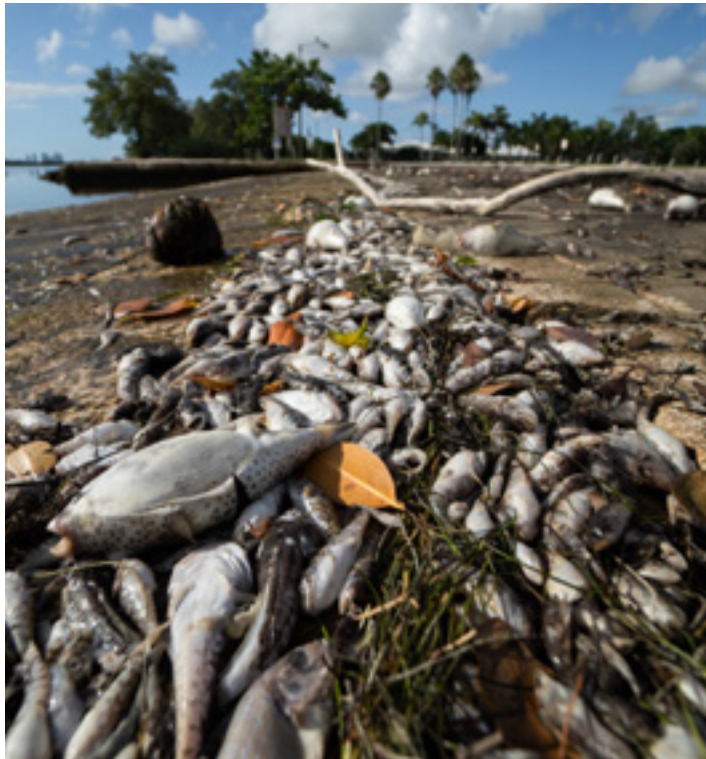
Figure 1. Dead fish found at Morningside Park on August, 11, 2020. Photo Credit: Sendit4thesea.

Between August 10-15, 2020, the Miami community reported thousands of dead and dying marine life or animals struggling for air across northern Biscayne Bay (Figure 1), impacting both bottom-dwelling and highly mobile fish. Non-profits, research institutions, and government agencies started collecting data when these observations began (Figure 2). Data indicate that low DO levels led to the fish kill, although the contributing role(s) of accompanying toxicants cannot be ruled out.

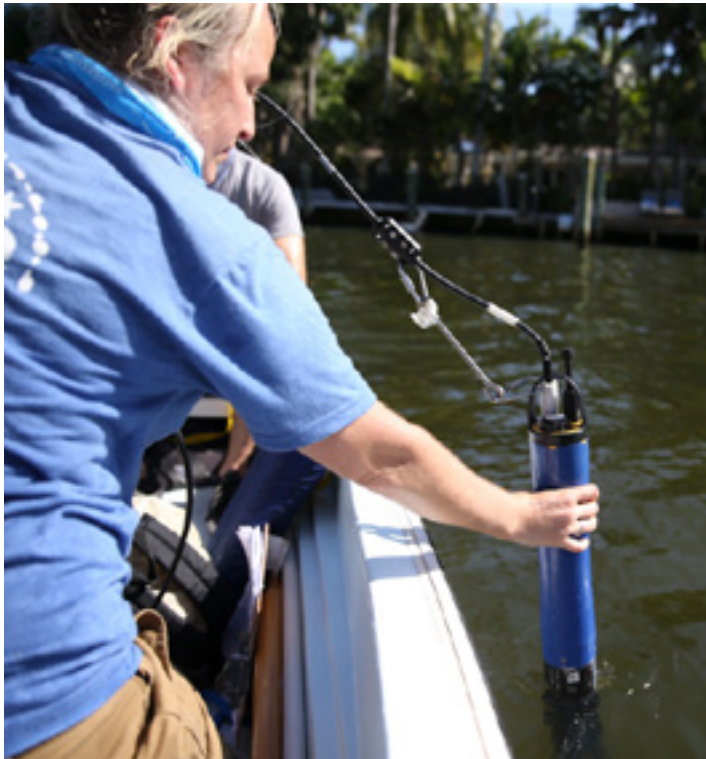
Figure 2. Miami Waterkeeper staff collecting data and observations near Morningside Park with a YSI EXO sonde on a Seakeepers Society vessel.

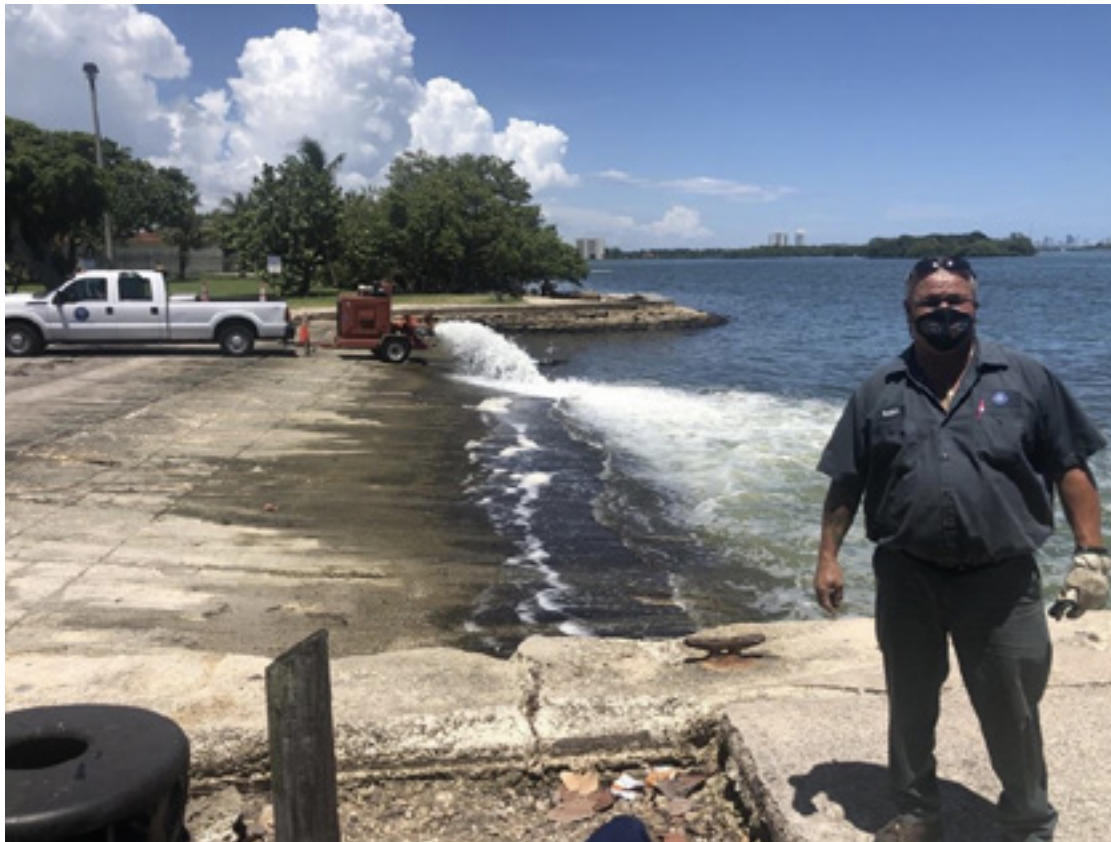
Figure 4. Emergency aeration provided by the City of Miami’s stormwater pumps at Morningside Park from August 16-20.

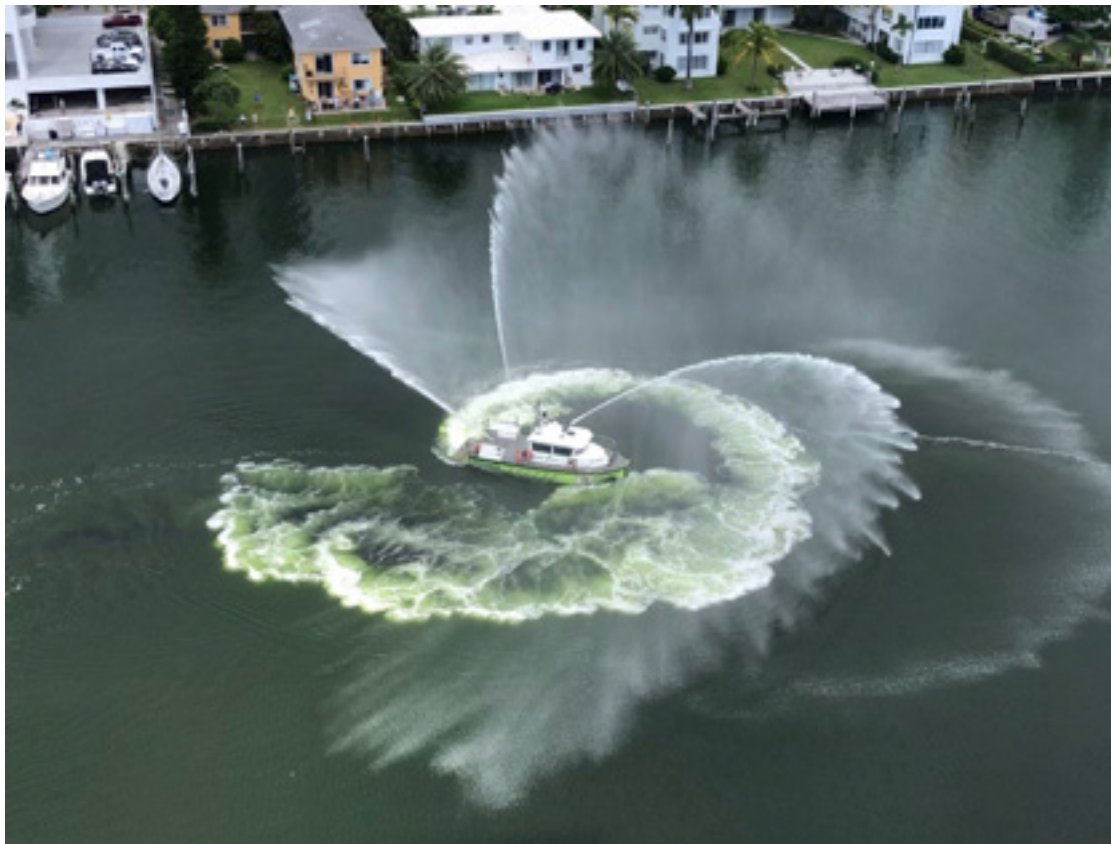
Figure 5. Port of Miami fireboats attempting to aerate Biscayne Bay by agitating the water on August 15, 2020.  
Photo Credit: Christy Raynor.

In response, oxygen pumps were installed at Pelican Harbor marina by the Phillip and Patricia Frost Museum of Science staff to provide oxygen to the congregated marine life, particularly various species of rays (Figure 21). On August 15, 2020, in an effort to improve DO conditions, Miami Waterkeeper requested emergency aeration efforts from PortMiami and City of Miami. In coordination with Miami Dade County and PortMiami, fireboats were sent to oxygen-starved areas of the Bay near North Bay Village (Figure 5). As these boats were deployed in an emergency mode, researchers were not fully prepared with a complete experimental design to measure their efficacy. However, anecdotal evidence

collected by FIU CREST researchers suggests that this was an effective temporary measure in the immediate area. Where the fireboats were operating, surface DO was measured at 30%, while about 100 yards away, DO was only 15% (Schonhof 2020). However, this could have been due to a pre-existing difference in DO levels rather than the operation of the fireboats. We recommend future controlled studies to investigate an ameliorative effect, if any. Similarly, the City of Miami deployed stormwater pumps as aerators at Morningside Park, Albert Pallot Park, and Margaret Pace Park between August 16 and August 20 (Figure 4); monitoring occurred only at Morningside Park. DEP observed that DO levels near Morningside Park increased with the aeration efforts, but that turbidity levels also increased (FDEP BBAP 2020). Langdon found that DO levels increased at this location after the commencement of aeration (Figure 14). Critically, he also recorded that the salinity stratification initially observed at this site began to break up with the initiation of aeration, showing that the water column was becoming more mixed. Mortality reports and reports of wildlife struggling for oxygen slowed or stopped in these areas after interventions,

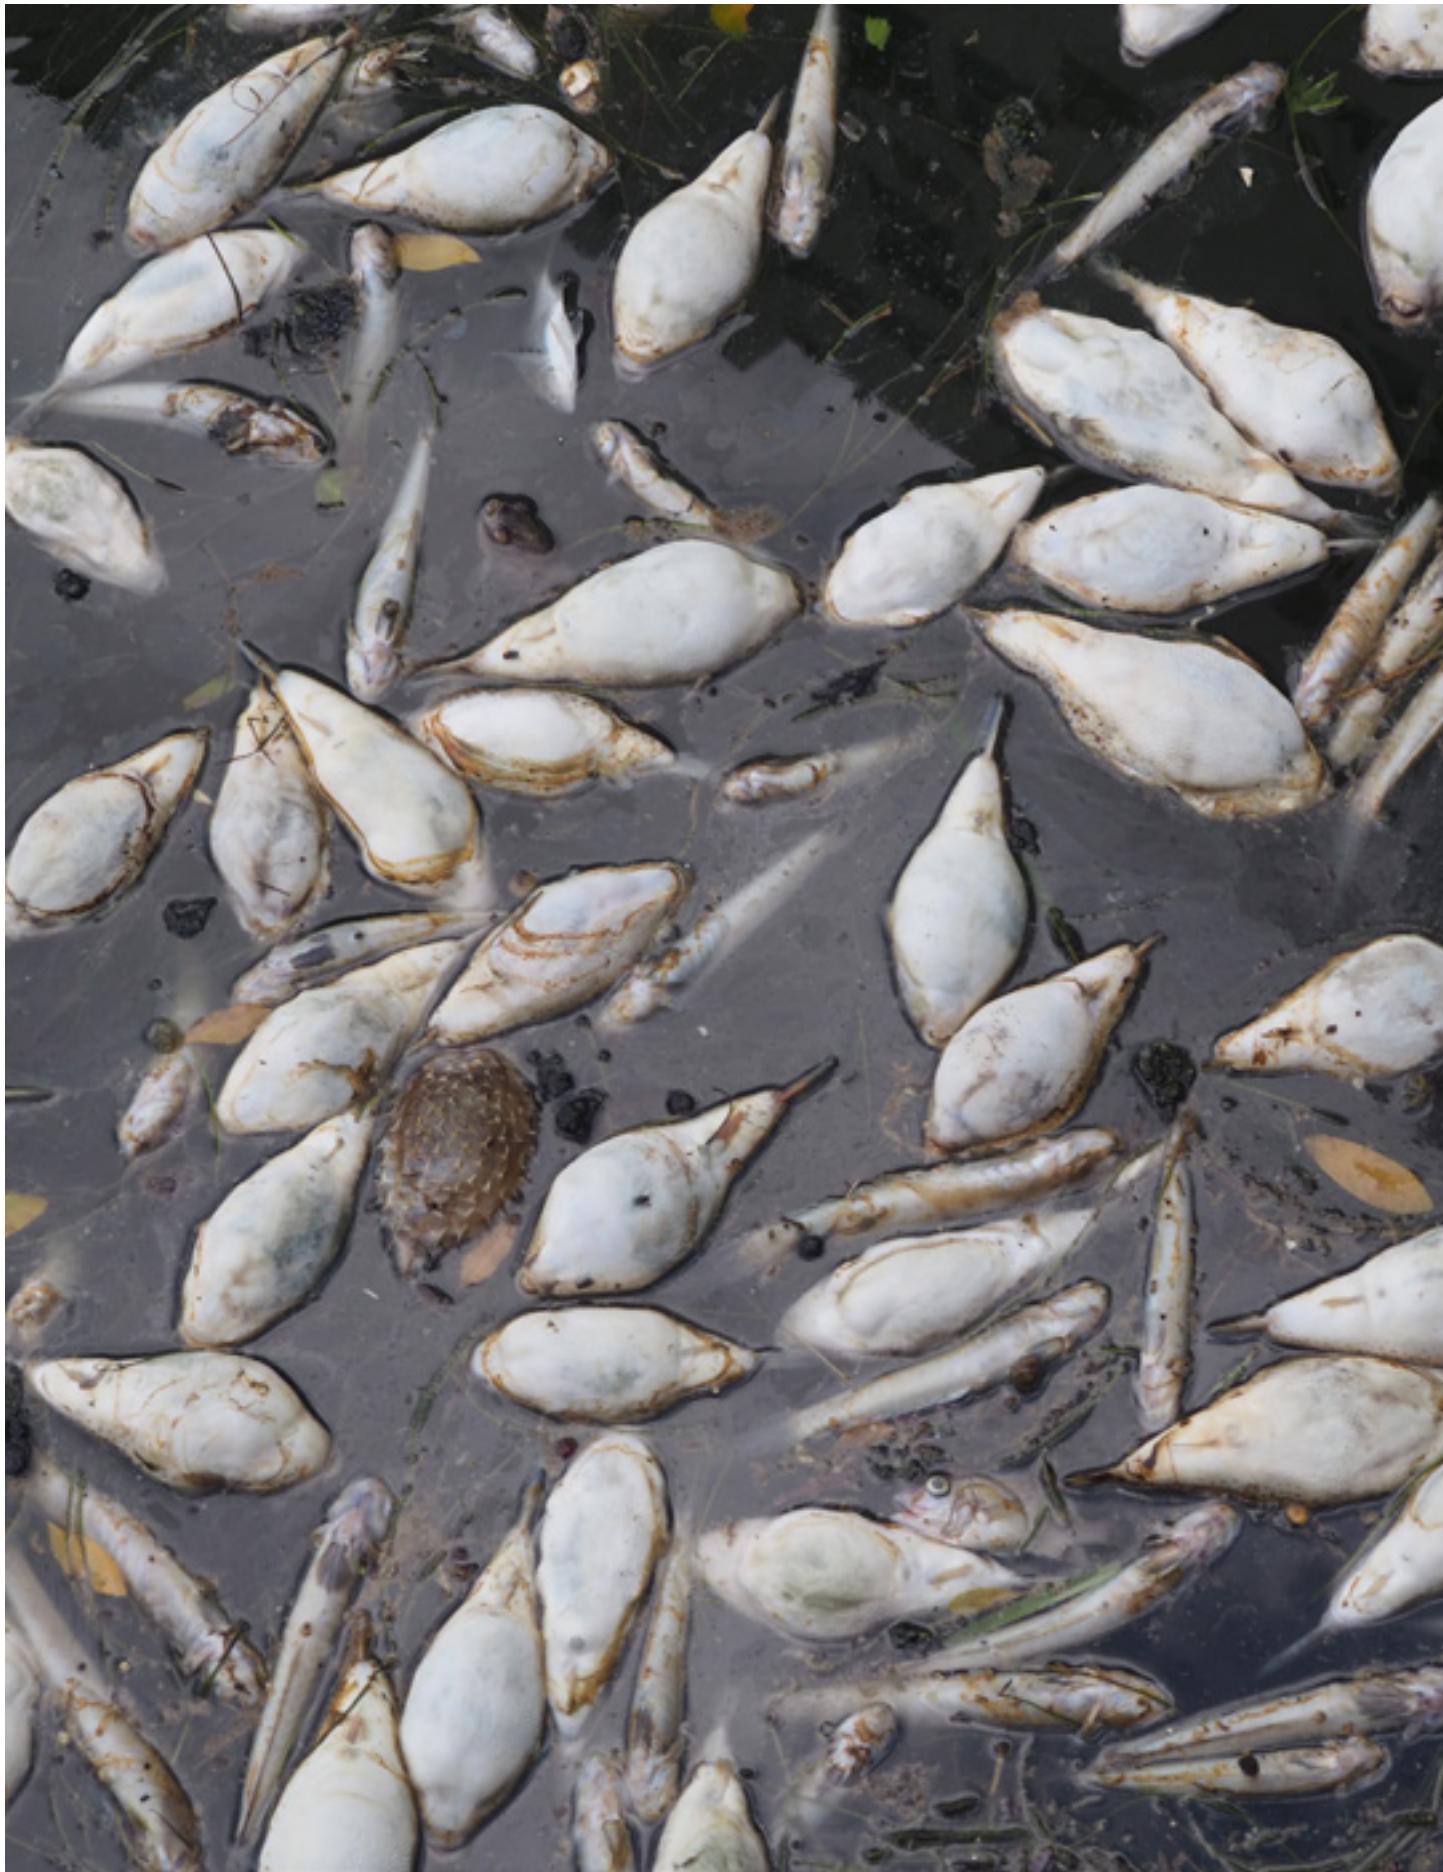
Figure 7. Submitted photo from the public that aided in identifying the species impacted by the fish kill. Photo Credit: Antony Williams.

Miami Waterkeeper staff analyzed a total of 497 digital images and videos that the public submitted. These photos and videos served to enumerate and determine the taxonomic identities of the dead and moribund fishes (Figure 7). Based on the analysis of the images sent to Miami Waterkeeper, at least 27,640 fish and several other organisms are estimated to have been killed, with a total of 56 taxa documented (Table 1). About 44% of the images were dead gulf toadfish, *Opsanus beta*, making them, by far, the most severely affected species (Figure 8). This bottom-dwelling nesting species

is highly site attached and likely do not leave their sites when they encounter stressful conditions. Of the documented fish, 8,835 were unidentified due to a lack of identifiable features in the photo.

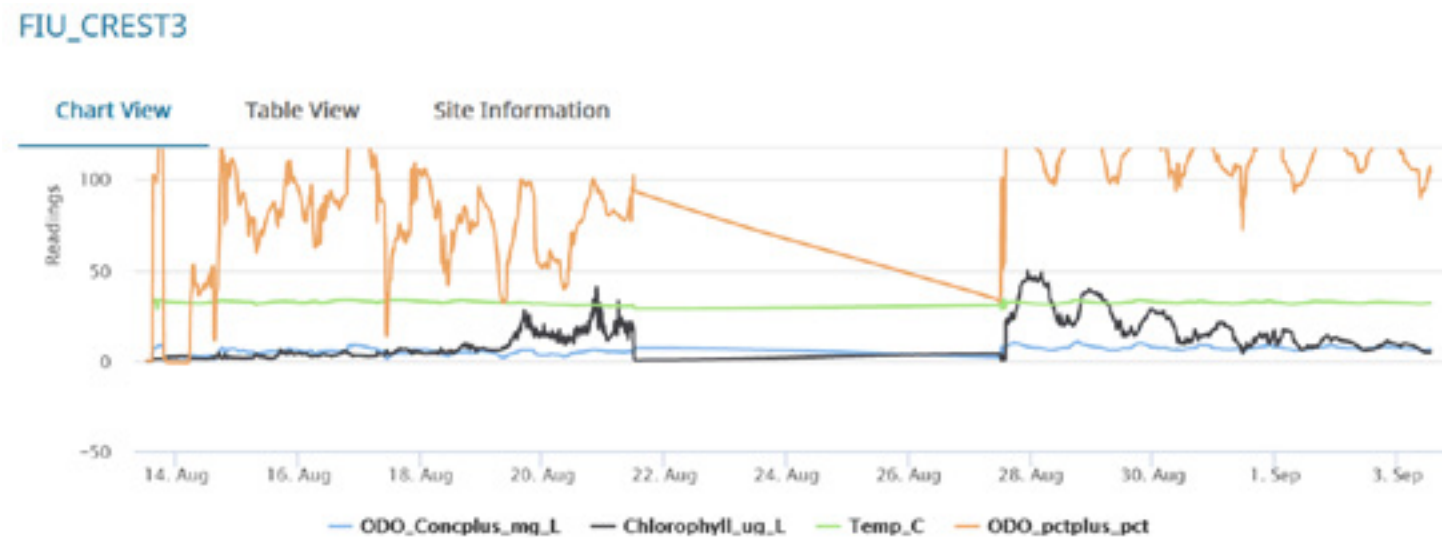
Figure 10. FIU CREST buoy reading showing the drop in DO to 0 on August 14, southeast of North Bay Village. The blue line indicates the concentration of DO, black is chlorophyll-a, green is the temperature, and orange is the percentage of DO.

University [FIU] Institute of Environment National Science Foundation Center of Research Excellence in Science and Technology [CREST] research buoy data and Florida Department of Environmental Protection [DEP] datasonde stations BB14 and JT71, Serafy 2020). DEP Biscayne Bay Aquatic Preserves (BBAP) staff also recorded that oxygen levels dropped to 0% overnight at some of their monitoring locations and in situ sondes (Serafy 2020). At BBAP’s Biscayne Bay 14 (BB14) and Julia Tuttle 71 (JT71) sites (Figure 9), hypoxia persisted intermittently on the same date as the CREST buoys (Figure 10), August 14th. The longest

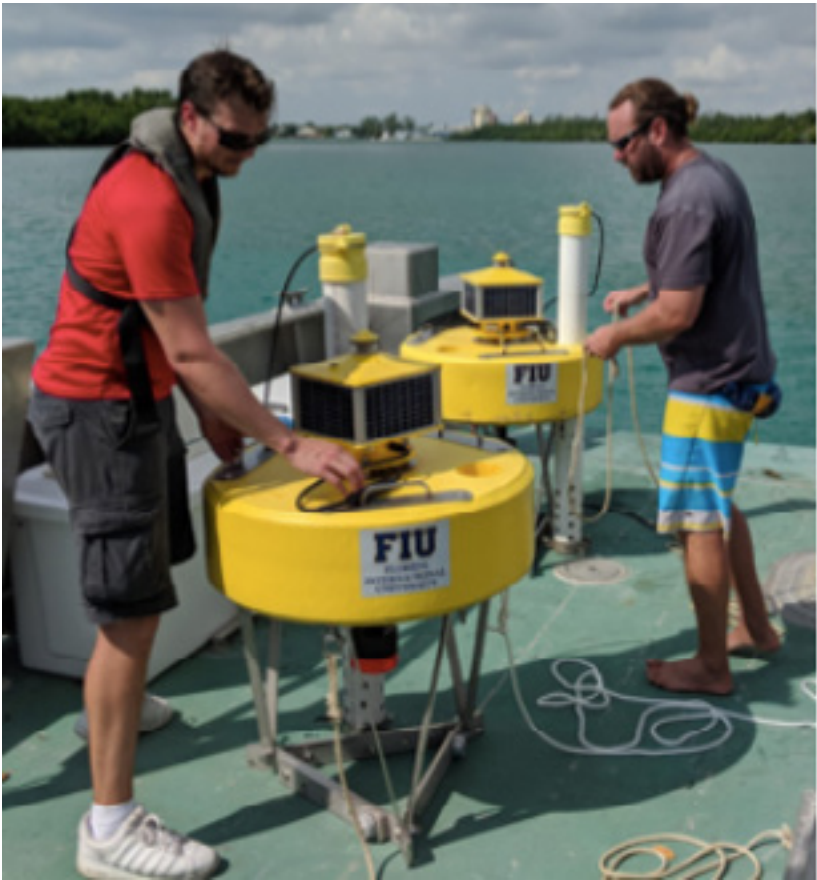
Figure 12. FIU researchers with Xylem EXO sondes that were moved to northern Biscayne Bay in response to the fish kill. Data is available in real time at <https://crestcache.fiu.edu/research/research-buoys/index.html>

FIU CREST also conducted extensive transects of the northern Bay with their autonomous vehicle fleet equipped with Xylem EXO Sondes (Figure 12) and Simrad Ek80 fisheries echosounders, which were towed near the water surface. Data can be visualized at this [site](#). Analysis of DO on August 14 and August 15 revealed that the DO levels were lower on the 14th, especially near the JFK Causeway and Pelican Harbor. DO had increased near the JFK Causeway and Pelican Harbor when another transect of the area was performed on the 15th. On August 27, FIU Institute of Environment CREST [research buoys](#) were relocated to the northern Bay to capture conditions in real-time. One buoy was located south of the Biscayne Canal (north of Biscayne Bay station JFK03) and the other was southeast of North Bay Village (at Biscayne Bay station JT29) (Figure 13).

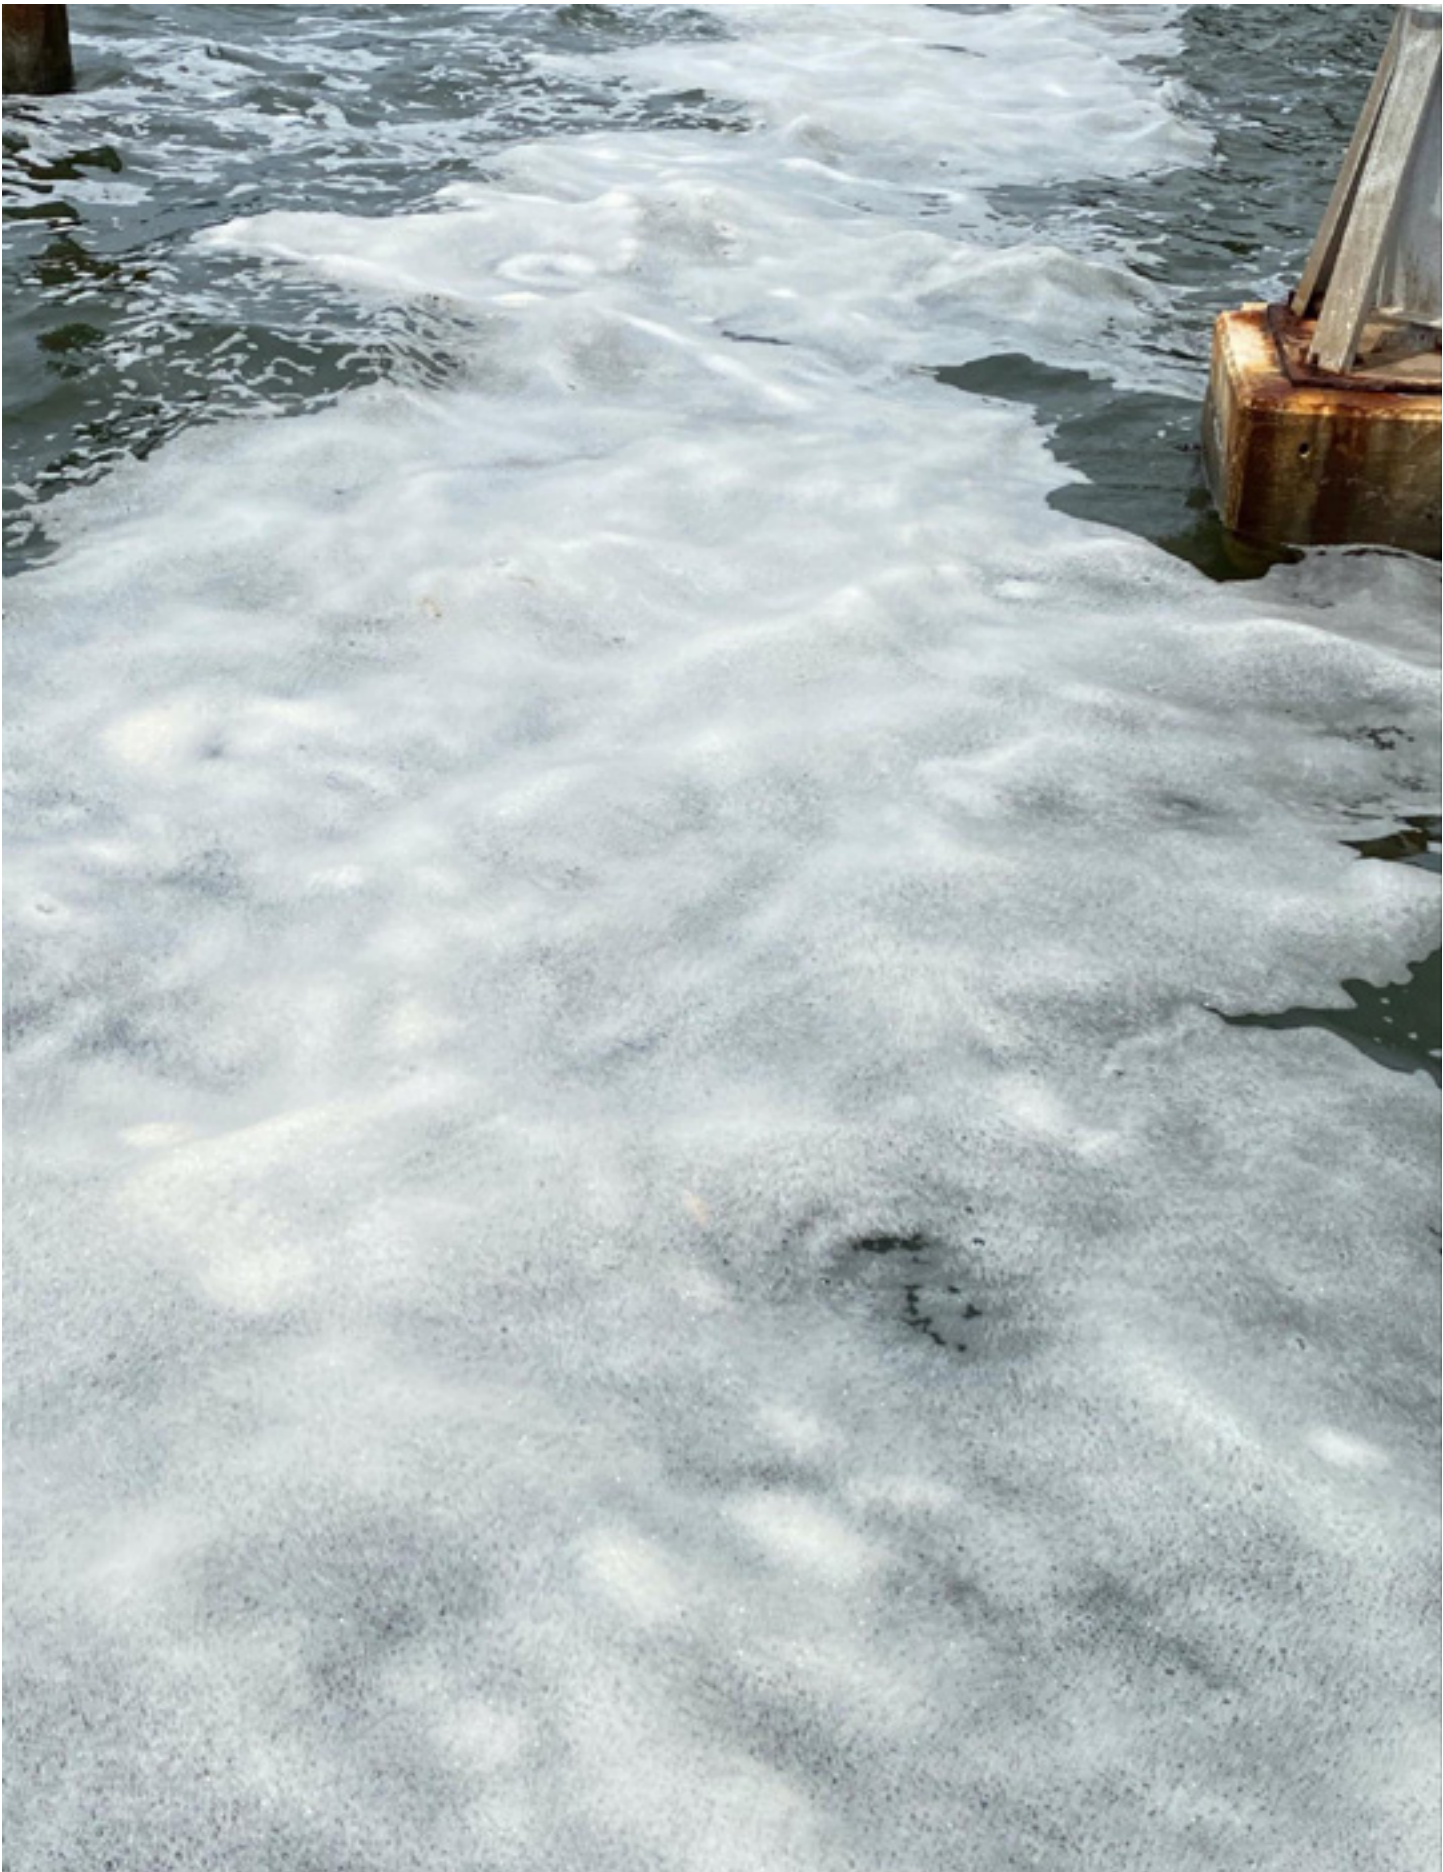
Figure 18. White “foam” that was observed early in the day (August 21, 2020), and later turned green by the afternoon. Photo Credit: Michelle Salem.

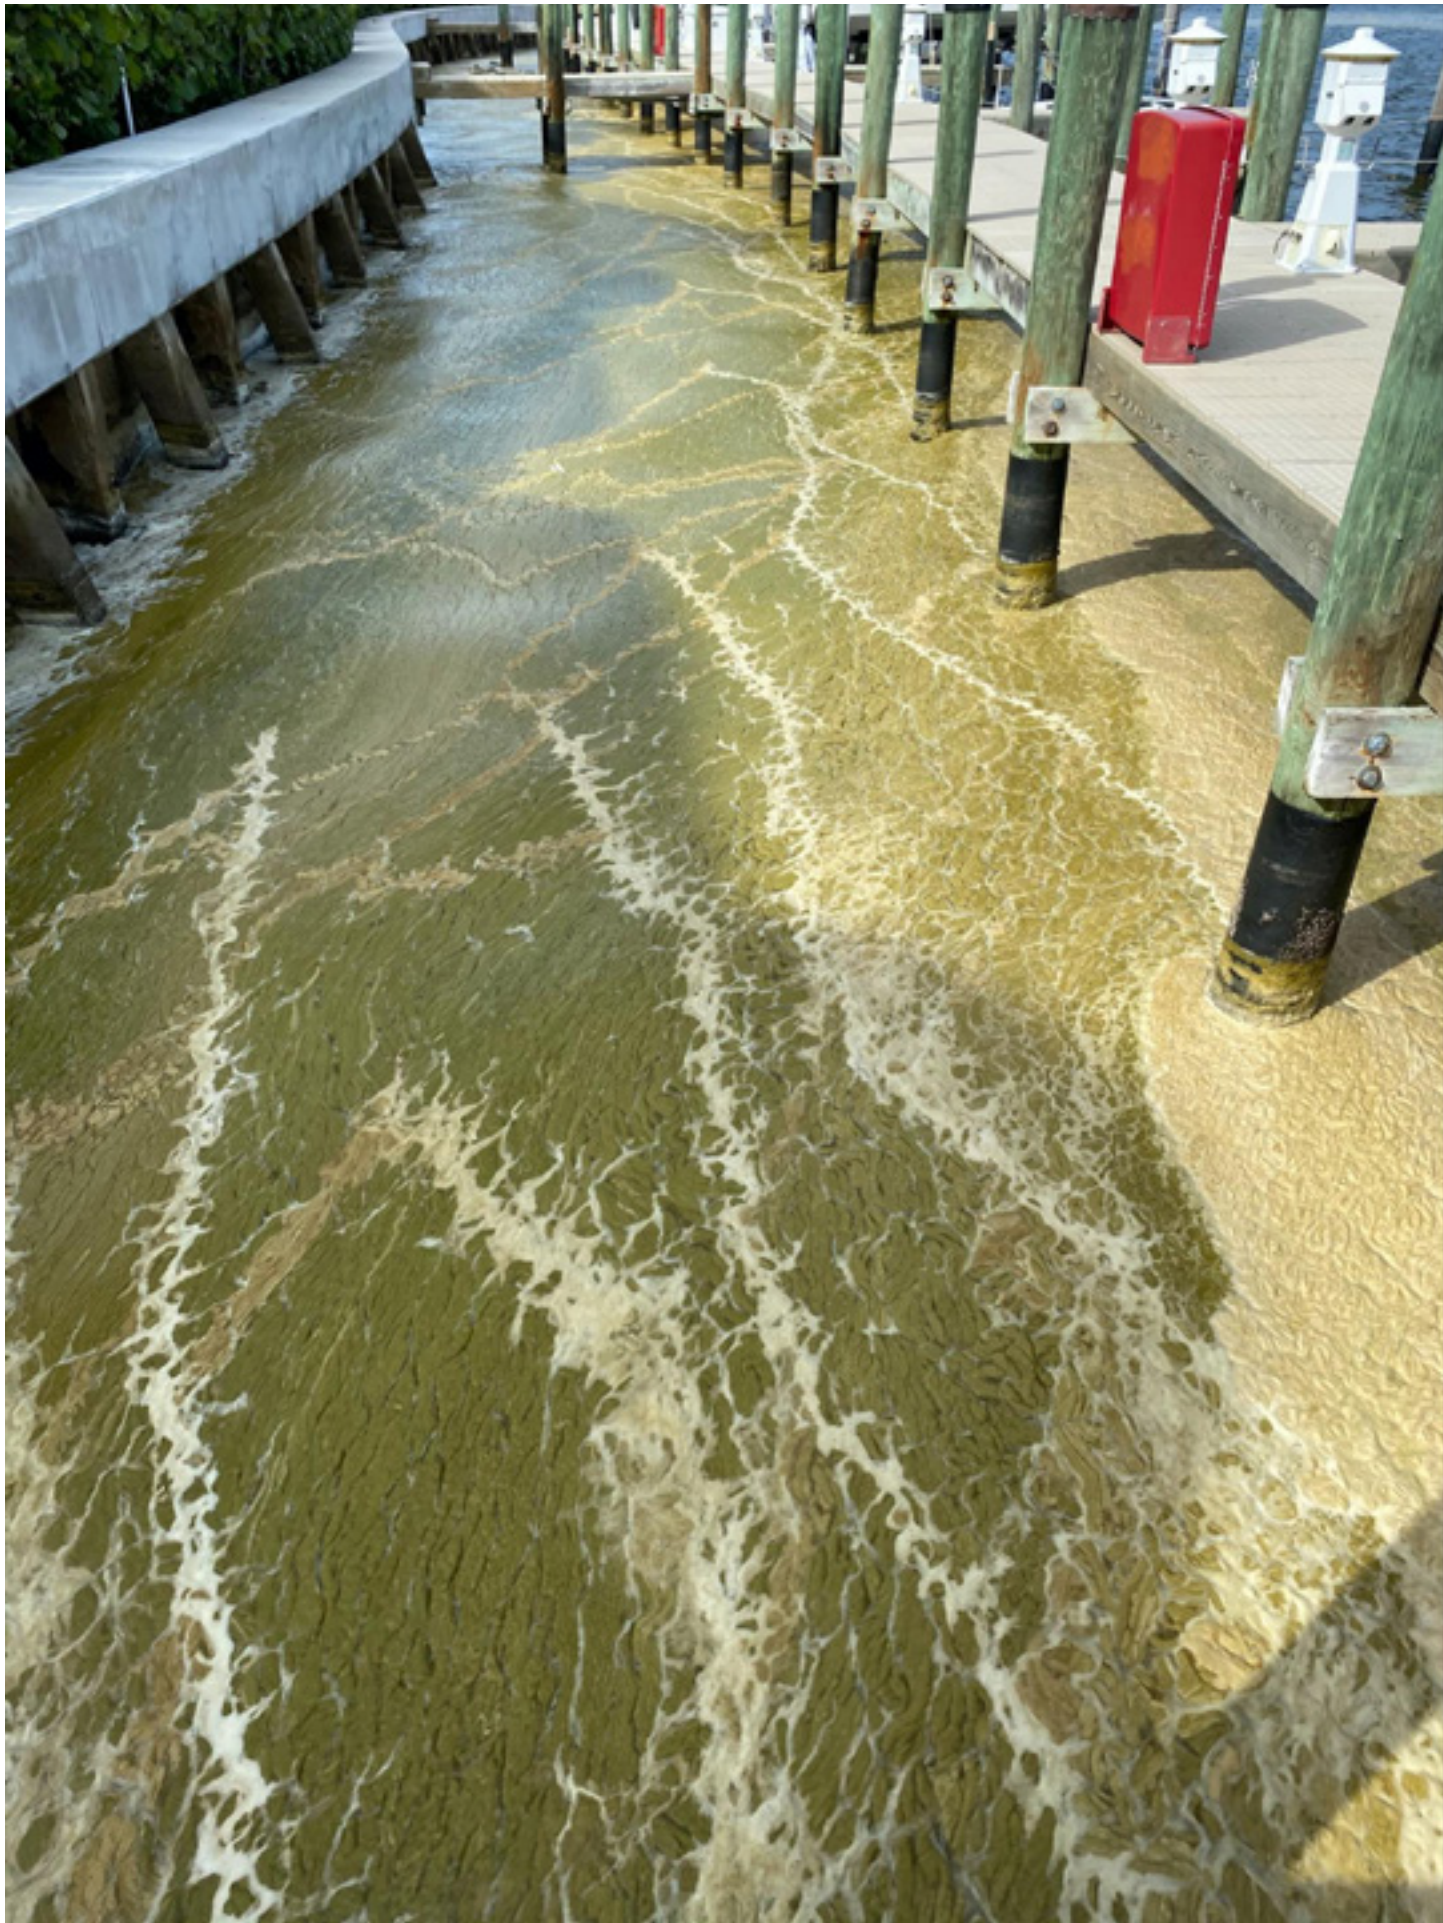
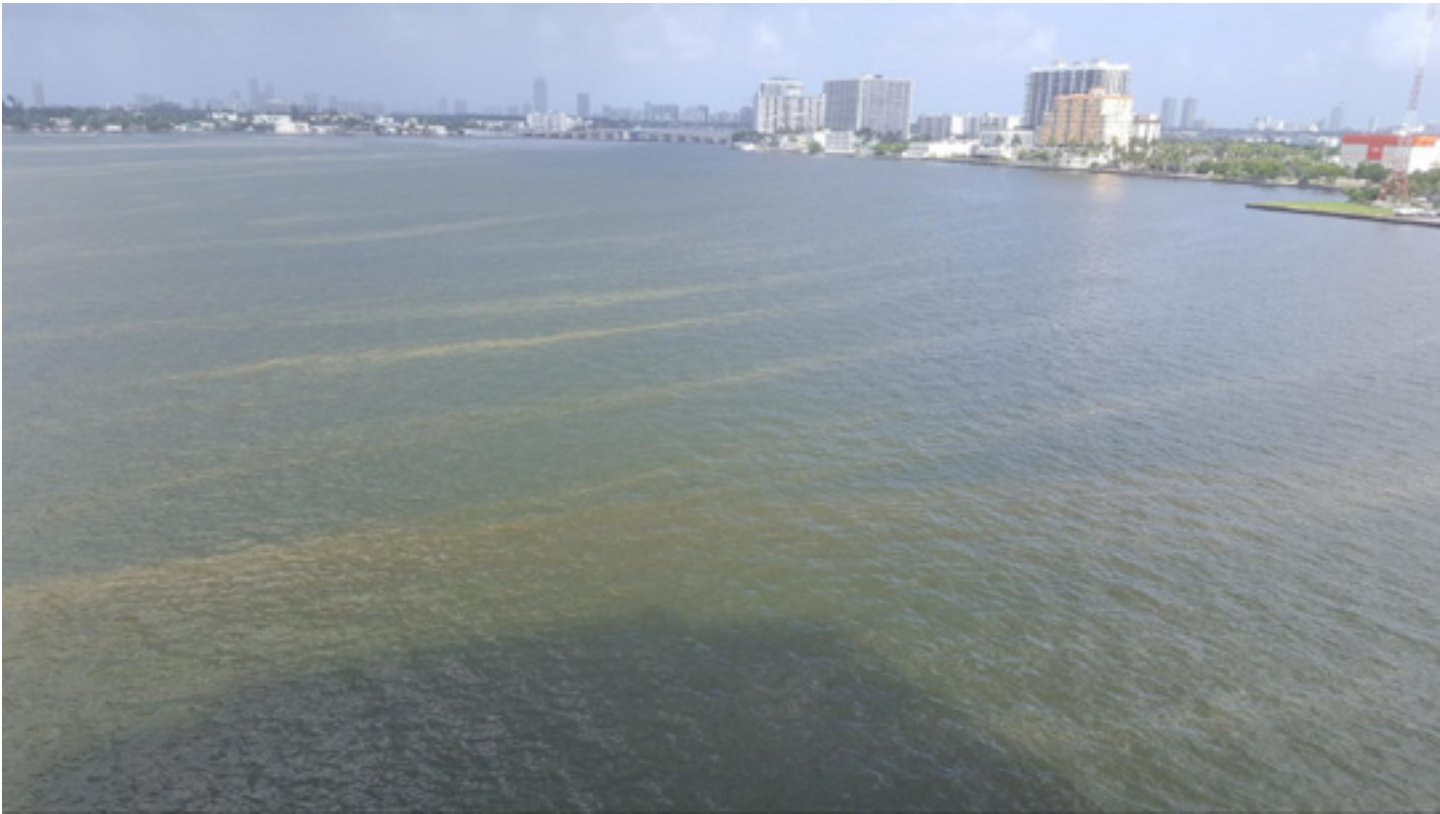
Figure 19. A) (left) Thick algae mat at 12000 N Bayshore Drive on August 21, 2020. Photo Credit: Adam Cohen. B) (above) Algae pictured East of Harbour Island on August 21, 2020. Photo Credit: Denise O'Brien.

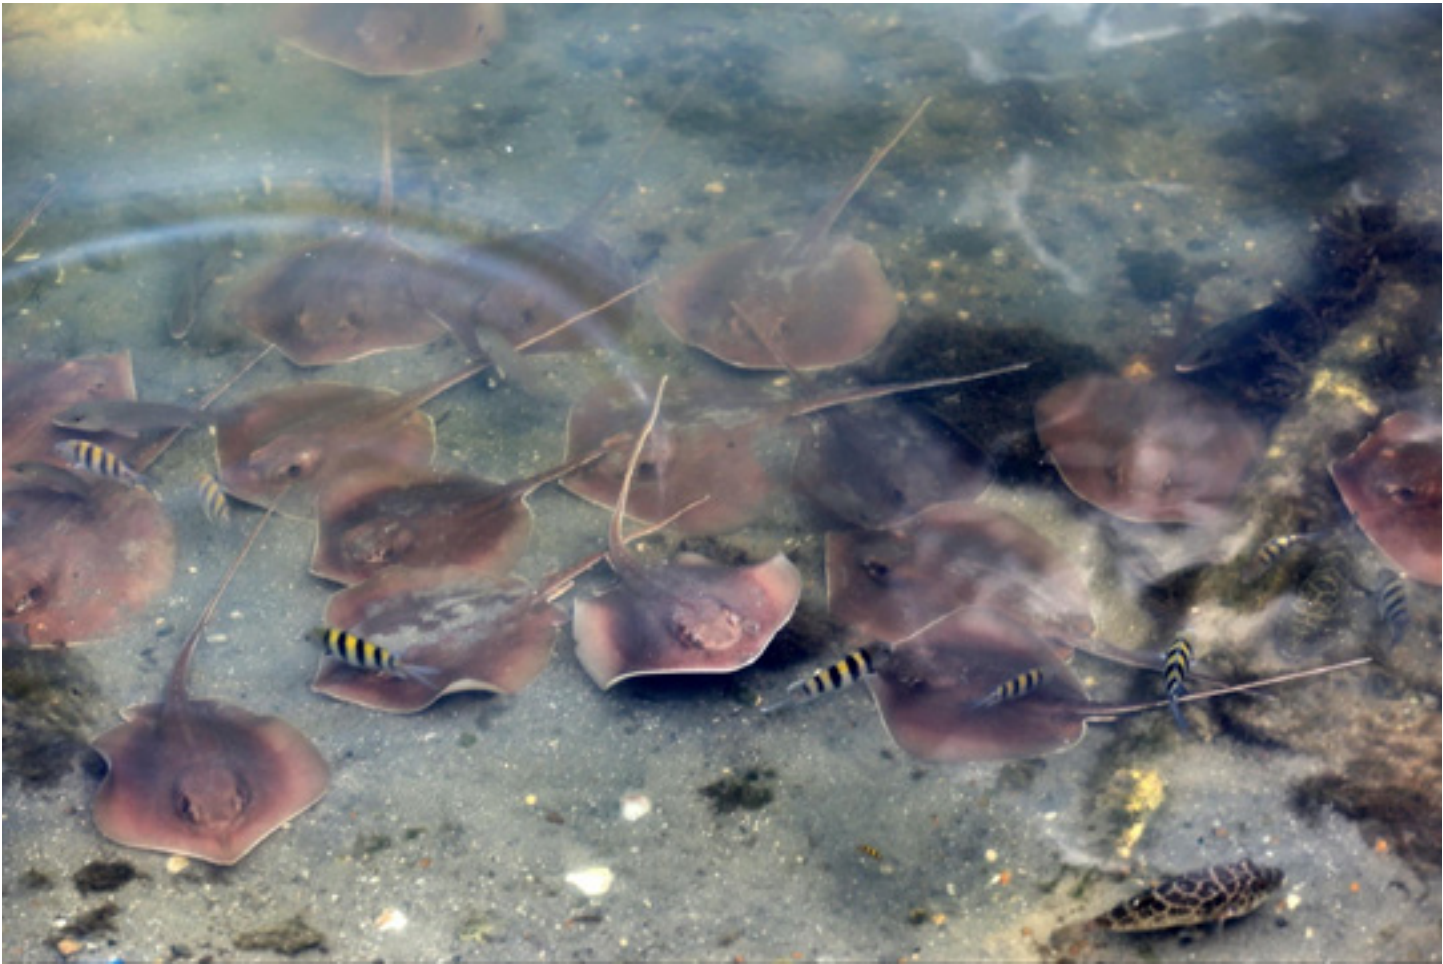
Figure 20. Congregating fishes and rays at Pelican Harbor on August 13, 2020, before the Phillip and Patricia Frost Museum of Science staff added aeration. Photo Credit: Logan Fazio.

Measurements (e.g., FIU, UM, Miami Waterkeeper, DERM, DEP) found low DO, specifically near Pelican Harbor/79th Street Causeway and the Little River/Belle Meade area during the fish kill event. Fishes, especially skates and pufferfishes, were observed to be congregating at the surface, exhibiting abnormal behavior, and struggling to breathe at Pelican Harbor, Morningside Park, Albert Pallot Park, and Margaret Pace Park. The fishes were at the shoreline and their behaviors were described as “gasping” (Figure 20).

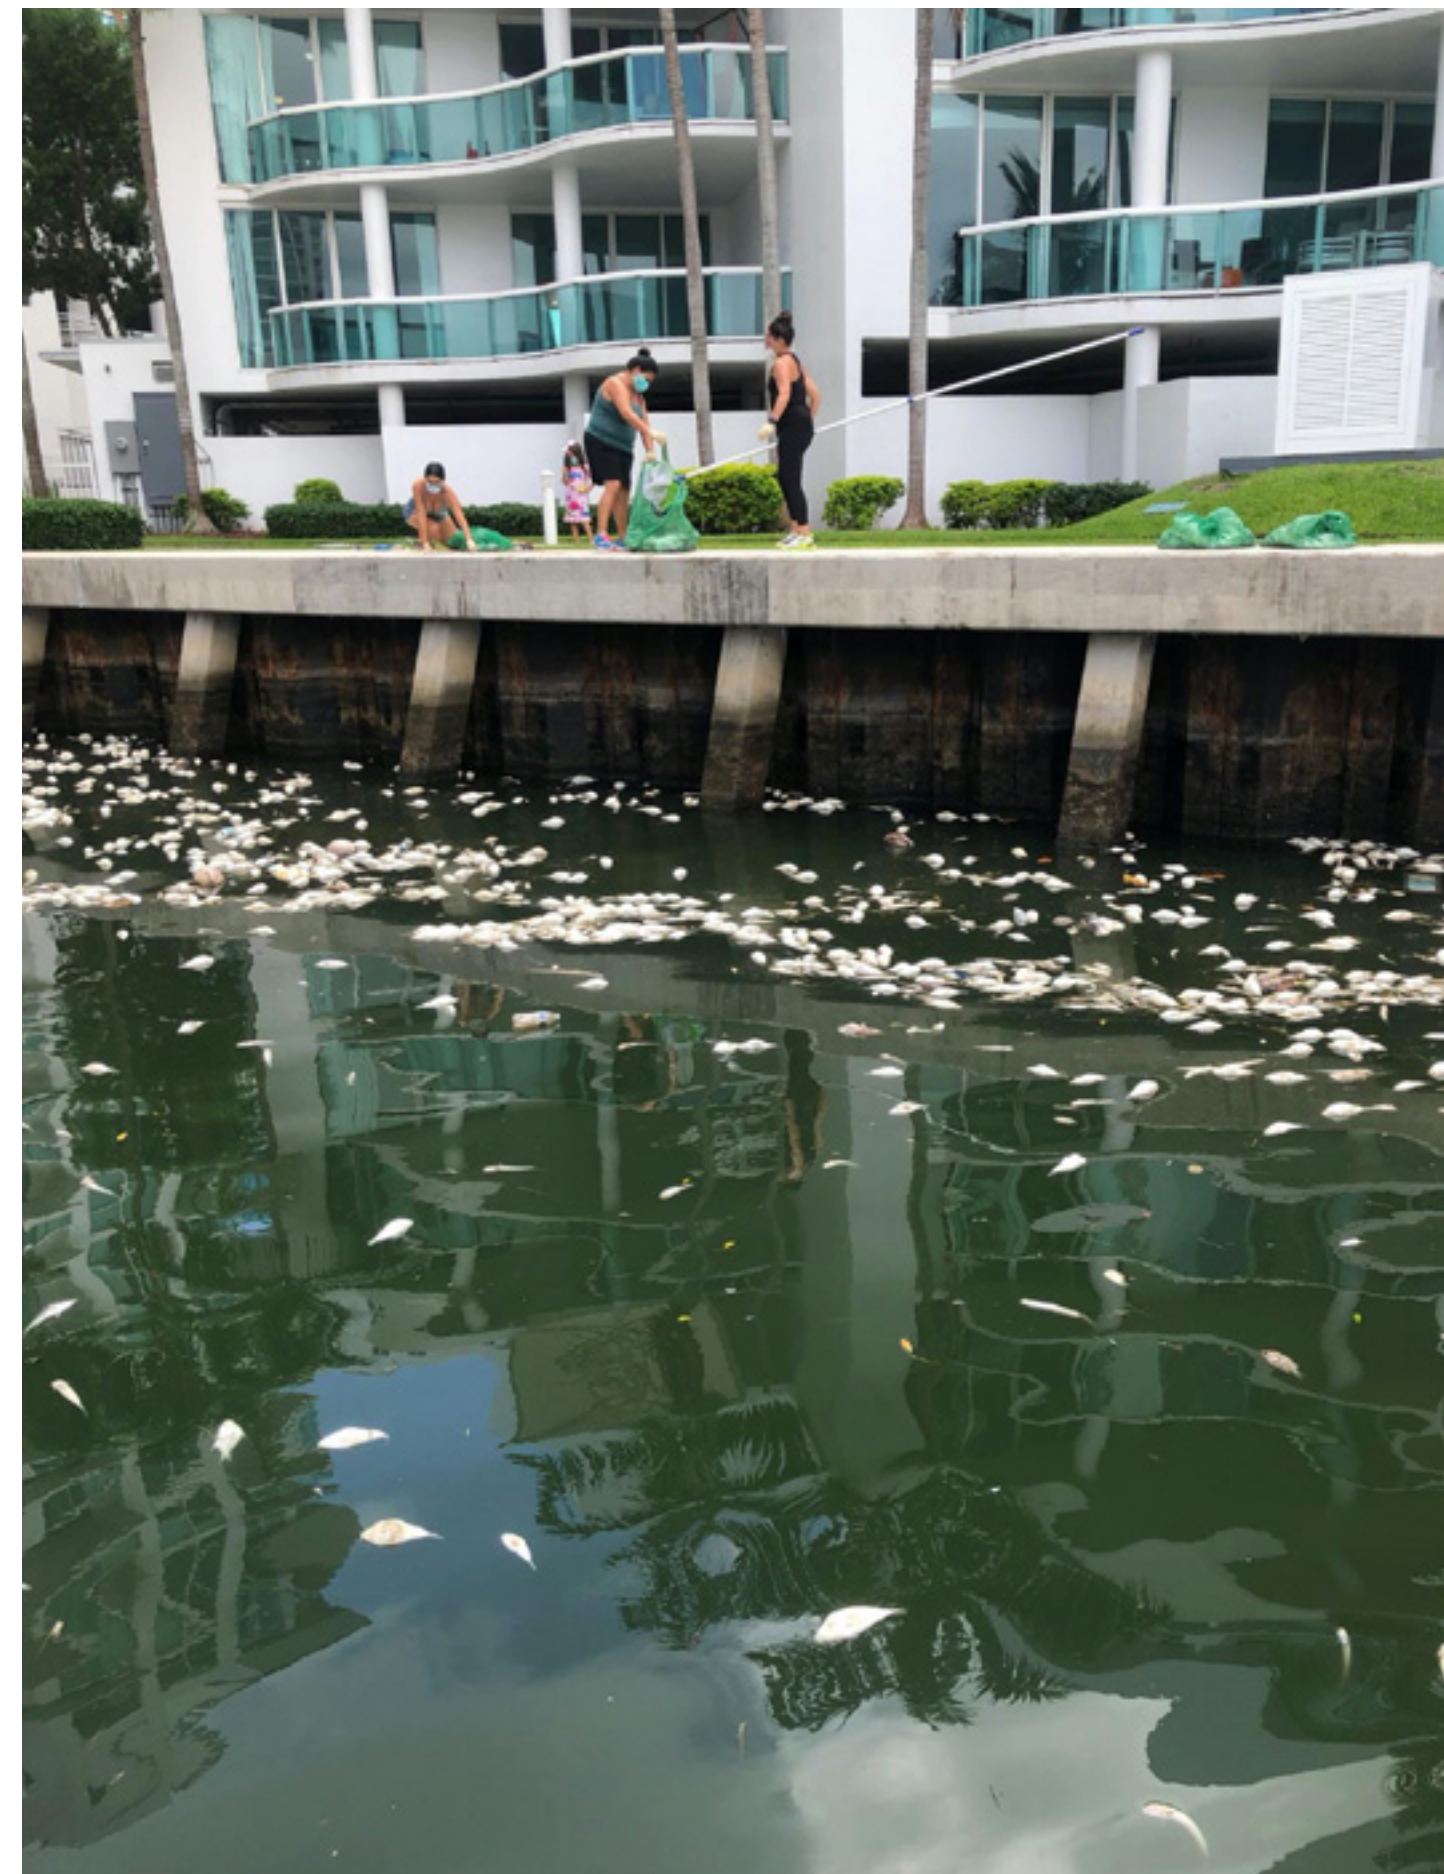
Figure 23. Members of the public volunteering to clean up dead fish from the Bay. Photo Credit: Cody Eggenberger.

Animal carcasses began to gather on the shorelines and decompose, further exacerbating water quality problems. Dozens of members of the public volunteered to clean up fish at accessible areas and by kayak and paddleboard (Figure 23). The City of Miami's Scavenger vessel also assisted in removing floating fish carcasses

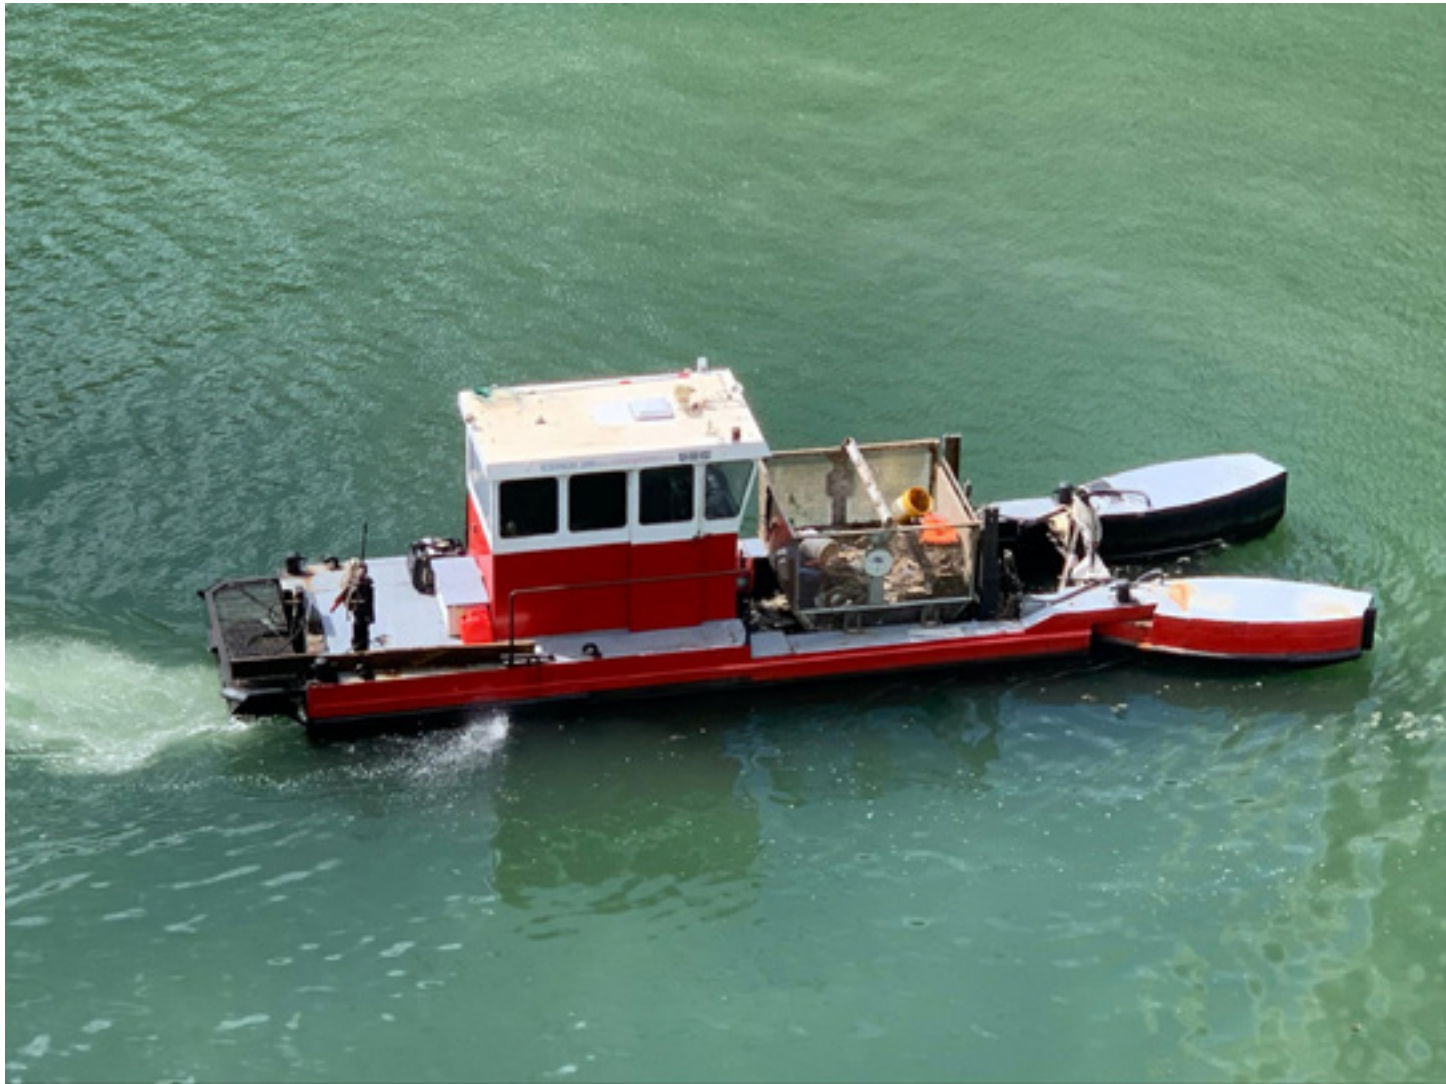
Figure 24. The City of Miami's contracted scavenger vessel removing floating fish carcasses on August 17. Photo Credit: Kathryn Angleton.

The City of Miami also deployed their contracted Scavenger vessel along their shoreline to both clean up fish carcasses and to aerate the water (Figure 24). The Scavenger was concentrated near the Brickell area and near Albert Pallo Park.
