# FISH KILL IN BISCAYNE BAY: A REPORT

MIAMI  
WATERKEEPER

# SCIENTIFIC AND TECHNICAL FISH KILL DATA AND OBSERVATIONS

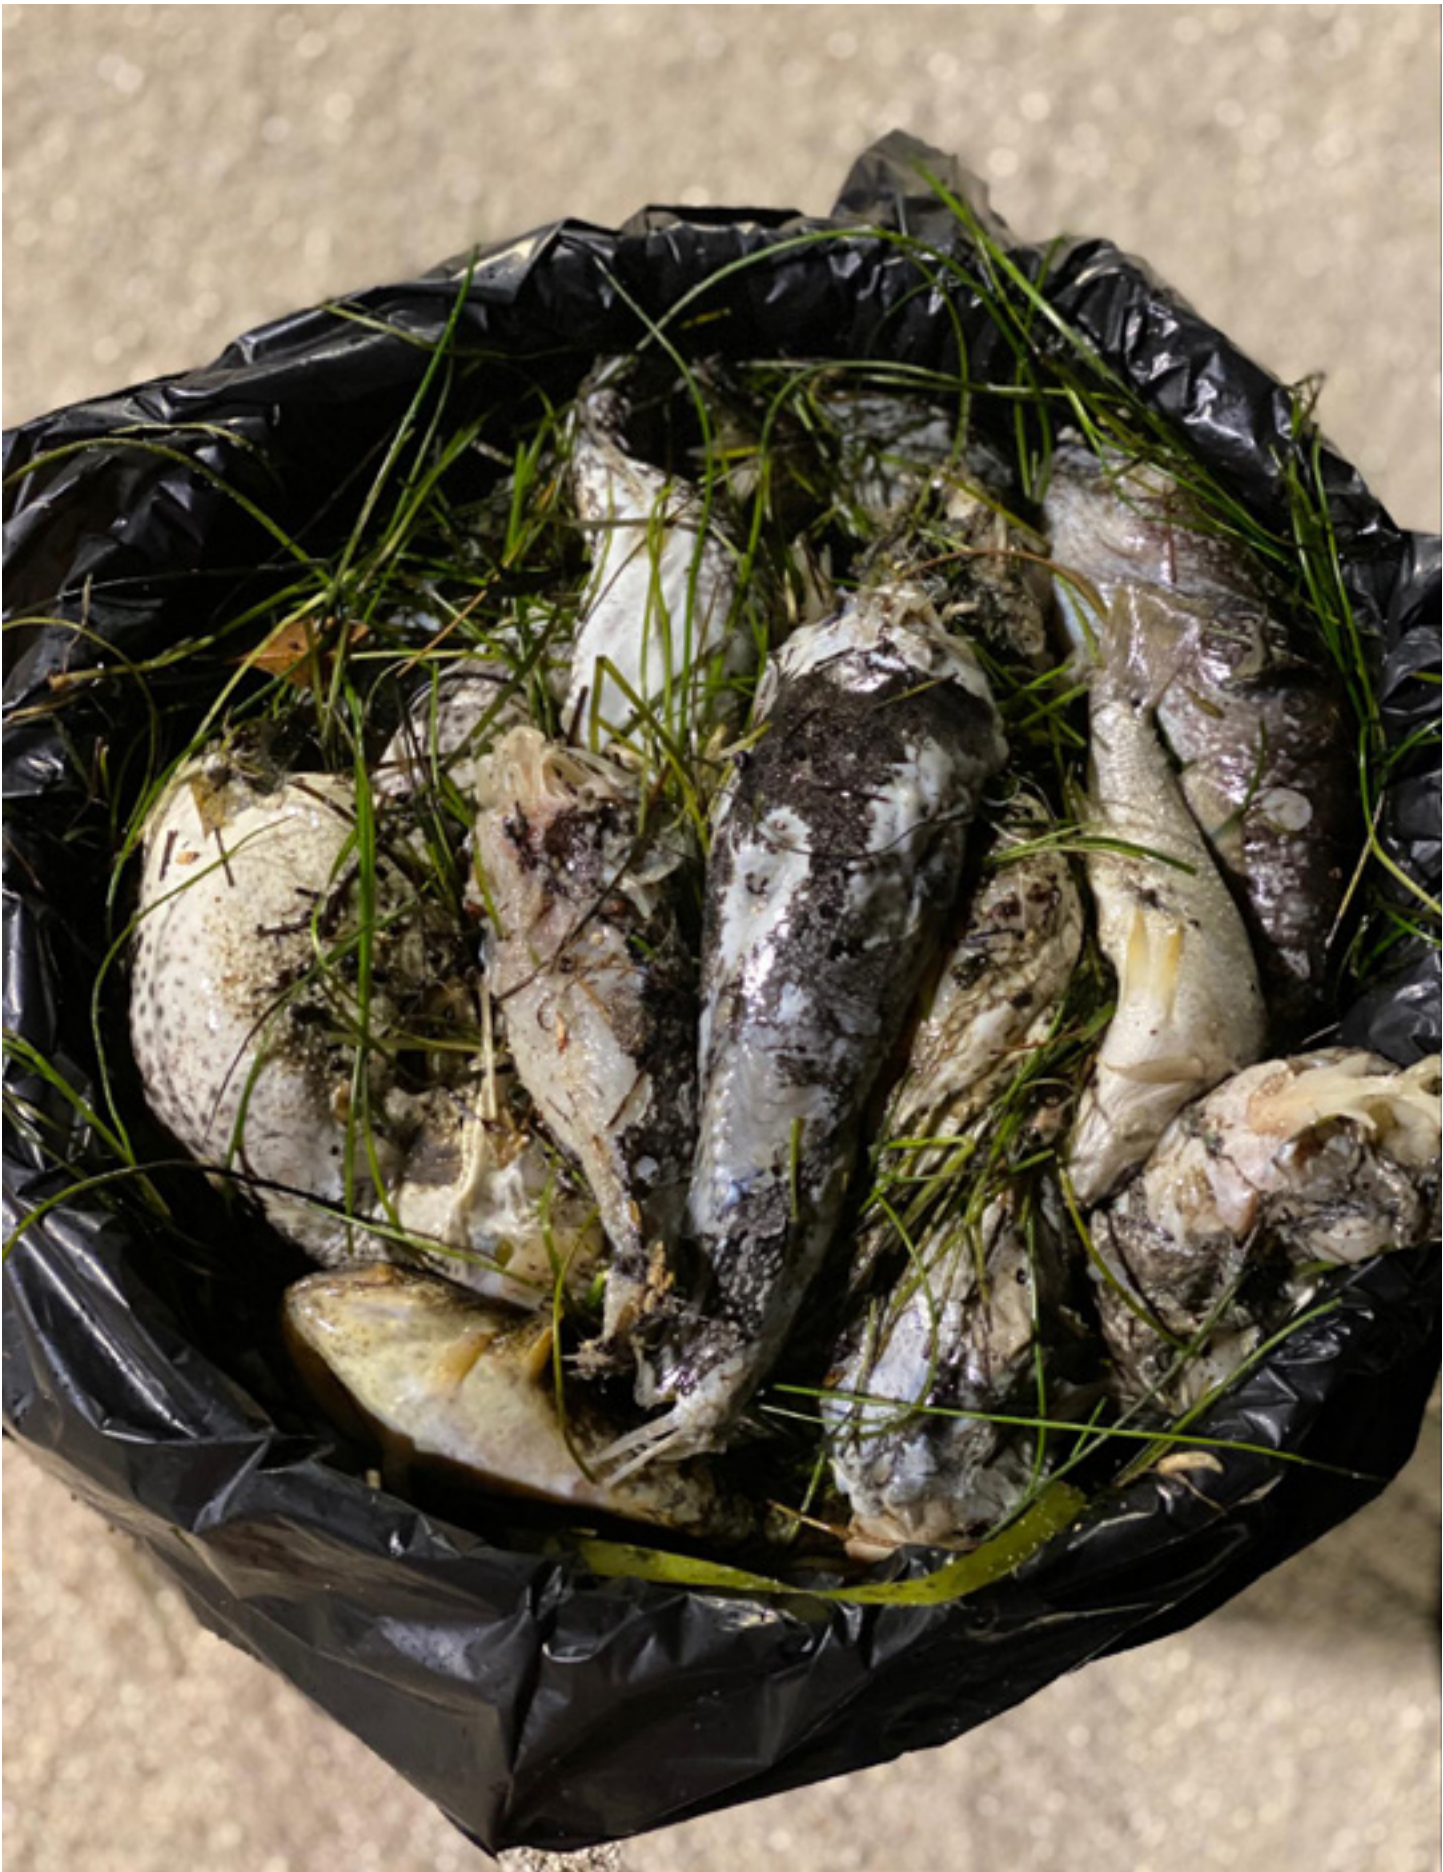
Figure 25. A trash bag filled with dead and decaying fish resulting from the fish kill event.

(Figure 24). Miami Waterkeeper collaborated with Fertile Earth Worm Farm and the City of Miami to coordinate composting the decaying fish. Designated compost bins were placed at Morningside Park, Albert Pallot Park, and Margaret Pace Park to further clean up efforts (Figure 25).

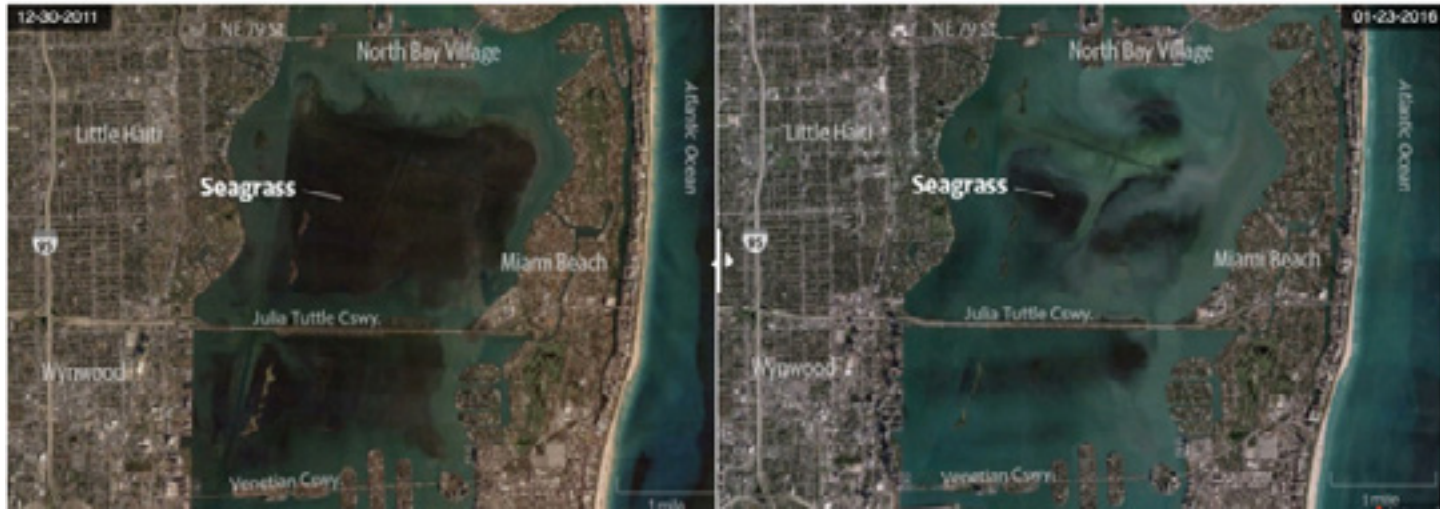
Figure 27. Areas of seagrass loss observed between December 30, 2011, and January 23, 2016. (via Google Earth).
