Local Catastrophe

The Starrigavan Valley Landslide

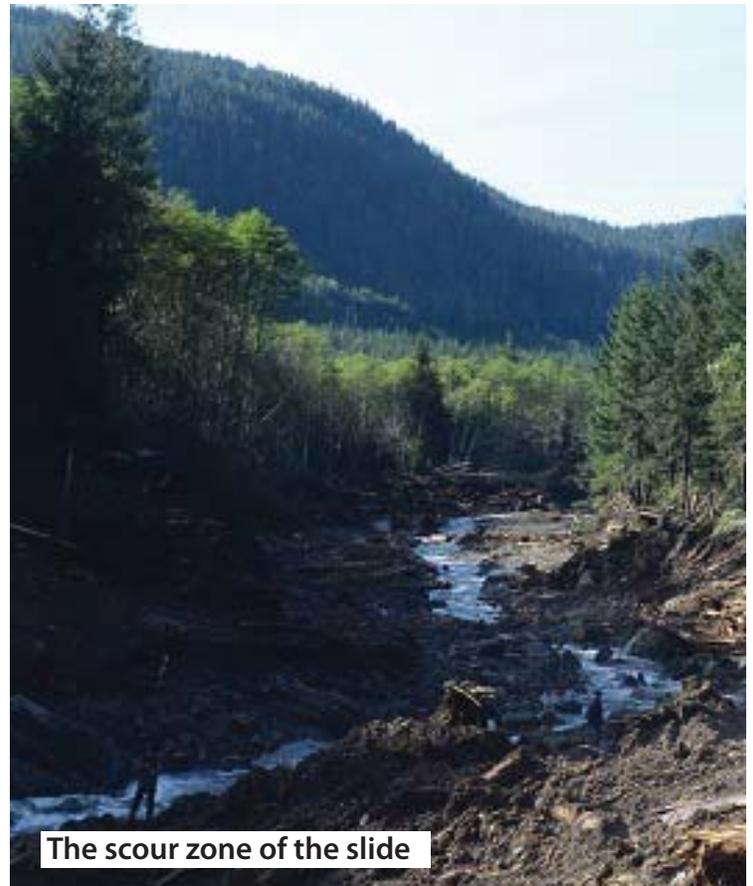
The scour zone of the slide
