WALK2TRANSIT: BETTER BUS STOPS

BY SUSTAIN CHARLOTTE

Walk2Transit is Sustain Charlotte's project that gives transit riders a voice.

Throughout 2017, more than 250 volunteer participants helped collect observations around some of Charlotte's least walkable bus stops.

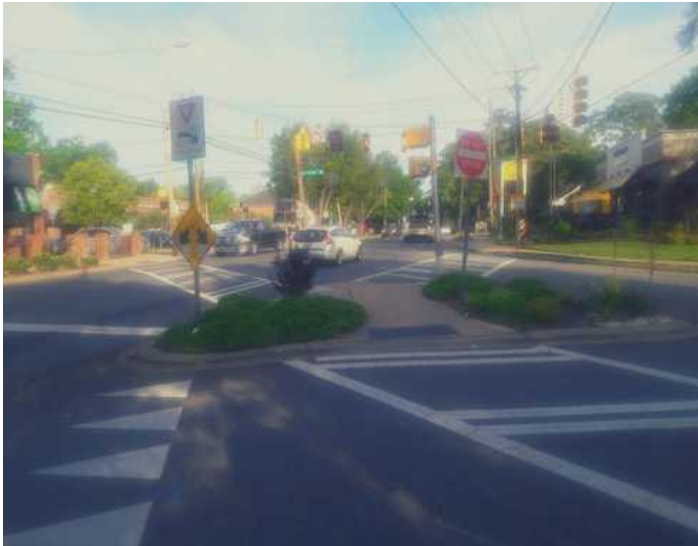
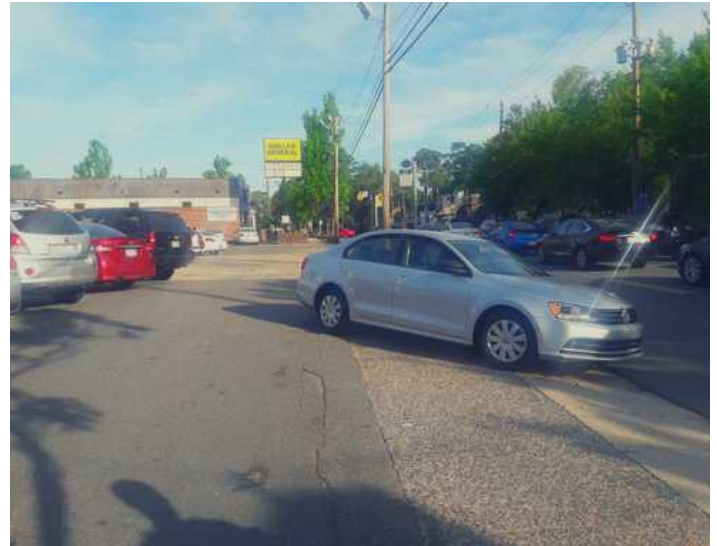
E SEVENTH ST NEAR BASCOM ST

*A pedestrian refuge island (left) made participants feel safe at E 7th, Pecan & N Caswell.
Bus stops on E Seventh St overlapped with parking lots (right).*

E Seventh St is difficult for pedestrians to safely cross, particularly at rush hour. There are bus stops near N Dotger Ave, but the spacing of traffic and poor lines of visibility often results in a long wait to cross four lanes with no median. Even at a marked crosswalk with bright yellow signage to alert drivers to pedestrian activity, few drivers yielded to participants as they waited to cross Seventh St. Along the northern side of Seventh St, several areas have parking lots without clear delineation from sidewalks.

More pedestrian crossings across E Seventh are needed to give safe access to and from bus stops.

Better bus stops should be built on the northern side of E Seventh when redevelopment occurs so waiting areas for transit riders are buffered from traffic.

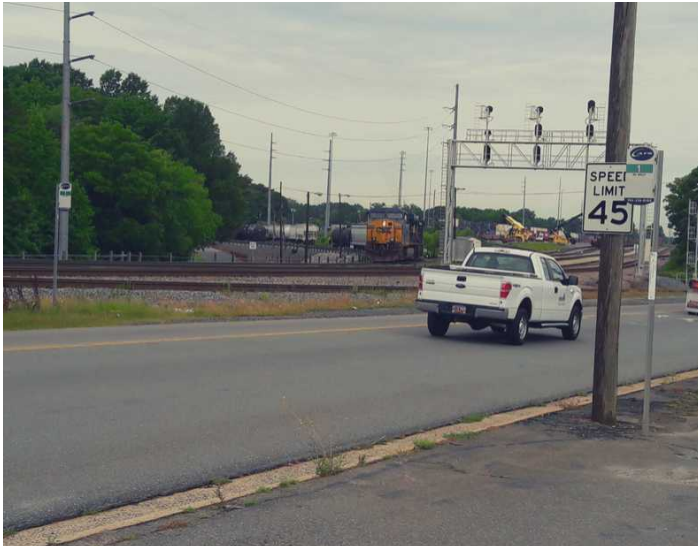
ROZZELLES FERRY RD NEAR S HOSKINS RD

Bus stops adjacent to the roadway and freight rail tracks were uncomfortable for participants (left). Cracked, narrow back-of-curb sidewalks and long sidewalk gaps were abundant (right).

The low availability of sidewalks rose to the top of participants' observations in this area. Many sidewalk panels are badly cracked and/or uneven. Large portions of the eastern side of Rozzelles Ferry Rd lack sidewalks. The western side of Rozzelles Ferry Rd has a bus stop with a waiting area uncomfortably close to freight rail tracks. With only two lanes of traffic on Rozzelles Ferry, crossing the street was not too difficult. However, some of the pedestrian crossing paint is worn out.

Due to the poor condition of sidewalk panels and several blocks of missing sidewalk, this area's narrow back-of-curb sidewalks should be replaced with **continuous wider sidewalks with planting strips**.

Recognizing the need to provide bus stops on the western side of Rozzelles Ferry Rd and also meet railroad right-of-way requirements, we encourage the **city to work with the railroads to provide a more comfortable bus stop for transit riders** waiting at these inbound stops just yards from the tracks.

Worn crosswalk and pedestrian marking paint needs to be re-striped to help increase visibility of crossings.

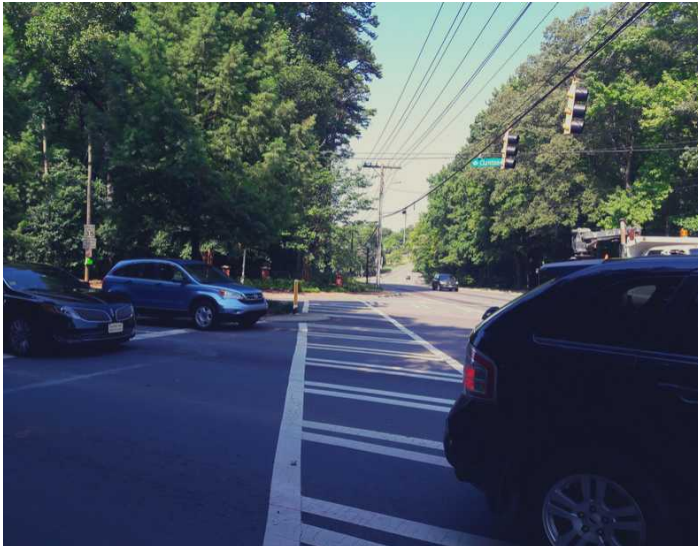
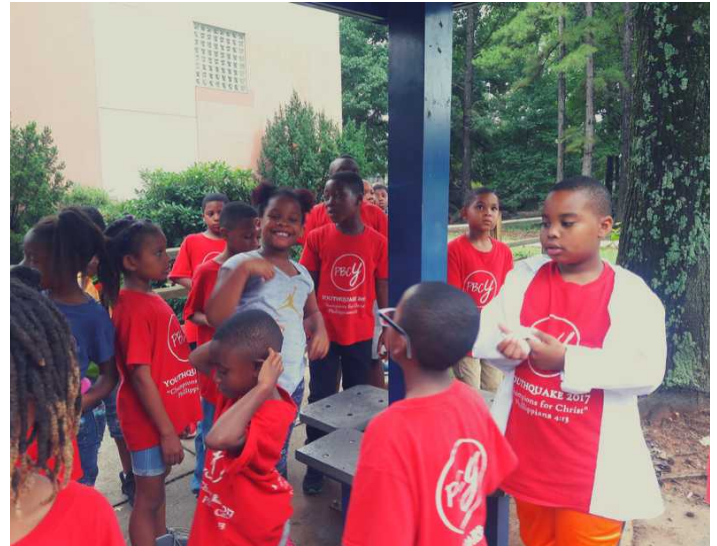
CLANTON RD NEAR WEST BLVD

Even with a crosswalk, the intersection at Clanton Rd and West Blvd felt uncomfortably wide (left). The young participants loved the amenities at the bus stop near the Arbor Glen Rec Center (right).

Pedestrian refuge islands and painted crosswalks on Clanton Rd have made it more comfortable for pedestrians to cross. But the narrow back-of-curb sidewalks combined with encroaching vegetation and organic litter make it very difficult for two people to walk side-by-side. Participants liked the availability of seating and shelter at the bus stop near the Arbor Glen Rec Center, and noted the contrast between this comfortable stop and others nearby that have only sign poles.

More crossings and additional benches and shelters at the bus stops on Clanton Rd would improve these stops.

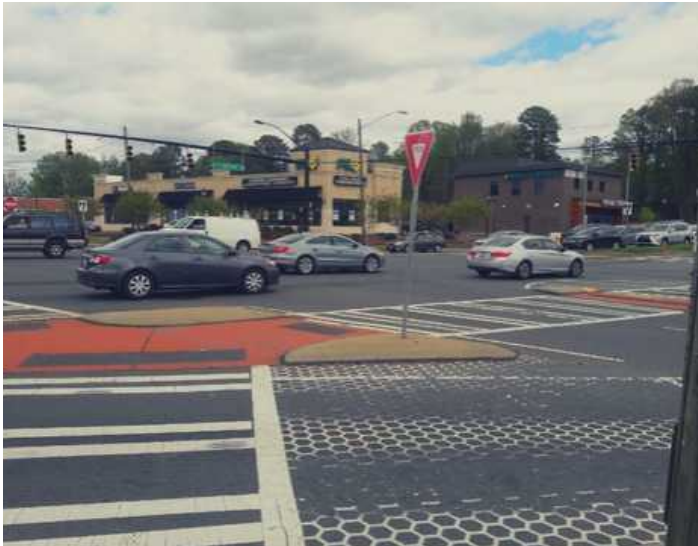
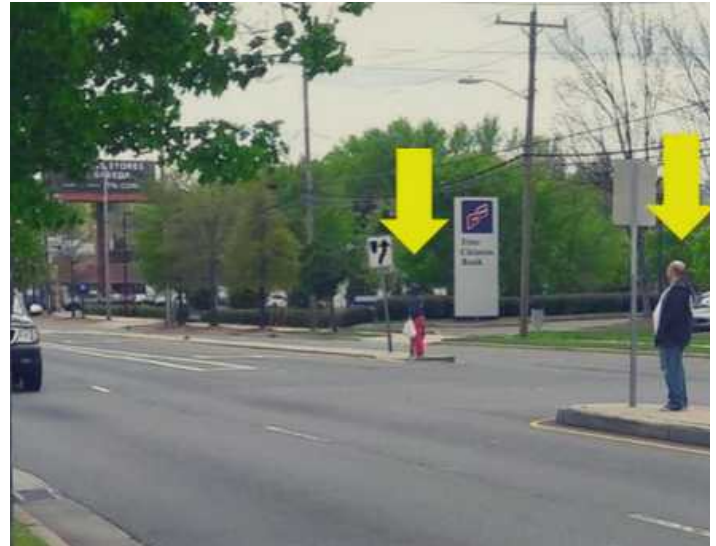
SOUTH BLVD NEAR TYVOLA STATION

*Pedestrian refuge islands (left) made participants feel safer.
We saw several pedestrians crossing South Blvd at Grover (right, marked by arrows).*

The most urgent need is for better pedestrian access across South Blvd adjacent to the Tyvola LYNX station at Grover St. There is no marked crosswalk here, yet numerous pedestrians cross South Blvd by crossing two lanes of traffic at a time, then pausing in the raised median before completing their crossing. No pedestrians were observed walking north to cross at the nearest signalized intersection at Tyvola Rd and South Blvd. At the intersection of Old Pineville Rd and Tyvola Rd, turning drivers were failing to yield to pedestrians.

CDOT is planning to add a **pedestrian crossing at Grover St** to help people safely navigate South Blvd. We support the timely construction of this crossing.

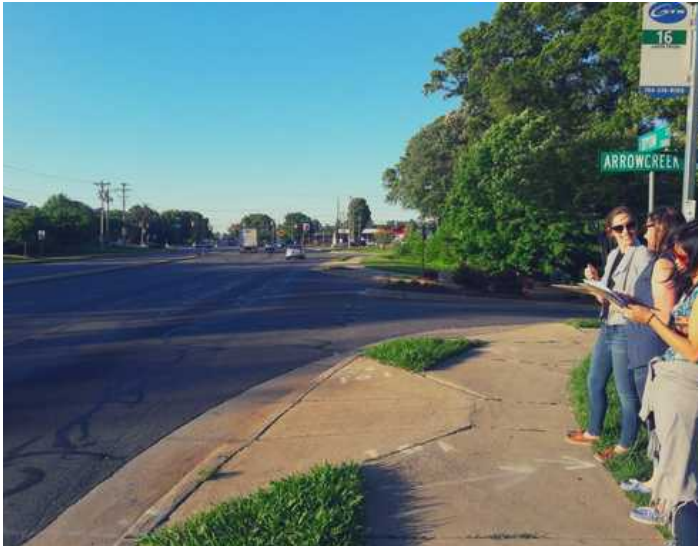
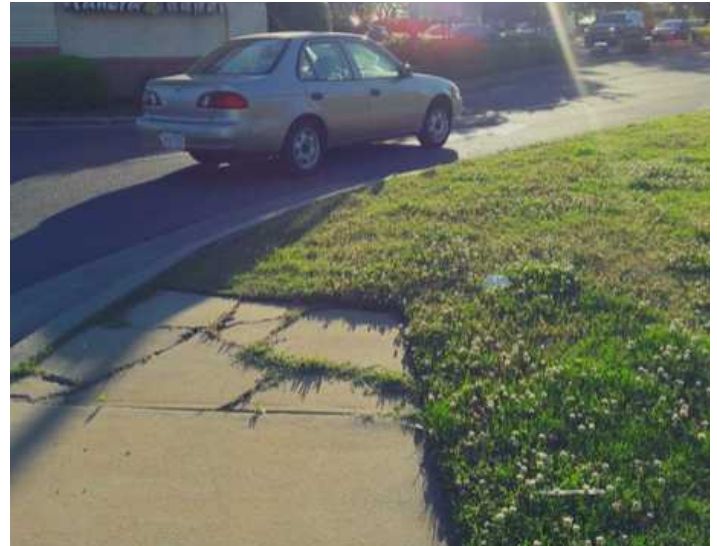
SOUTH TRYON NEAR W ARROWOOD RD

Speeding traffic and few crossings made South Tryon uncomfortable for participants (left). Disjointed sidewalks in this shopping center made it hard to access bus stops on foot (right).

The most urgent need is for better pedestrian access across S Tryon St and for safer major intersections. Participants observed a high incidence of speeding. This is particularly problematic because there are 4 lanes of traffic with not even a raised median to help pedestrians cross. Traffic signals north of W Arrowood Rd are widely spaced and there are bus stops on both sides of S Tryon St without crossing opportunities. Participants observed a bus rider run across four lanes of traffic after disembarking at a southbound stop.

The popularity of several large anchor stores at Whitehall Commons has resulted in increased vehicular traffic. We are aware that the shopping center is outside of CDOT's jurisdiction, but note that participants found it hard to walk through it due to disjointed sidewalks and no crosswalks.

Several **pedestrian refuge islands are recommended to improve safety of people crossing S Tryon north of W Arrowood Rd.** We support the timely funding and construction of these crossings.

Intersection improvements at W Arrowood and S Tryon, and at Whitehall Commons and S Tryon are recommended to prioritize pedestrian safety and remedy unsafe turning by drivers.

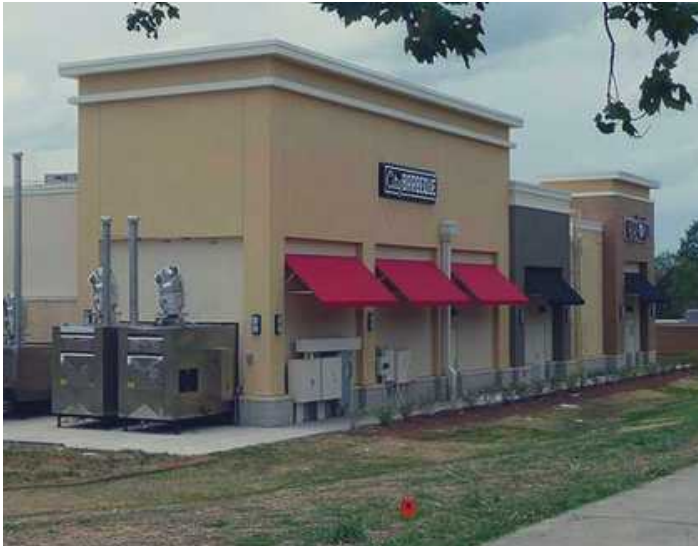
*Uninviting backs of buildings and mechanical equipment face the Blue Line at JW Clay Station. (left; photo by Martin Zimmerman via Charlotte Agenda) .
Will better transit access reduce the need to build expensive parking decks on campus? (right)*

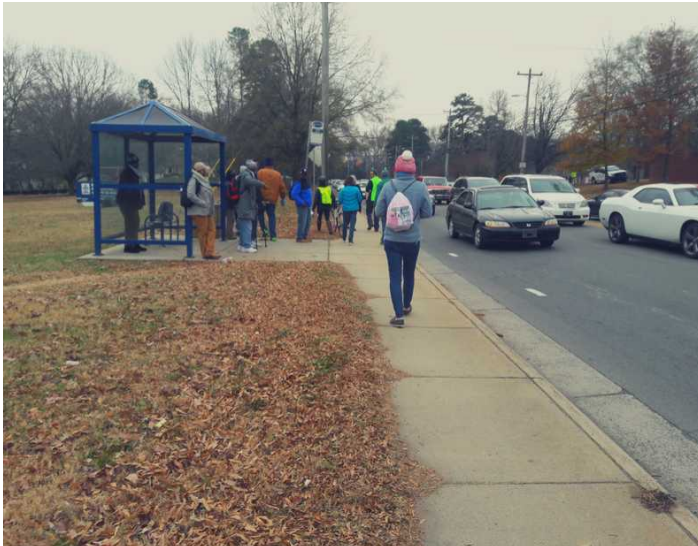
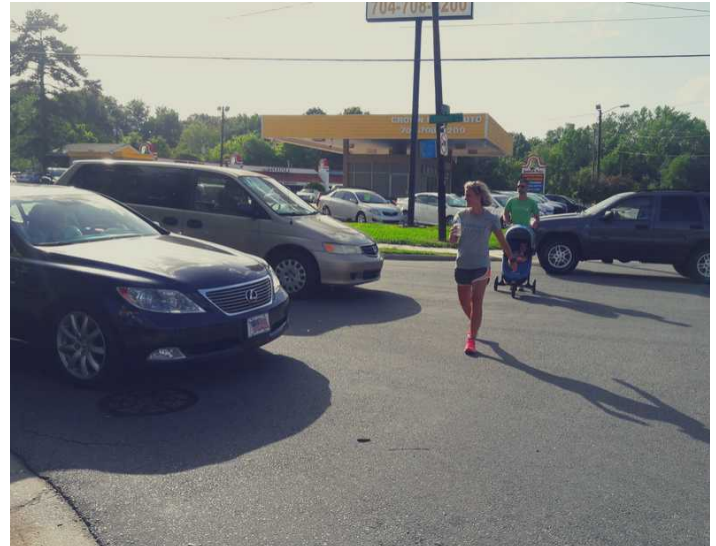
MONROE RD: EAST MECK HIGH SCHOOL TO SARDIS RD N

Many students used this bus stop near East Meck High School (left). With 5 lanes of traffic and few marked crosswalks, pedestrians lack choices for crossing busy Monroe Rd (right).

The most urgent need is for better pedestrian access across Monroe Rd. The corridor has four to five lanes and few signalized crossings. There is also a lack of pedestrian refuge islands. Participants observed some drivers misusing a center turning lane at the southern part of the audit area by driving in it for too long instead of making turns properly. Narrow back-of-curb sidewalks dominate in this area. In the residential area south of East Meck High School, there are extremely long stretches of Monroe Rd with no crossing opportunities at all.

Many more safe crossing opportunities are needed for pedestrians to travel between the bus stops and destinations on opposite sides of Monroe Rd.

Addition of **benches and shelters at the higher-ridership bus stops** would improve comfort for riders and allow them to wait farther from passing traffic.

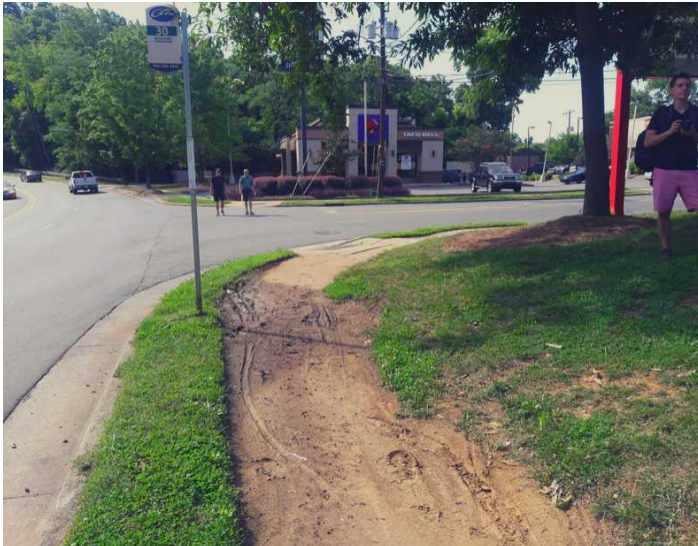
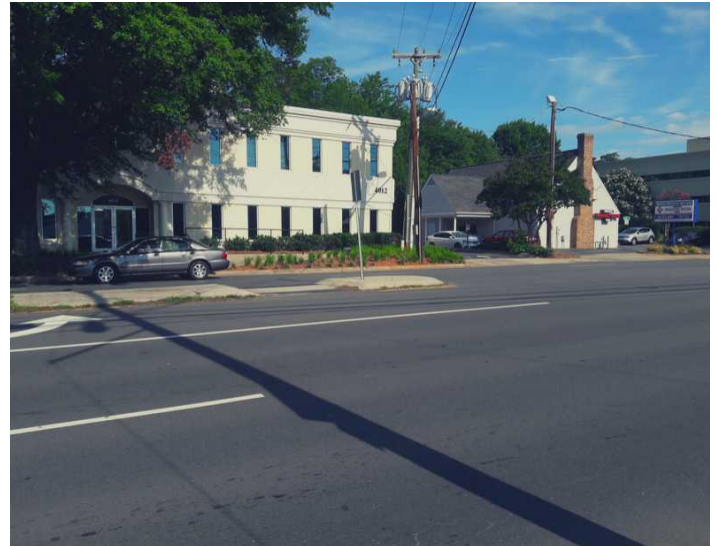
E WOODLAWN RD NEAR BRANDYWINE RD

This bus stop at E Woodlawn and Brandywine Rd needs improvement to prevent standing water (left). The pedestrian refuge on Park Rd near Holmes Dr makes it safer to cross to the shopping center (right).

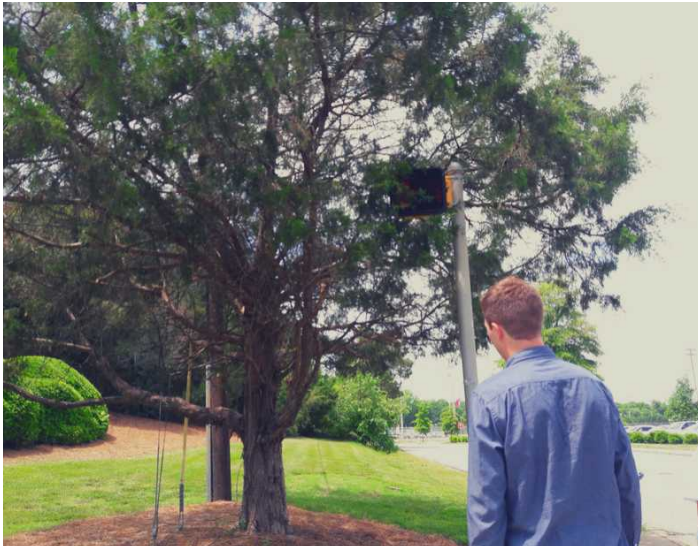
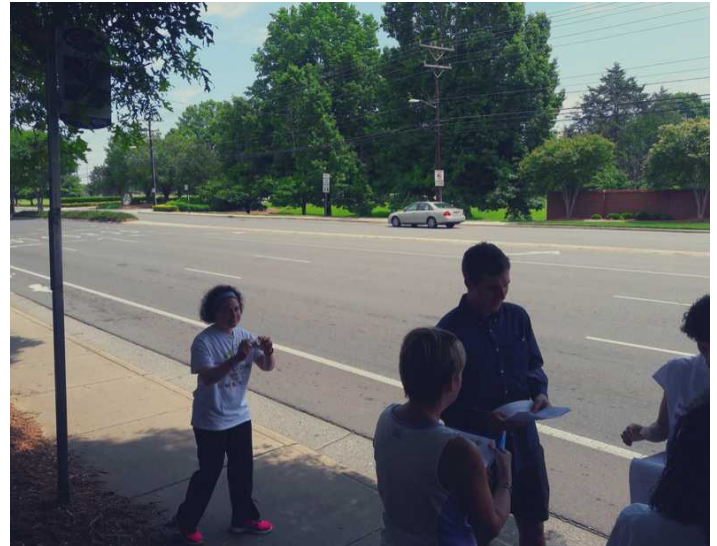
PARK RD NEAR SOUTH MECK HIGH SCHOOL

Tree branches obscured this crossing signal (left). With turn lanes increasing Park Road's width in this area, it is not safe for pedestrians to cross outside of signalized intersections (right).

The large populations of senior adults on the east side of Park Rd and the large population of high school students on the west side present a unique challenge. Senior adults may not be able to cross safely or quickly due to limited vision, hearing, and/or mobility. A small group of students was observed darting across the four lanes of traffic far from the nearest signalized intersection. This risky crossing behavior among students is likely common. Many cars on Park Rd were clearly exceeding the 35 mph posted speed limit by at least 10 to 15 mph.

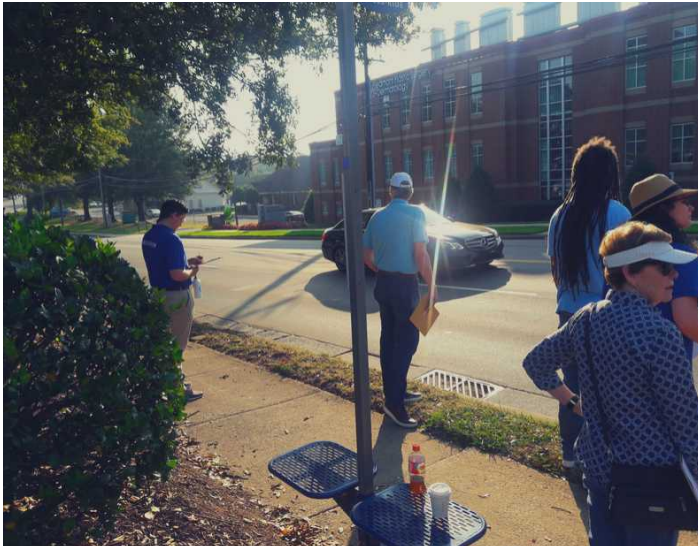
S SHARON AMITY RD AND RANDOLPH RD

Participants found it hard to cross 4 lanes of traffic with no median on S Sharon Amity Rd (left). Vegetation overhanging the sidewalk created an obstacle for pedestrians (right).

Narrow back-of-curb sidewalks should be replaced with **wider sidewalks with planting strips**.
