Rainforest logging breach report – VicForests "Granton Road" VicForests coupe 868-506-0009, Lind forest block

Date of survey: 24th March 2019 **Date of report:** 27th March 2019

Report author: Ed Hill Mapping: Owen Hanson

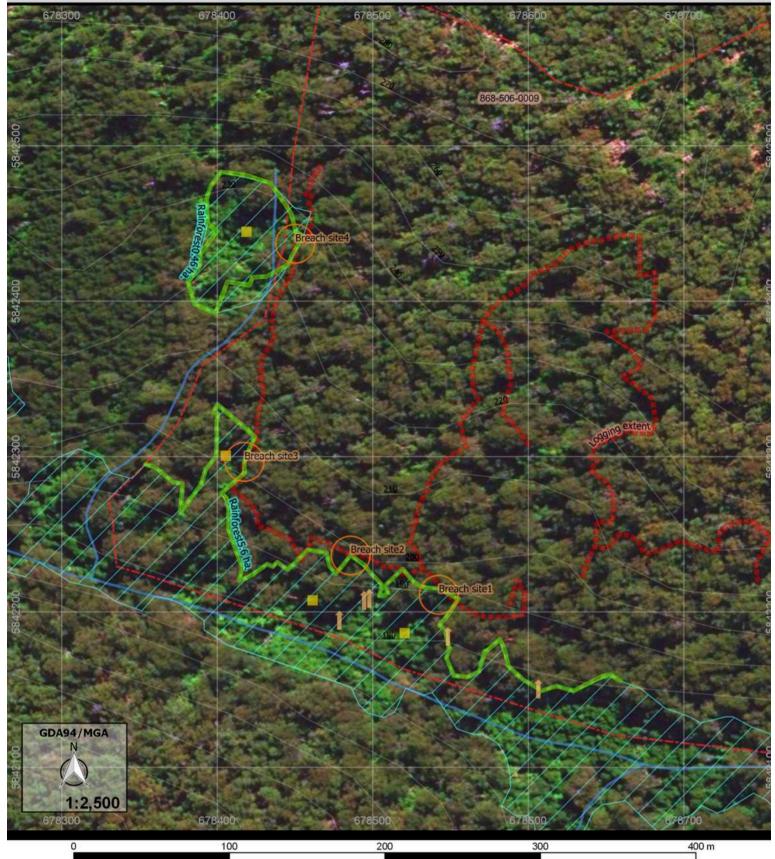
Yellow squares, to the south of breach sites one and two on the Map at figure 1, represent locations where closed canopy rainforest was noted as being contiguous with rainforest adjacent to logging disturbance and contiguous with rainforest along the watercourse bordering the southern boundary of the coupe.

Logging has occurred at the edge of and possibly within closed canopy warm temperate rainforest along a section of the southern boundary of the coupe. The red dotted line in the map at figure 1 depicts the extent of logging disturbance and follows the edge of the logged area abutting the rainforest stand.

Assessed Warm Temperate Rainforest and logging disturbance within VicForest Logging Coupe 868-506-0009. Granton Ridge trk Lind Forest Block, Cann River district.

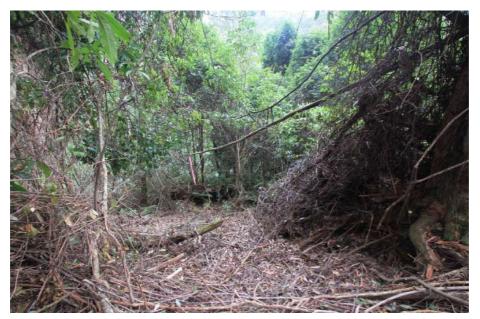
Photo (above): Logging disturbance at breach site two within required rainforest buffer on southern boundary of coupe. Note logging has occurred adjacent to rainforest canopy.

In some locations VicForests coupe boundary tapes are placed in areas dominated by rainforest species and directly adjacent to or tied to established rainforest canopy species. Placement of these tapes indicates that VicForests staff have failed to identify rainforest vegetation and DELWP staff have failed to conduct an appropriate 'rainforest spot check'

VicForests coupe boundary demarcation tapes have been incorrectly placed along this section of the southern boundary resulting in significant damage to forest directly adjacent to the rainforest stand that should have been retained within a rainforest buffer.
