POTENTIAL HAZARDOUS BUILDING MATERIALS INVENTORY

**Miller's Department Store
230 Penobscot Avenue
Millinocket, Maine 04462**

June 2016

TRC Project No: 233392

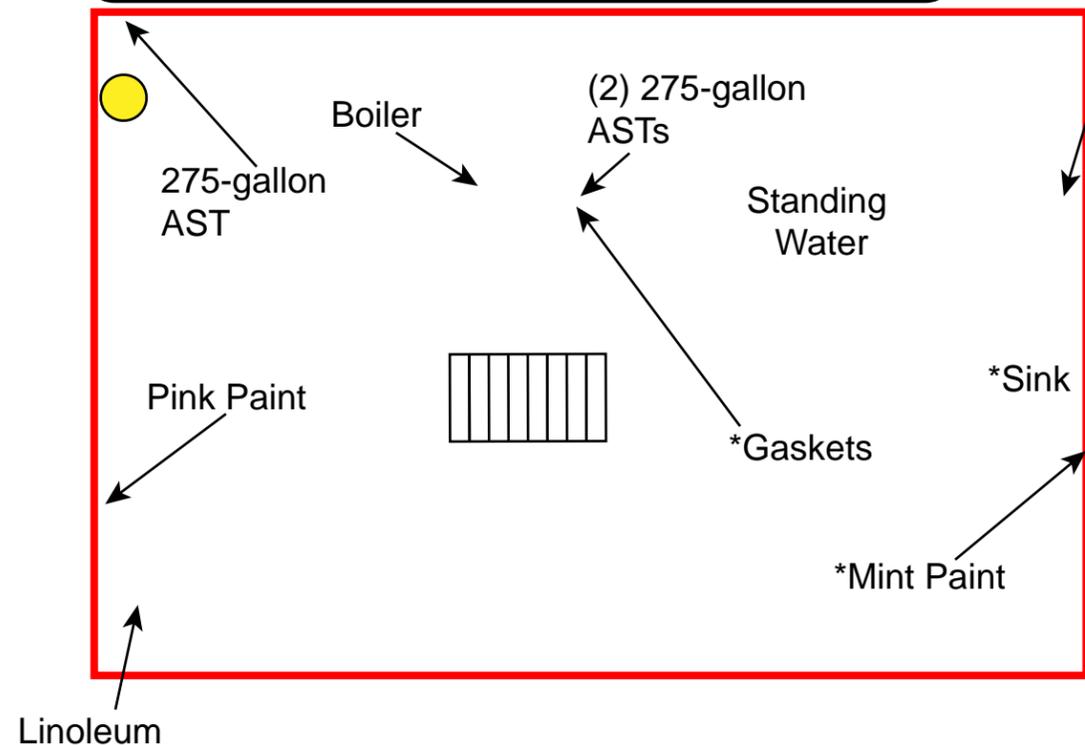
Throughout Basement:
 - Graffiti
 - Mold
 - Cans of Paint
 - Cleaning Supplies
 - Bricks / Cinder Blocks and Mortar

Piping from Possible Former AST

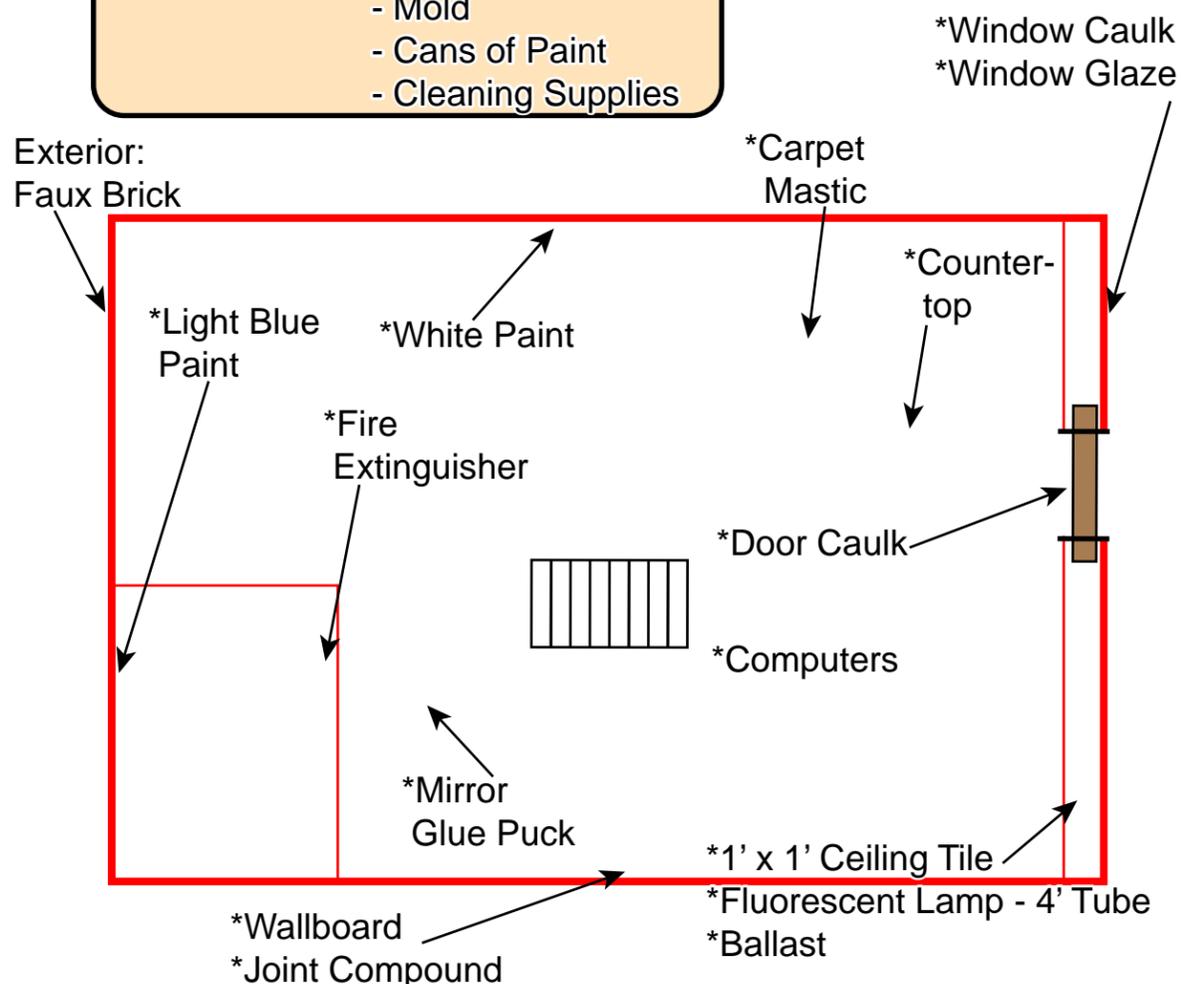
1st Floor

Throughout 1st Floor:
 - Mold
 - Cans of Paint
 - Cleaning Supplies

Exterior:
 Faux Brick
