**Mackay Conversation Group complaint – significant apparent erosion and sediment control breaches on the Adani rail corridor**

### Photographs showing lack of sediment and erosion control measures at Adani's North Galilee Basin Rail Project.

These photographs were taken between Serpentine Creek and Chainage 266, on the 6th of July 2021.

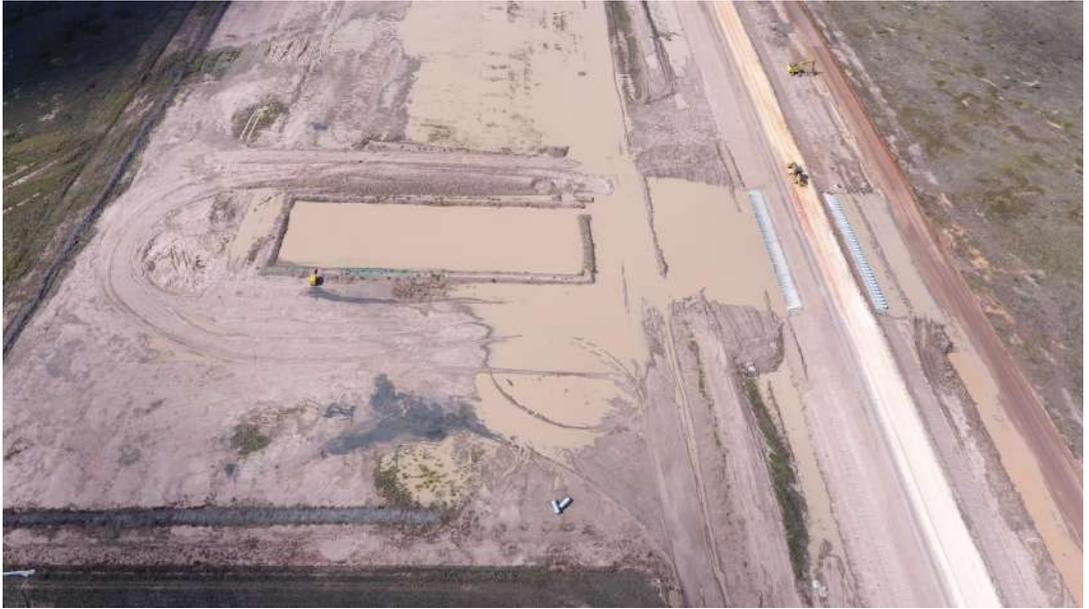
- **Images 45 and 48 (these images are the reverse of 31, 33, 34 & 35):** Again, these images show extensive ponding. There is visible damage to the bank near the excavator. No erosion or sediment control works are evident on the exits of the dams pictured. A break in the bank is evident in the top left of image 48 especially.

<p data-bbox="483 825 852 909">Looking east back towards pics 36-39 A break in the bank is evident in the top left of image 48 especially.</p>
50	541678.816	7614029.988
