Enhancing Walkability in National City's Old Town Neighborhood

This report documents the results of a workshop and walk audit conducted by WalkSanDiego on August 20, 2005, including priority issues and recommendations for pedestrian improvements in the Old Town neighborhood. Also included are WalkSanDiego's suggestions for improvements.

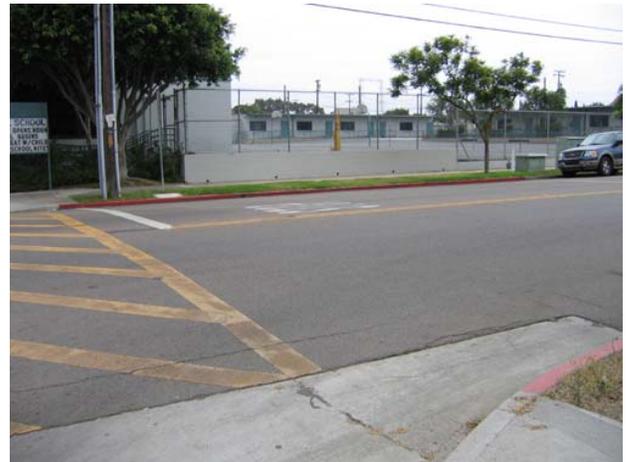
1 Kimball Elementary School (Coolidge Avenue & 18th Street)

Traffic Characteristics: Kimball Elementary School covers two city blocks and is bordered by Harding Avenue on the west, 18th Street on the north, Hoover Avenue on the east, and 19th Street on the south. The intersection of Coolidge Avenue and 18th Street is at the front entrance of the school and forms a "T." Drivers frequently use 18th Street as a thoroughfare for traveling from the western side of the city to National City Boulevard and eastern destinations. Of course, drivers also use 18th Street and other nearby streets to drive students to and from the school and the nearby church at 18th Street and Harding Avenue, which hosts activities and functions for children and adults almost every day. Comparatively, 18th Street accommodates a relatively high traffic volume when measured against other neighborhood east-west streets such as 16th and 17th Streets, but the traffic calming measures are not much different.

Issues: Drivers traveling eastbound on 18th Street typically travel at speeds well over 25 mph prior to entering this area due to higher speed limits and minimal traffic calming measures at the entrance to the community at 18th Street and Wilson Avenue (see "Wilson Avenue & 18th Street" section of this report). When these conditions are mixed with children walking to and from school, plus church traffic, these pedestrians are immersed in potentially dangerous conditions. Only one crosswalk paired with a stop sign currently exists along the entire stretch of 18th Street in this study area – crossing 18th Street on the west side of the intersection with Coolidge Avenue. Common to all streets in this residential neighborhood, the streets are wider than necessary, which exposes students and parents to longer crossing times and higher vehicle speeds than what is appropriate for a school zone or a residential street.

- ▶ Provide two more marked crosswalks at the intersection of 18th Street and Coolidge Avenue, with all crosswalks featuring a separate stop bar that forces drivers to stop farther back of the crosswalk. The crosswalks should be painted yellow as is standard for a school zone and could match the diagonal style of the intersection's current crosswalk. Corner bulb-outs at the intersection would reduce pedestrians' exposure to traffic, make pedestrians more visible to drivers, and provide pedestrians with greater visibility. The entire lengths of Coolidge Avenue and 18th Street are ideal for this treatment as they are the primary feeder streets for the school.

- ▶ Diagonal parking, which currently exists in some portions of Coolidge Avenue, would encourage slower driving speeds through reduced street widths, though some workshop participants expressed concern about children playing between diagonally parked cars and increasing their exposure to traffic. Some workshop participants suggested creating a student drop-off area on 19th Street behind the school that includes lighting. Others suggested closing Coolidge Avenue to traffic from the 16th Street to 18th Street and creating a park with vehicular access to residences via the alley, which may be feasible in longer-term planning for the area.

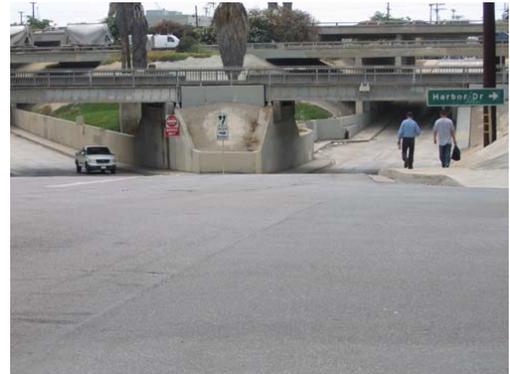
2 Wilson Avenue & 18th Street

Traffic Characteristics: As 18th Street is one of the few east-west streets in the Old Town neighborhood that crosses Interstate 5, it experiences a relatively high volume of traffic. Drivers typically use 18th Street to travel between eastern and western portions of the city, Interstate 5, and National City Boulevard. It also fronts Kimball Elementary School in the Old Town neighborhood (see “Kimball Elementary School” section of this report). Wilson Avenue is the only north-south thoroughfare in the Old Town neighborhood, connecting Mile of Cars Way with Civic Center Drive and Interstate 5 access points on both ends. Land uses on Wilson Avenue are primarily industrial/commercial on the north end, and residential on the south end with the West 22nd Street trolley station. While posted for slower neighborhood speeds, these streets tend to accommodate drivers who are entering the neighborhood from faster roadways, or who are anticipating connections to faster roadways.

Issues: As the roadway travels downhill underneath Interstate 5, drivers tend to pick-up and maintain an accelerated speed along 18th Street through the intersection with Wilson Avenue and toward the school. Additionally, this section of 18th Street is designed in a slight “S” pattern, which limits drivers’ view of pedestrians and traffic on the right side when approaching the intersection. Drivers on northbound Wilson Avenue stop at the intersection, but then must creep through the crosswalk to view the difficult-to-see traffic on eastbound 18th Street that is not required to stop.

The sidewalks on 18th Street under Interstate 5 are of minimal width with no pedestrian buffer zones adjacent to the street. Many children who attend Kimball Elementary School live on the west side of Interstate 5 and walk these sidewalks and cross this intersection via 18th Street. When discussed during the walk audit, workshop participants related a number of vehicle crashes at this intersection, many of which go unreported due to drivers’ lack of insurance. Only one crosswalk currently exists at this intersection, which crosses Wilson Avenue on the south side.

- ▶ Eastbound 18th Street is in need of traffic calming measures, which could include a combination of measures such as narrowing the street, widening the sidewalk, or installing a traffic circle, raised medians near crosswalks, bulb-outs, or bicycle lanes.
- ▶ Crosswalks with stop bars should be added to the other three crossings at the intersection.
- ▶ Improved street lighting at the intersection may improve visibility of pedestrians at night.
- ▶ Public art along the walls on 18th Street under Interstate 5 may help add to the neighborhood’s sense of identity and further discourage speeding.

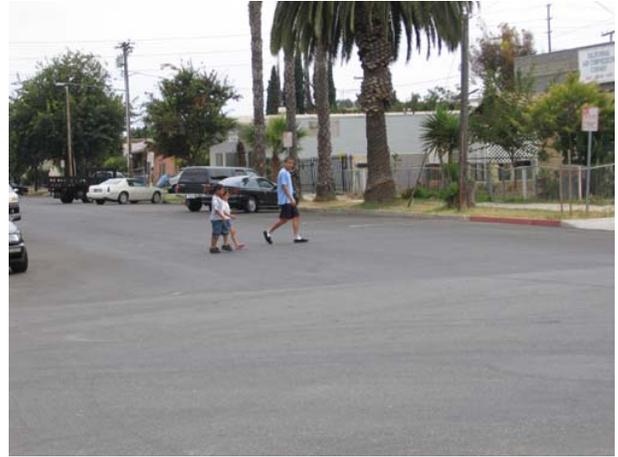
3 Residential Streets

Traffic Characteristics: In addition to use by residents, all neighborhood residential streets are used by commuters and employees of nearby businesses, often as an east-west “short-cut” alternative to the arterial streets of Civic Center Drive, East 18th Street, or Mile of Cars Way. Traffic typically moves faster than the posted speed limit. Several automotive oriented businesses are located on these streets, along with small lot single-family homes and some multi-family housing. Coolidge Avenue functions as the main school route through the neighborhood to Kimball Elementary School.

Issues: For the most part, residential street intersections do not have traffic controls, i.e., stop signs, yield signs, etc., nor marked crosswalks. Lack of these facilities is problematic at all intersections and is especially dangerous at intersections used by school children. Cut-through commuters speeding through residential streets pose a safety problem for pedestrians, with vehicular collisions occurring on a regular basis according to residents; however, due to the particular circumstances of the drivers involved, these accidents are not always reported to the police. School children also report incidents where either they or their friends have had “near misses” with vehicular traffic when crossing streets. Some auto repair shops in the area

double park the vehicles to be repaired so sidewalks are not passable or sight lines are blocked, which may also contribute to accidents. Sidewalks in some areas are cracked and broken. Residents would like to see street beautification, additional trash receptacles where needed, and additional street lighting.

- ▶ Crosswalks and stop bars should be marked at all intersections with installation of curb extensions at select intersections where needed to shorten crossing distances and increase pedestrian visibility. Further study should determine which intersections are the best candidates for curb extensions; however, the main school route along Coolidge Avenue is a prime candidate to receive this treatment. Other intersections suggested for curb extensions include Harding Avenue at 14th Street, 15th Street, 16th Street, and Civic Center Drive.

- ▶ Traffic calming should occur through a combination of traffic circles at intersections, additional stop signs, and painted lines to narrow lanes.
- ▶ All street curb corners should be painted red at intersections to improve the sight lines for oncoming traffic and coupled with a diligent enforcement program so violators understand that offenses will not be tolerated.

- ▶ Center lines should be marked on Harding, Coolidge, and Hoover Avenues, and their cross streets, which effectively narrows the traffic lane, as vehicles can no longer speed down the center of the street.

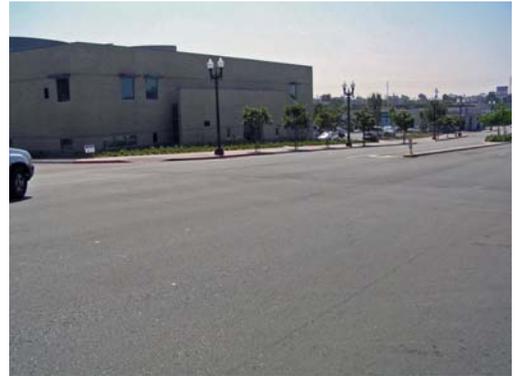
4 National City Boulevard between Civic Center Drive & 16th Street

Traffic Characteristics: National City Boulevard is a major arterial thoroughfare, with four lanes of traffic, some signalized intersections, and parallel parking on both sides of the roadway. Recent improvements have added positive pedestrian features to the roadway including a planted median, sidewalk improvements, and historic street lights.

Issues: The newly opened Library at East 15th Street and National City Boulevard has no marked crosswalks to enable pedestrians coming from the west side of National City Boulevard to safely access the facility. Additionally, there are no marked crosswalks to the Library from the immediately adjacent cross streets. Residents noted that the Library’s entry area is not inviting for pedestrians as it seems more car-oriented.

- ▶ Install marked crosswalks and curb extensions at National City Boulevard’s intersections with 14th and 15th Streets. Consider installation of a pedestrian activated light to further create safe crossings in this area for residents trying to reach this area from west of National City Boulevard.
- ▶ There should be safe and direct walking routes from the surrounding residential areas to the Library. Install marked crosswalks and supporting safety improvements as needed.
- ▶ Beautify the library’s entry area with plantings, shade, signage and interesting public art so it is more appealing to pedestrians. Sign the exiting driveways from the Library to alert drivers to pedestrians and consider paving treatment within the Library parking lot to enhance pedestrian circulation safety.

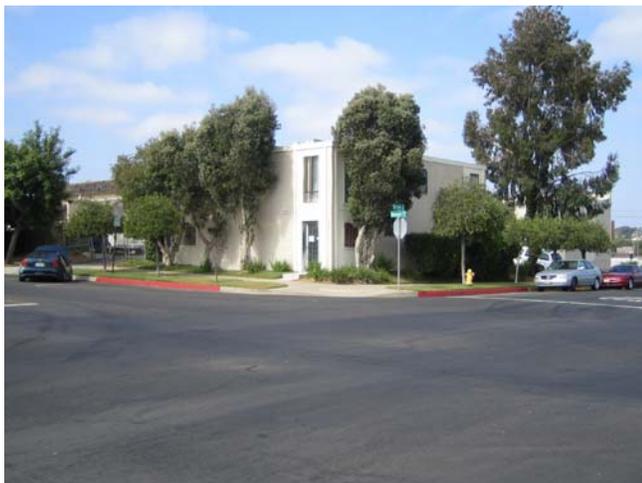
5 16th Street / Roosevelt Avenue / West Avenue Intersection

Traffic Characteristics: The intersection of West Avenue, 16th Street, and Roosevelt Avenue is designed for two lanes of traffic with parallel parking on both sides. West Avenue meets the intersection at an angle, which is different than most street intersections in the area.

Issues: Vehicles traveling south on Roosevelt gather speed on the hill, while vehicles traveling north on West Avenue are going uphill and do not have good sight distance as they approach the intersection at the crest of the slope. The intersection is not marked with crosswalks for pedestrian use, which when combined with excessive vehicle speeds and the long distances between street corners, creates an unsafe situation for pedestrians.

- ▶ Install marked crosswalks with curb extensions to shorten crossing distances.
- ▶ Consider installation of pedestrian-activated flashing lights embedded in the crosswalk to alert drivers to pedestrian traffic between Hoover and Roosevelt Avenues. Further study would be needed to determine if such an improvement is warranted.

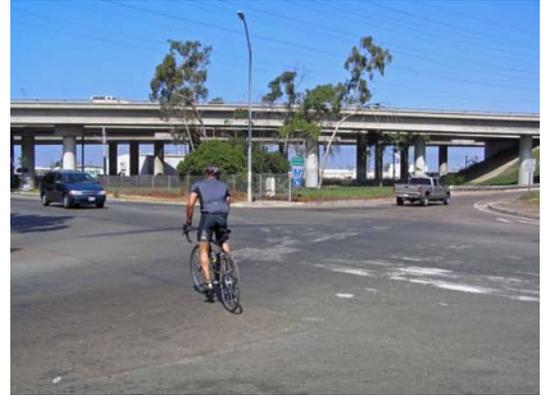
Wilson Avenue, Civic Center Drive & I-5 Onramp

Traffic Characteristics: The intersection of Wilson Avenue, Civic Center Drive, and the northbound I-5 onramp is located at the northwest corner of the study area. Traveling east on Civic Center Drive showcases the neighborhood's recent pedestrian improvements with an abundance of attractive street lighting and relatively wide and improved sidewalks.

Issues: Civic Center Drive's wide sidewalks and historic street lighting terminate at this intersection. Wilson Avenue and Civic Center Drive are still wide streets that encourage faster vehicle speeds. Pedestrians are forced to cross the spacious intersection without crosswalks. Crossing the entrance to the I-5 onramp is particularly harrowing for pedestrians as the northeast curb's wide turning radius facilitates faster turning speeds onto the onramp. The sidewalk ramp on this corner fronts Civic Center Drive, but pedestrians using the ramp and crossing the onramp must spend more time exposed to traffic. Similarly, the sidewalk ramp on the northwest corner faces east for crossing the onramp, so pedestrians using the ramp and crossing south across Civic Center Drive are exposed to traffic longer than necessary.

- ▶ The intersection is a strong candidate for a traffic circle to calm traffic. The onramp to I-5 is adequately long for vehicles to build speed for entering the highway from the intersection, so traffic calming measures should not cause unsafe driving conditions on the onramp.
- ▶ The corners would benefit from bulb-outs that would reduce pedestrians' exposure to traffic, make pedestrians more visible to drivers, and provide pedestrians with greater visibility. Such treatments could include attractive landscaping, would complement the existing improvements on Civic Center Drive, and would serve as a pleasant gateway to the neighborhood.

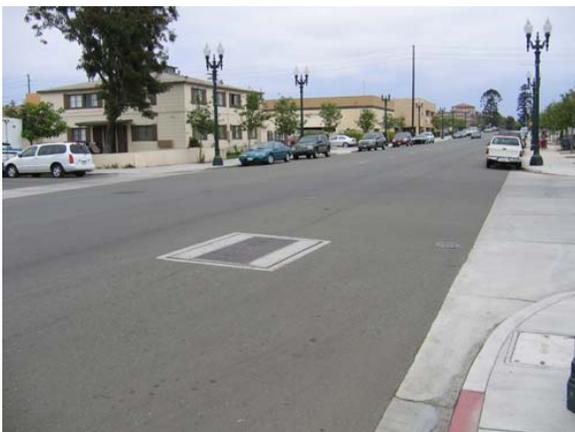
Civic Center Drive between Harding Avenue & National City Boulevard

Traffic Characteristics: Civic Center Drive is a busy roadway that carries vehicular traffic between freeway on- and off-ramps and up to National City Boulevard. It has four lanes, parallel parking on both sides, wide sidewalks, plantings, and attractive street lighting. Except for a traffic signal at National City Boulevard, there are no other traffic signals.

Issues: Civic Center Drive is considered too wide for safe crossing by residents and acts as a barrier for pedestrians coming from the residential streets to the north. These residents feel left out of the Westside Specific Plan process, consider their area to be a part of the Old Town neighborhood, and want it included in planning and implementation activities. Residents feel that while the historic street lighting on Civic Center Drive is attractive, light standards are spaced too close, making the street too bright at night and affecting adjacent homes. Additional features to improve the pedestrian environment for local residents were also mentioned, such as more shade trees and benches.

- ▶ Install curb extensions and a marked crosswalk at the intersection of Civic Center Drive and Coolidge Avenue, which is along the main route to Kimball Elementary School.
- ▶ Residents suggested that some street lights from Civic Center Drive be moved to 12th Street where there is a need for additional lighting. Another alternative to reduce brightness could be use of lower wattage bulbs or a different bulb type, which would also reduce energy usage.
- ▶ Consider installing some benches in select appropriate areas along Civic Center Drive.

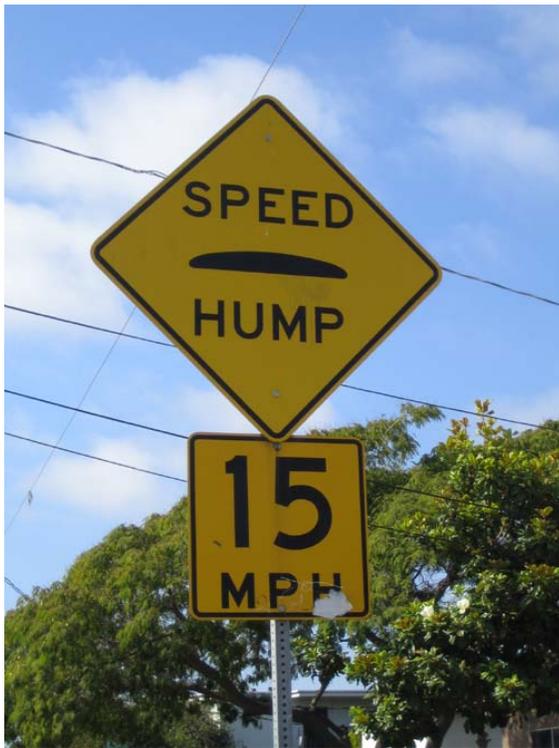
9 Wilson Avenue between 18th Street and Civic Center Drive

Traffic Characteristics: Wilson Avenue has two traffic lanes with parallel parking on both sides but no traffic control south of Civic Center Drive. The street is excessively wide, which encourages speeding from vehicles traveling between the two major east-west cross streets, Civic Center Drive and Mile of Cars Way. The west side of Wilson Avenue in this area is made up of industrial uses, while the east side of the street has a mix of industrial businesses and residences on small lots.

Issues: High traffic volumes and speeding during commute hours is the biggest problem for this section of Wilson Avenue. Littering from employees in the area was also mentioned by the residents.

- ▶ Adding a stripe to delineate the parallel parking area from the traffic lane would effectively narrow the street with potential to slow traffic. Installation of a traffic light at 18th Street has been previously mentioned, while residents suggested that stop signs may be appropriate at other intersections.

- ▶ Residents also suggested that speed bumps and lower speed limits may be appropriate; however, studies show that use of speed bumps need to be considered very carefully, as they are often not effective and only serve to anger drivers. Additionally, their use is not recommended if Wilson Avenue is a main route for emergency vehicles. WalkSanDiego typically does not endorse use of speed bumps. While lower speed limits can be very effective when law enforcement is present to vigorously enforce them, it is recognized that police officers have many duties and cannot always be available for this purpose.

- ▶ WalkSanDiego suggests further study to determine which portions and intersections of Wilson Avenue pedestrians are using most frequently and focus improvement efforts on those areas or encourage alternate routes for pedestrians.

- ▶ Additional trash receptacles, maintained by the City, could be placed on the streets to reduce litter.
