**MIAMI
WATERKEEPER®**

Attachment A
Miami Waterkeeper
Stormwater Inspection Report (excerpts)
Inspection Date: 11/7/17

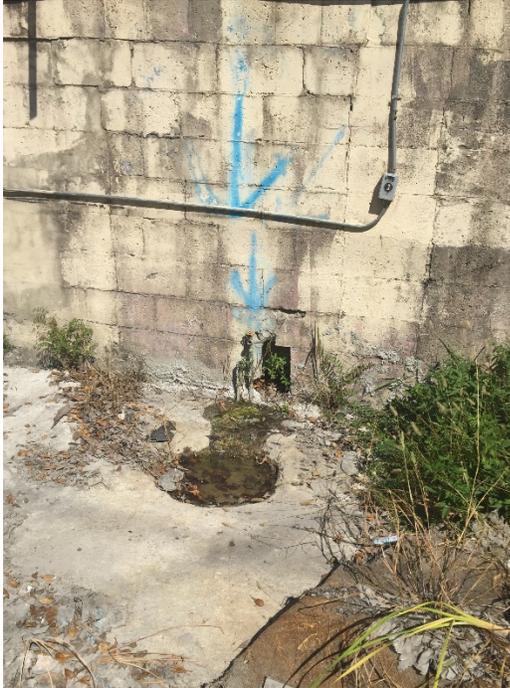
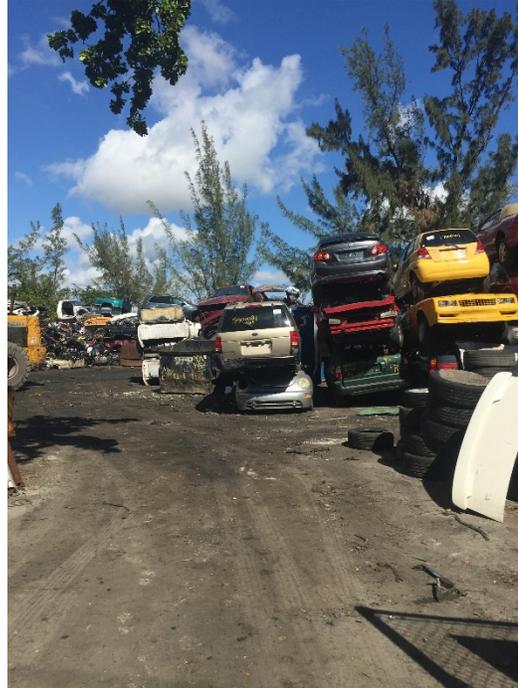
Site address: 3737 NW South River Drive, Miami, FL 33142

Field Observations: No access. Vehicle access restricted by locked gate and pedestrian access is only through an office. Photos were only able to be obtained through one gate. All scrap, parts, and vehicle storage are on bare ground (no pavement/gravel). Piles of scrap and numerous vehicles are located directly adjacent to the Miami River on the north side of the site. A sparse row of Australian pines is located between these storage areas and the river. No physical barrier was observed between the trees/storage area and the river. The site is above grade. Surface water flow direction appears to be north to northeast. Potential for debris and/or contaminants to enter the river from the storage area exists. One stormwater outfall was observed adjacent to the south of the site. Potential for stormwater/contaminates to enter the stormwater outfall and enter the receiving water body exists.

(pictures taken next to site)

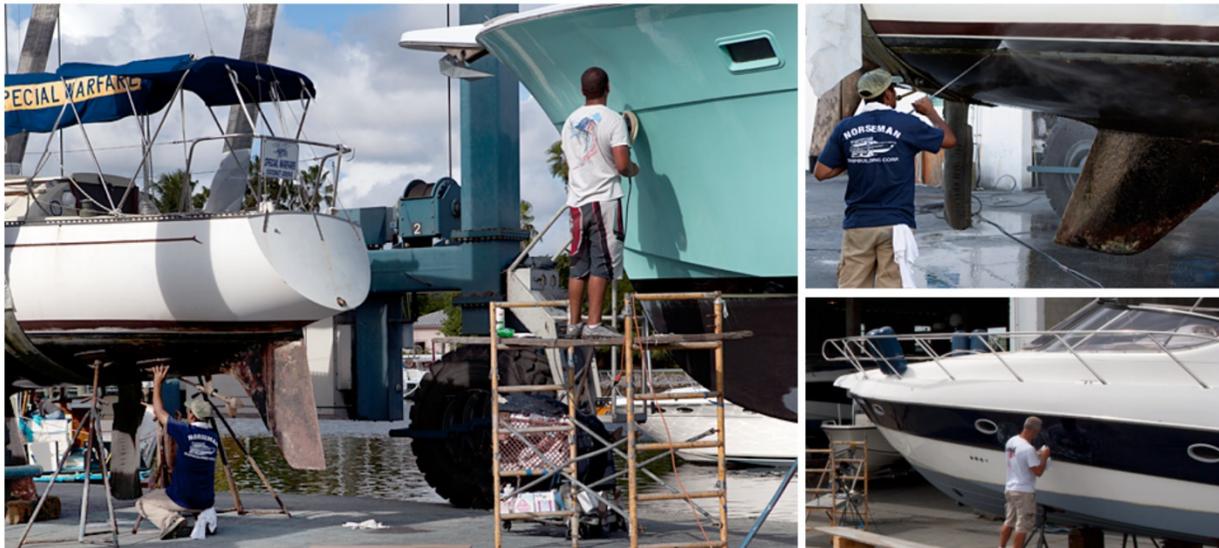
Site address: 437 NW S. River Dr., Miami, FL 33128

Field observations: No access. Vehicle access restricted by locked gate and pedestrian access is only through an office. No Photos Taken. Website still shows pictures of people conducting boat maintenance including pressure washing outdoors, without cover.

(from Norseman Shipbuilding website)
